UNITED STATES  
NUCLEAR REGULATORY COMMISSION  
OFFICE OF INSPECTION AND ENFORCEMENT  
WASHINGTON, D.C. 20555

October 17, 1979  
IE Bulletin No. 79-13  
Revision 2  
Page 1 of 5

CRACKING IN FEEDWATER SYSTEM PIPING

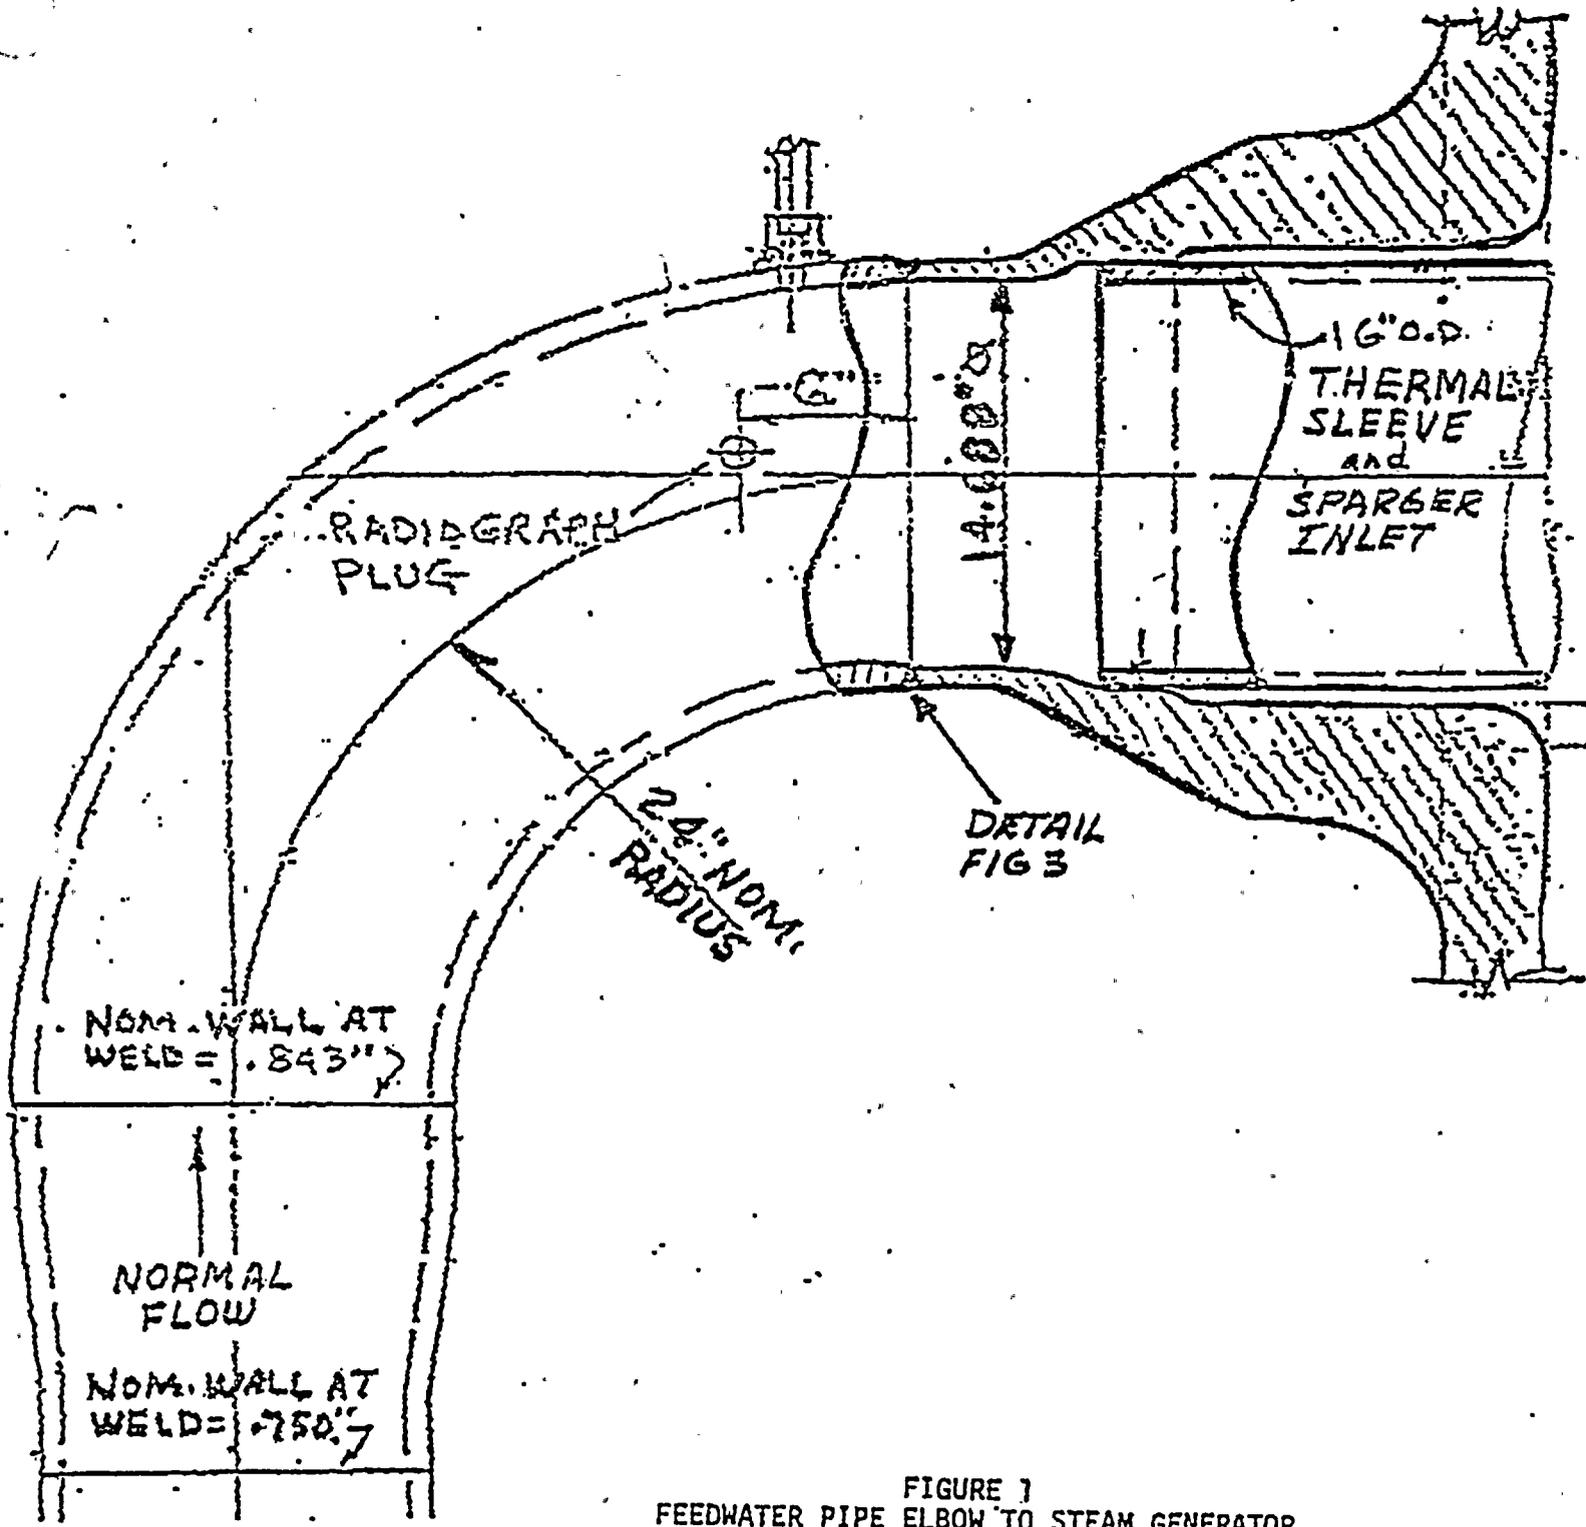
FIGURE 1  
FEEDWATER PIPE ELBOW TO STEAM GENERATOR  
NOZZLE INSTALLATION (DC COOK)

The feedwater nozzle-to-pipe configurations for D. C. Cook and for San Onofre are shown on the attached figures 1 and 2. A typical feedwater nozzle-to-pipe weld joint detail showing the principal crack locations for D. C. Cook and San Onofre are shown on the attached figure 3.
