ACCESSION NBR: 8002040417 DOC. DATE: 80/01/30 NOTARIZED: NO DOCKET #
 FACIL: 50-410 Nine Mile Point Nuclear Station, Unit 2, Niagara Moho 05000410
 ADTH. NAME AUTHOR AFFILIATION
 RHODE, G.K. Niagara Mohawk Power Corp.
 RECIPIENT NAME RECIPIENT AFFILIATION
 RUBENSTEIN, L.S. Light Water Reactors Branch 4

SUBJECT: Forwards geological info for util as per 791025 ltr to NRC.
 Response to Request 361.5 will be provided by 800229.
 Response to Request 361.24 will be submitted w/responses to
 remaining four requests by 800601.

Re: Nine Mile Point Unit 2
Docket No. 50-410

Our letter of October 25, 1979 provided a schedule for providing geological information for Nine Mile Point Unit 2. Attached is this information except for Requests 361.5 and 361.24.

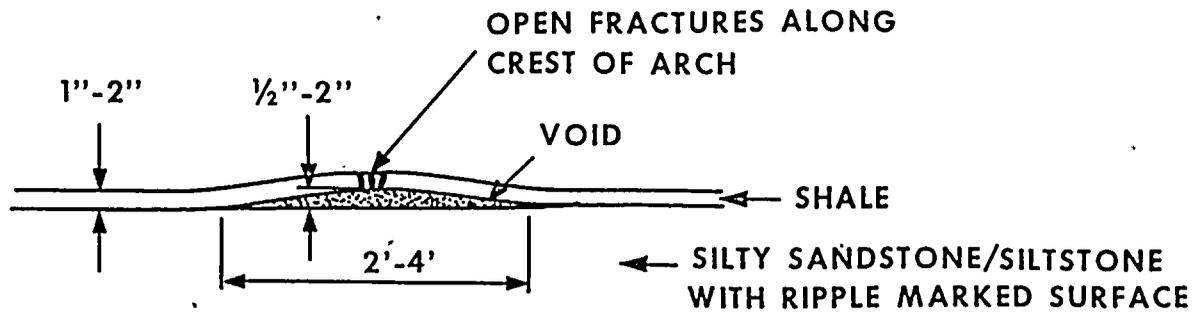
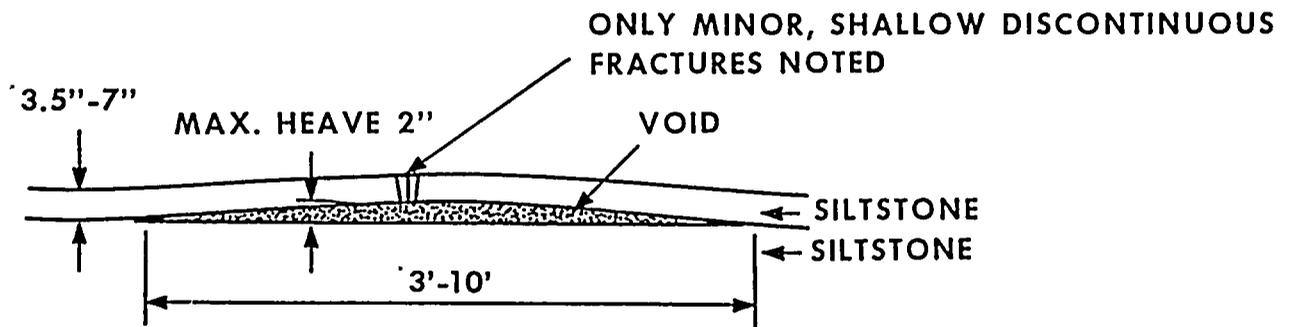
FIG 361.4-1

A buckle fold in the Control Building was noticed on August 12, 1976, following removal of muck which had been left in place since February 3, 1976 when a 25-foot rock column was blasted. Therefore, a period of six months, including the last part of winter, was available for heave development. This buckle appeared in a 1 to 2 inch thick shale layer overlying silty sandstone-siltstone, was 35 to 40 feet long and 2 to 4 feet wide with a N35°W trend, a 2-inch maximum amplitude and cracks on the crest (Figure 361.4-1). The floor of the Control Building excavation is 38 feet below the original bedrock surface.

The floor in the Circulating Water Encasement had not shown any anomalous features for four months from May 19, 1976, when the rock was removed immediately after blasting to September 20, 1976, when the floor was cleaned and geologically inspected. The buckle was discovered six months later at the beginning of April 1977, when the floor was again inspected in preparation for pouring mat concrete. The buckle was approximately 14 feet long and the crest-line was oriented N08°W to N30°E. The wave length of the buckle ranged from approximately 3 feet to 9.5 to 10 feet and the amplitude 1.75 inches. Dilation was apparent between a folded siltstone bed and an underlying siltstone bed creating a 1.75 inch void. The thickness of the arched layer ranged from a minimum of 3.5 inches to a maximum of 7 inches (Figure 361.4-1). The floor of the Circulating Water Encasement excavation is 35 feet below the original bedrock surface. Each of these buckle folds were confined to the floors of the excavations and did not affect the bedrock walls.

Once the rock loosened by the buckles was removed, no further buckling was noted, and the area was subsequently covered with fill concrete mud mats.

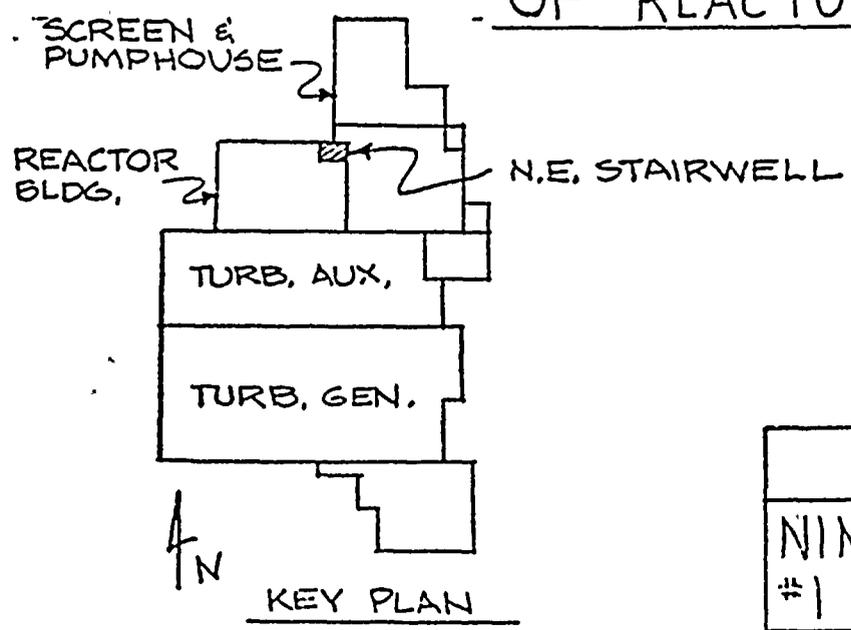
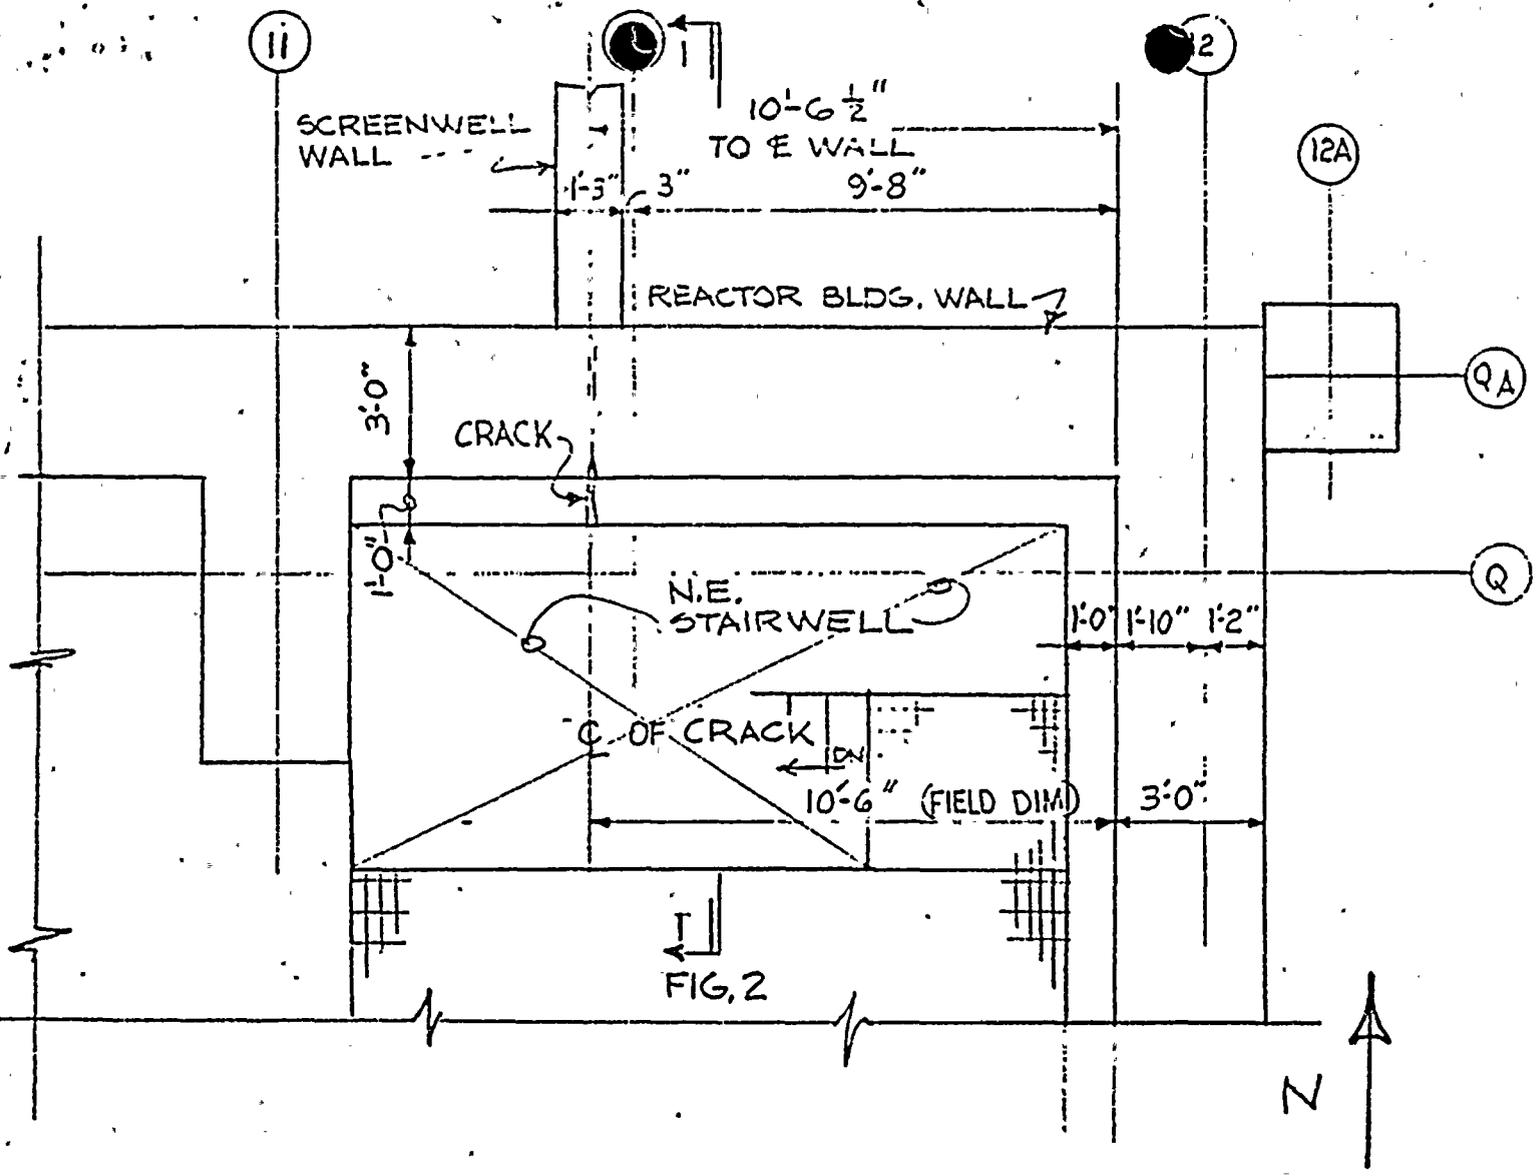
NIAGARA MOHAWK P.C.	
NINE MILE PT. NUCLEAR STA #1 REACTOR BLDG. WALL CRACK	
DESIGNER	DATE 1-30-52 SCALE 1/8"=1'-0"
FIGURE #1

RESPONSE The location and dimensions of the crack were originally documented in March 1977 (see Figures 1 and 2). It is located in the exterior north wall of the Nine Mile Point Unit 1 Reactor Building approximately 10.5 feet to the west of the east wall. At its maximum, it is one-eighth of an inch wide at a point approximately eighteen inches below the one foot ledge at Elevation 237 feet. At a point six feet below the ledge, it is approximately 1/32 inches wide. The crack extends down from the ledge at Elevation 237 feet approximately eight feet and extends above the ledge about the same distance. The upper and lower ends of the crack disappear in a random hairline pattern.

The cause of the crack has not been determined. As shown in Figures 1 and 2 the west wall of the Screenwell Building is in contact with (but not attached to) the north wall of the Reactor Building. With this structural configuration, there are several ways that the west wall of the Screenwell Building could contribute to the cause of the crack. Cracking of concrete can be attributed to relatively low temperature changes causing elongation in the intersecting Screenwell Building wall during original construction. From the attached figures, it can also be seen that small movements of the rocks supporting the Screenwell Building wall could produce sufficient load to cause the cracking in the Reactor Building wall.

When the crack was originally found in March 1977, a measurement was taken perpendicular to the wall to a reference point in the stairwell. This measurement was checked in May 1979 and negligible change was recorded. The present monitoring system consists of two parallel bars anchored side-by-side, one to each side of the crack line at elevations 236 feet and 232 feet (see Figure 3). This system will detect horizontal movement of the crack (widening) by separation of the two parallel bars anchored side-by-side. Vertical elongation of the crack is being monitored by means of measurement with a tape. Measurements are taken semiannually.
