Docket No. 50-410

IE Information Notice No. 80-08
Date: March 7, 1980
Page 1 of 1

THE STATES COMPANY SLIDING LINK ELECTRICAL TERMINAL BLOCK

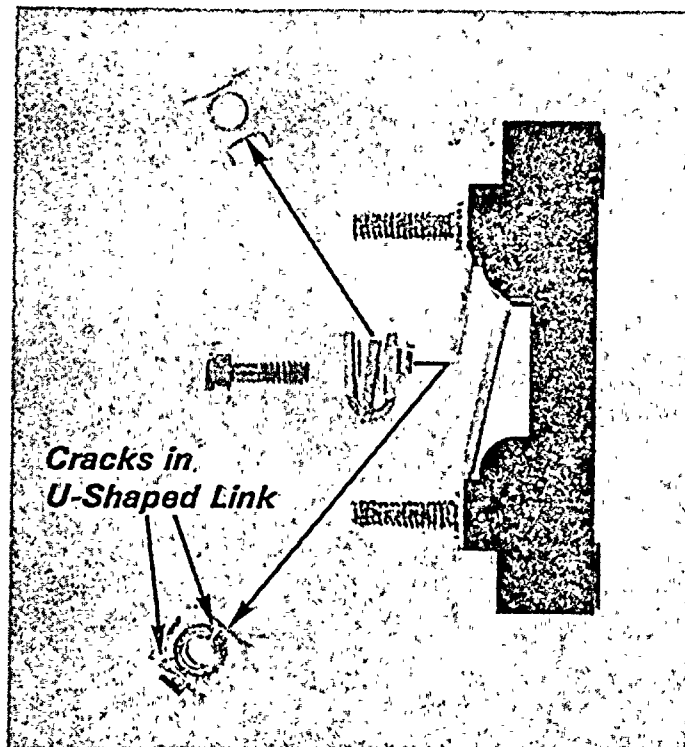
The defect, which has been identified in 5% of the terminal blocks checked, occurs in the form of a crack between the threaded screwhole and the side of the U-shaped link. When the screw is tightened the crack widens and a poor or intermittent electrical connection can result. A defective link is impossible to cinch tightly in place and is difficult to detect visually.

Attachment 1 shows the States Company terminal block. The defect, a crack in the bottom portion of the metal U-shaped link, is displayed in the exploded view of the terminal block assembly. These terminal blocks are widely used in the nuclear industry and may be used as permanent installations in safety related systems. The defective mechanical connection can cause an electrical circuit malfunction.

Exploded View of
States Company Terminal Block
