Re: Nine Mile Point Unit #2
Docket No. 50-410

BIOLOGICAL SHIELD WALL

INTERIM REPORT

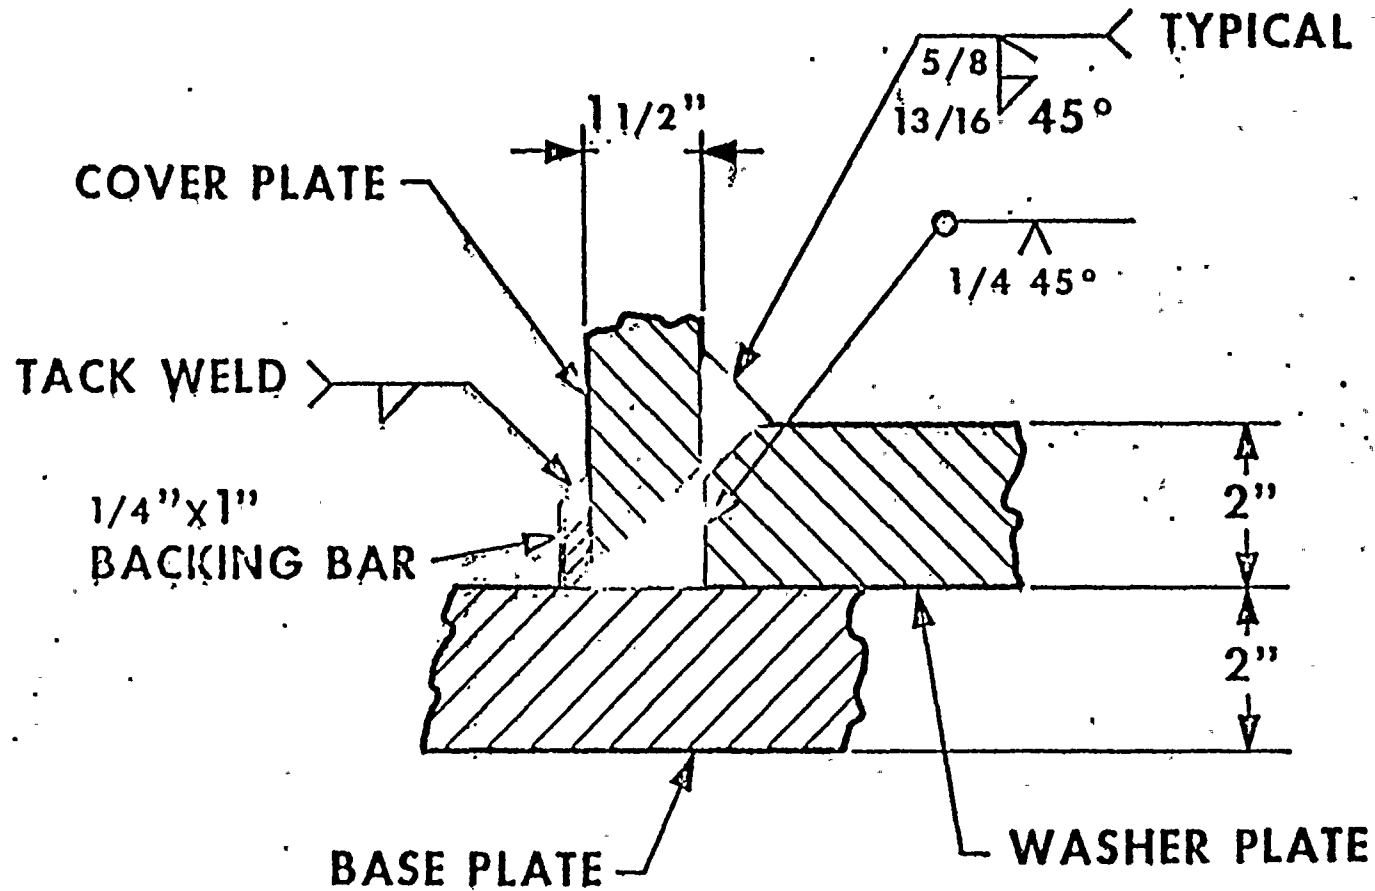
FIGURE 5

June 1. A specimen was removed from the base plate to perform a metallurgical examination of cover plate to base plate indications (Figure 5).

An approximately 18-inch-long section of the cover plate to base plate weld was removed for metallurgical analysis in June 1979. The analysis is complete and shows that no defects greater than 1/8 inch were present in the sample and that the small defects which were considered to be welding and fabrication related had arrested themselves in ductile areas. With the exception of the observed small defects (up to 1/8 inch), the overall metallurgical quality of the welds was considered acceptable.

- July 3. The cover plate to base plate weld joints were dispositioned to require 100 percent UT inspection and repaired as required. The UT was performed in accordance with AWS D1.1 with a 1/8 inch exclusion allowed at the root of the weld (based on engineering evaluation). This UT was completed (with the exception of two indications which are currently under engineering evaluation) in September 1979.

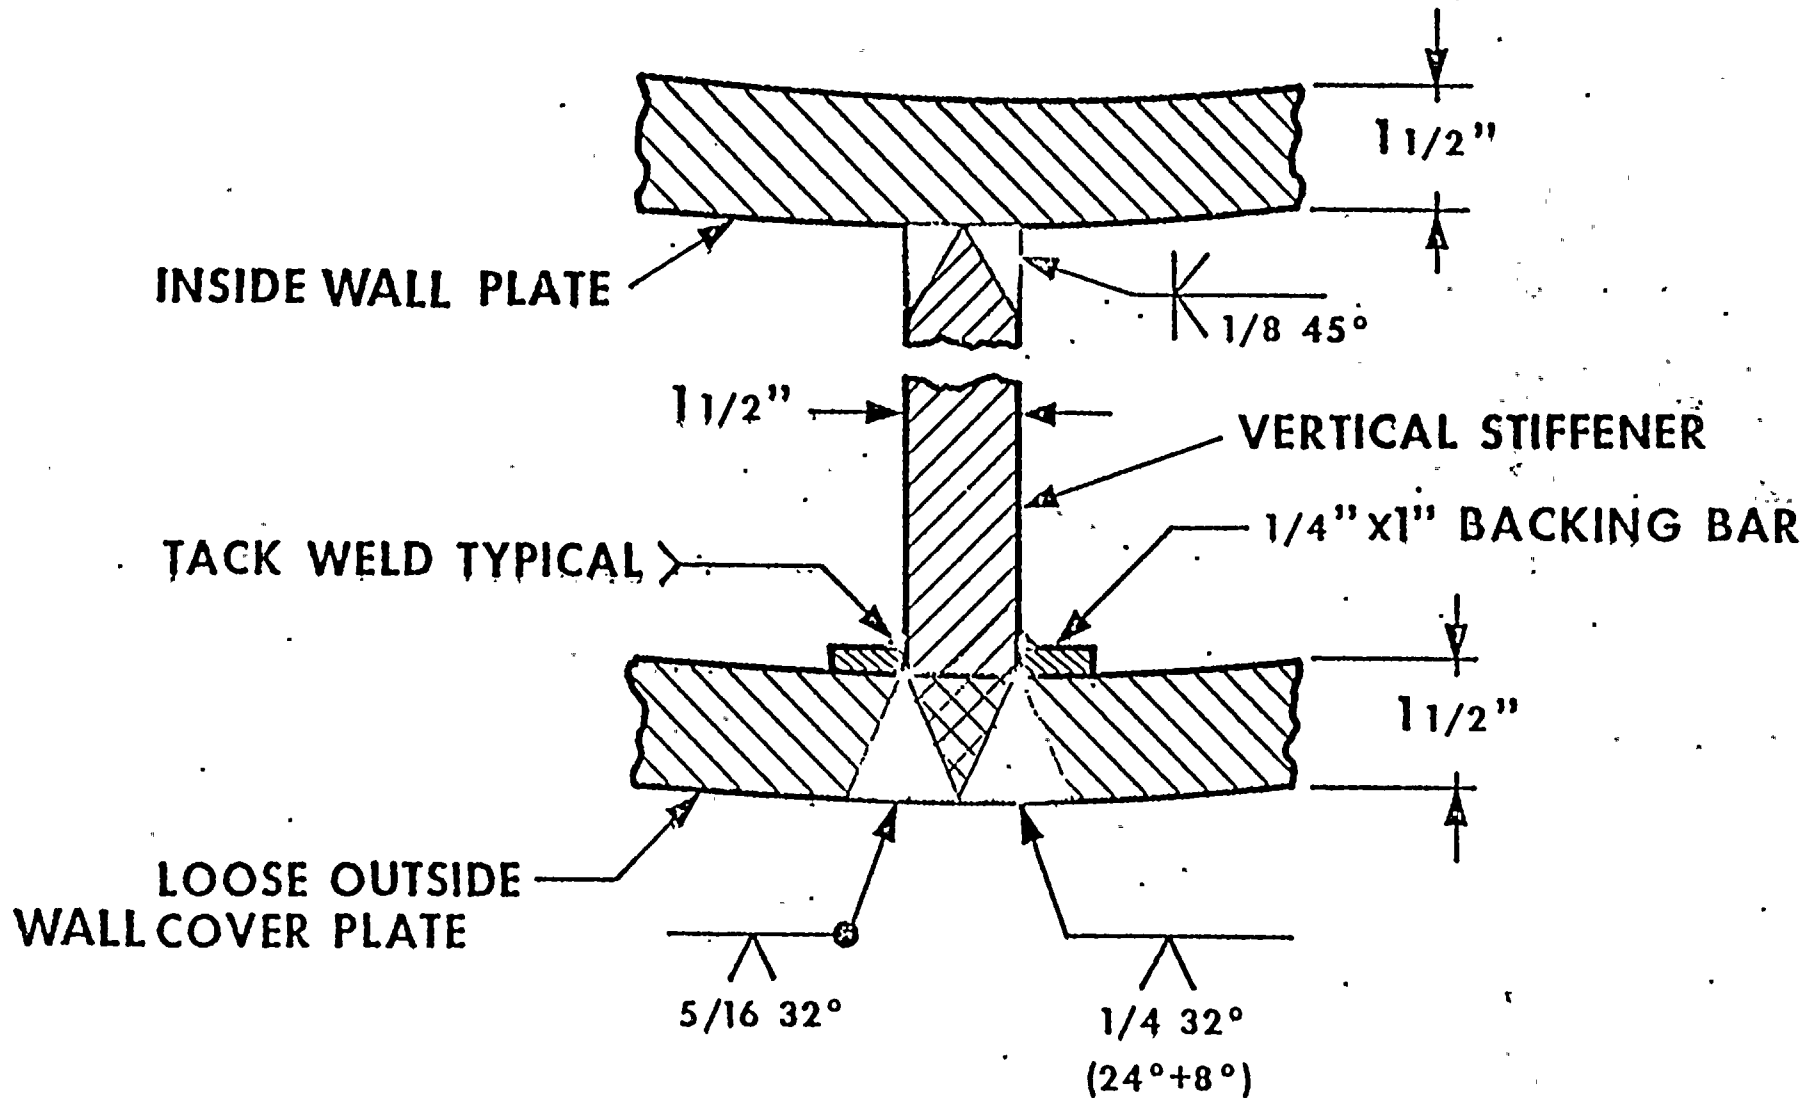
FIGURE 6

The results of the inner wall to stiffener sample plans showed that the first and third ring horizontal stiffener to inner wall (Figure 8) and the third ring vertical stiffener to inner wall (Figure 6) weld groups were rejectable. Therefore, the inner wall to stiffener welds on all three rings are being ultrasonically inspected from the inner wall side. Special UT techniques have been developed for the inspection of these welds. These UT techniques are qualified by the use of a test block and are not standard AWS techniques. The UT defect sizes and locations larger than 1/8 inch will be mapped. The 1/8 inch criteria deviates from AWS D1.1 but has been determined to be acceptable by engineering evaluation. Dependent on the defect sizes and locations, repairs will be performed, as required, based on engineering evaluation to determine allowable defect size for given locations.

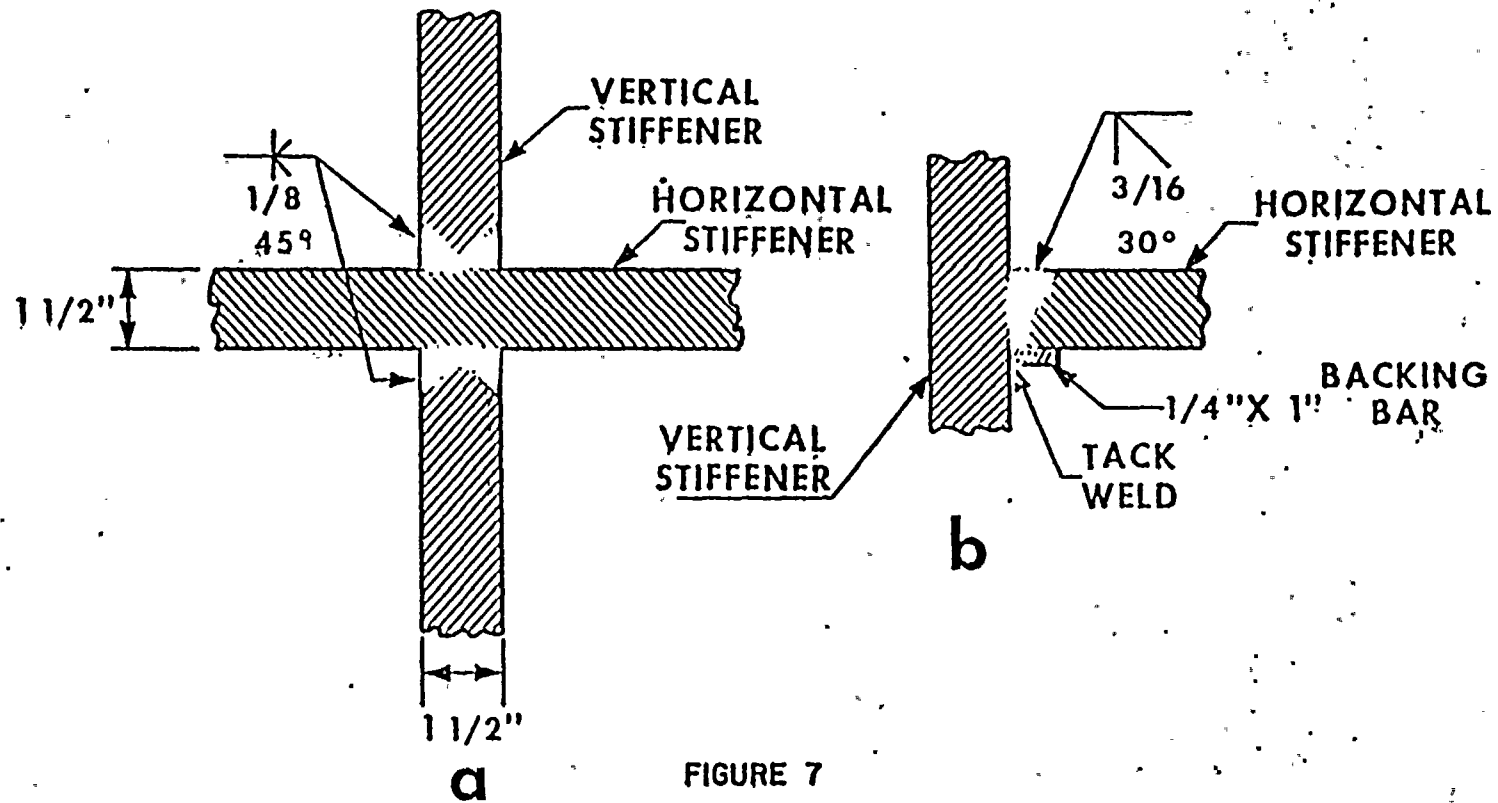
FIGURE 7

A large majority of the horizontal stiffener to vertical stiffener and vertical stiffener to horizontal stiffener (Figure 7) weld joints are inaccessible. In order to determine their acceptability, the UT defect data from the horizontal stiffener to inner wall and vertical stiffener to inner wall examinations will be used in an engineering evaluation.

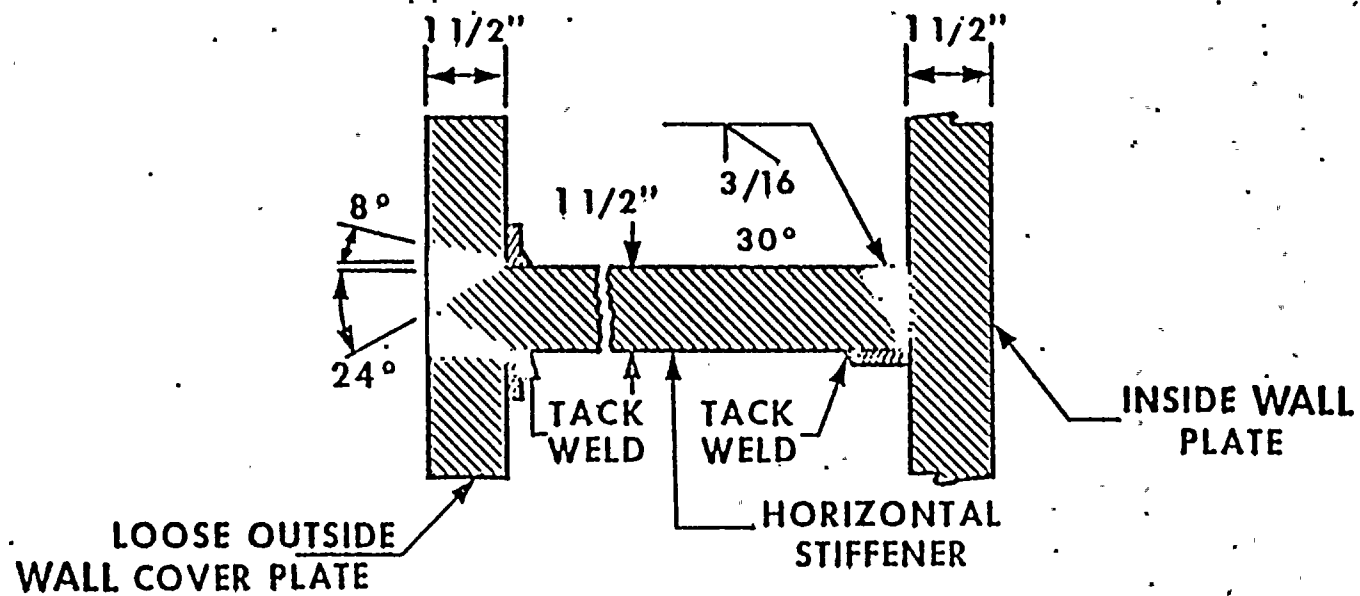
FIGURE 8

June - 2. UT and MT inspections of the horizontal stiffener to inner wall (Figure 8) welds for all three rings were performed. The inspections were performed on random accessible welds. (MT results are shown in Appendix D.)
July

July Based on unacceptable defects discovered by MT in the third ring horizontal stiffener to inner wall welds, additional MT inspection was performed on all accessible third ring horizontal stiffener to inner wall weld joints (approximately 2,000 inches out of a total of 6,000 inches).

By evaluation of data obtained to that time, it was concluded that the horizontal stiffener to inner wall welds on the first and second rings were acceptable but the third ring horizontal stiffener to inner wall welds were rejectable and would require complete reinspection and rework, as required.

The evaluation of two metallurgical samples (removed in November 1979) of the horizontal stiffener to inner wall welds, discussed in our interim report dated January 15, 1980, showed that the weld defects present in the sample were small, and that the largest detected defect arrested itself in a ductile area.

A third metallurgical specimen was taken in February 1980 from the horizontal stiffener to shield wall welds and was found to contain a 3/8 inch defect. A final report on the third specimen is currently being prepared. Although the fracture surface shows that a weld repair which was done adjacent to this defect probably has not affected the defect length, a fourth specimen, free of these complications, has been removed in April 1980 for evaluation. At this time, a determination has not been developed to the precise cause of the defects.
