Re: Nine Mile Point Unit 2
Docket No. 50-410

A potential deficiency involving the possible future movement of the Nine Mile Point Unit 2 Radwaste Building geologic feature was initially reported by telephone to Mr. A.C. Cerne of your staff on December 4, 1979. Since the investigation of the Radwaste Building geologic feature has not been completed, this letter serves as an interim report.

Q361.1

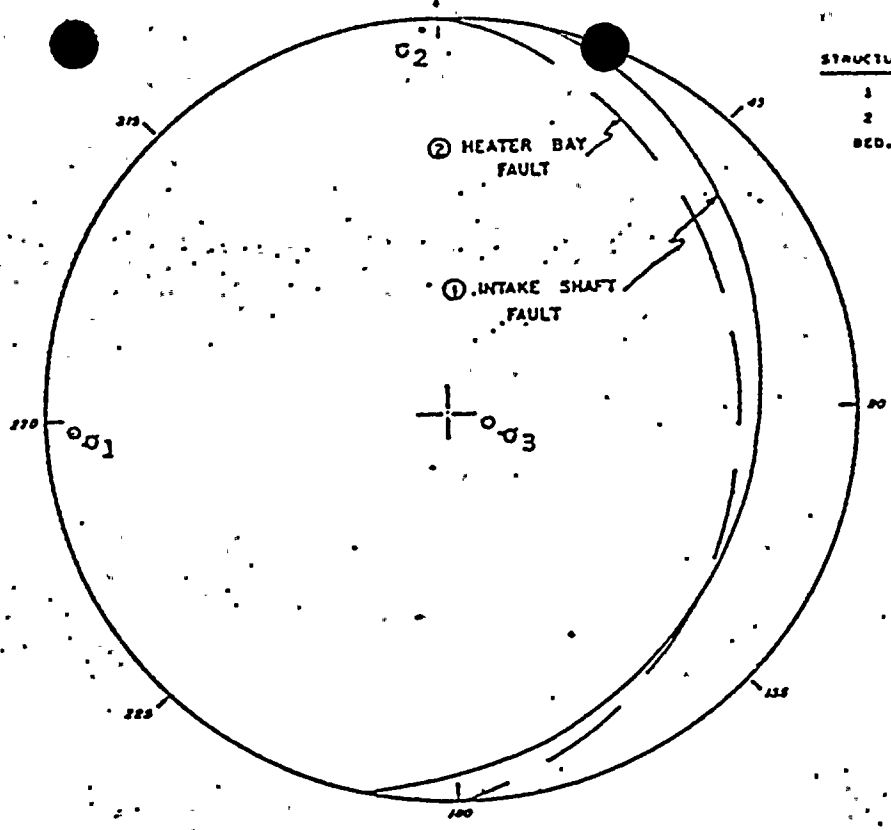
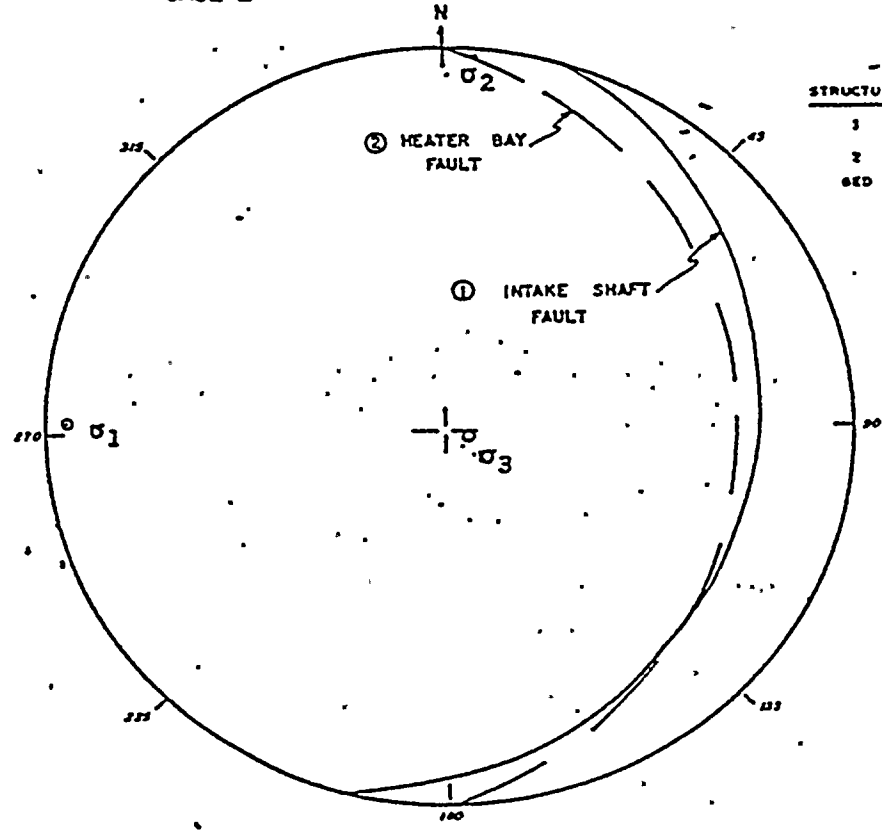
FIGURE 361.1-1

The stress tensor determined from strain-relief measurements in the Intake Shaft (NMPC, Vol. III, 1978) is commensurate with the orientation and sense of the slip vector indicated by the displacements identified along the Radwaste Fault and the east-dipping shaft fault. The stability of these faults has been evaluated as shown on Figure 361.1-1. For two cases (Table 3-18, Vol. III, NMPC, 1978) the normal stress and shear stress on the faults and on bedding were resolved from the three principal stresses, and the results are tabulated for each case (Figure 361.1-1).

Comparison of the computed values of shear stress with the shear strength for the east-dipping inclined faults reveals they are approximately equal if friction and cohesion parameters from laboratory testing are applied to analysis of the entire fault as a hypothetical, idealized plane. The irregular geometry of the fault (ranging in dip from 0 to 50 degrees) and the asperities on the fault plane contribute to the stability of the faults.

SHOWING RELATION OF PRINCIPAL STRESS ORIENTATIONS TO EAST-DIPPING THRUST FAULTS
