SUBJECT: Interim deficiency rept, originally reported on 810227, re possible horizontal crack in Unit 2, primary containment liner base, ring T-weld. Ultrasonic exam of joint will be performed using dual pitch & catch technique by 810831.

NINE MILE POINT UNIT 2

Interim Report to Potentially  
Reportable 10 CFR 50.55(e) Deficiency  
Involving the Primary Containment  
Liner Base Ring T-weld

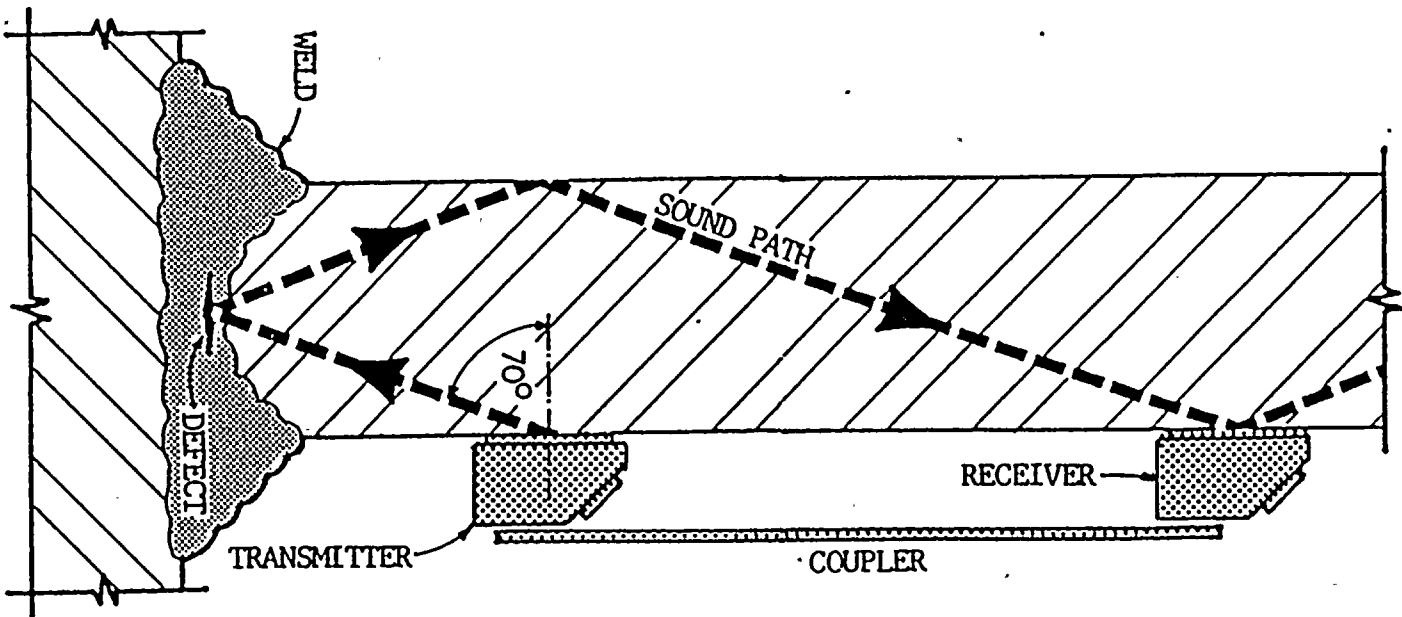
FIGURE 1

A review of the ultrasonic examination performed on the joint has been conducted. It was concluded that it was performed according to ASME III NF 5000 code requirements and that the single 45° and 70° transducer used is sufficient to detect the type of indications normally found in this type of weld joint. A study of the techniques used to examine the weld was made on samples from the River Bend Project which contained the horizontal defect and it was concluded that the single 70° and 45° transducer would not reliably detect the unique horizontal defect, but a dual 70° pitch and catch technique (as shown in the attached Figure 1) would.

Additional ultrasonic examination of the joint will be performed utilizing the dual 70° pitch and catch technique to determine whether the horizontal defect exists and needs to be reworked along with the indications recorded by the single 45° and 70° examinations. This ultrasonic examination will be performed by August 31, 1981 and the results reported to you in a final report by October 30, 1981.
