SUBJECT: Confirms previous verbal communication w/NRC re replacement of all 28-inch recirculation sys piping. Methodology being developed. Revised occupational dose estimate will be submitted w/next quarterly repair program status rept.

Re: Nine Mile Point Unit 1
Docket No. 50-220
DPR-63

Chronology and Conclusions

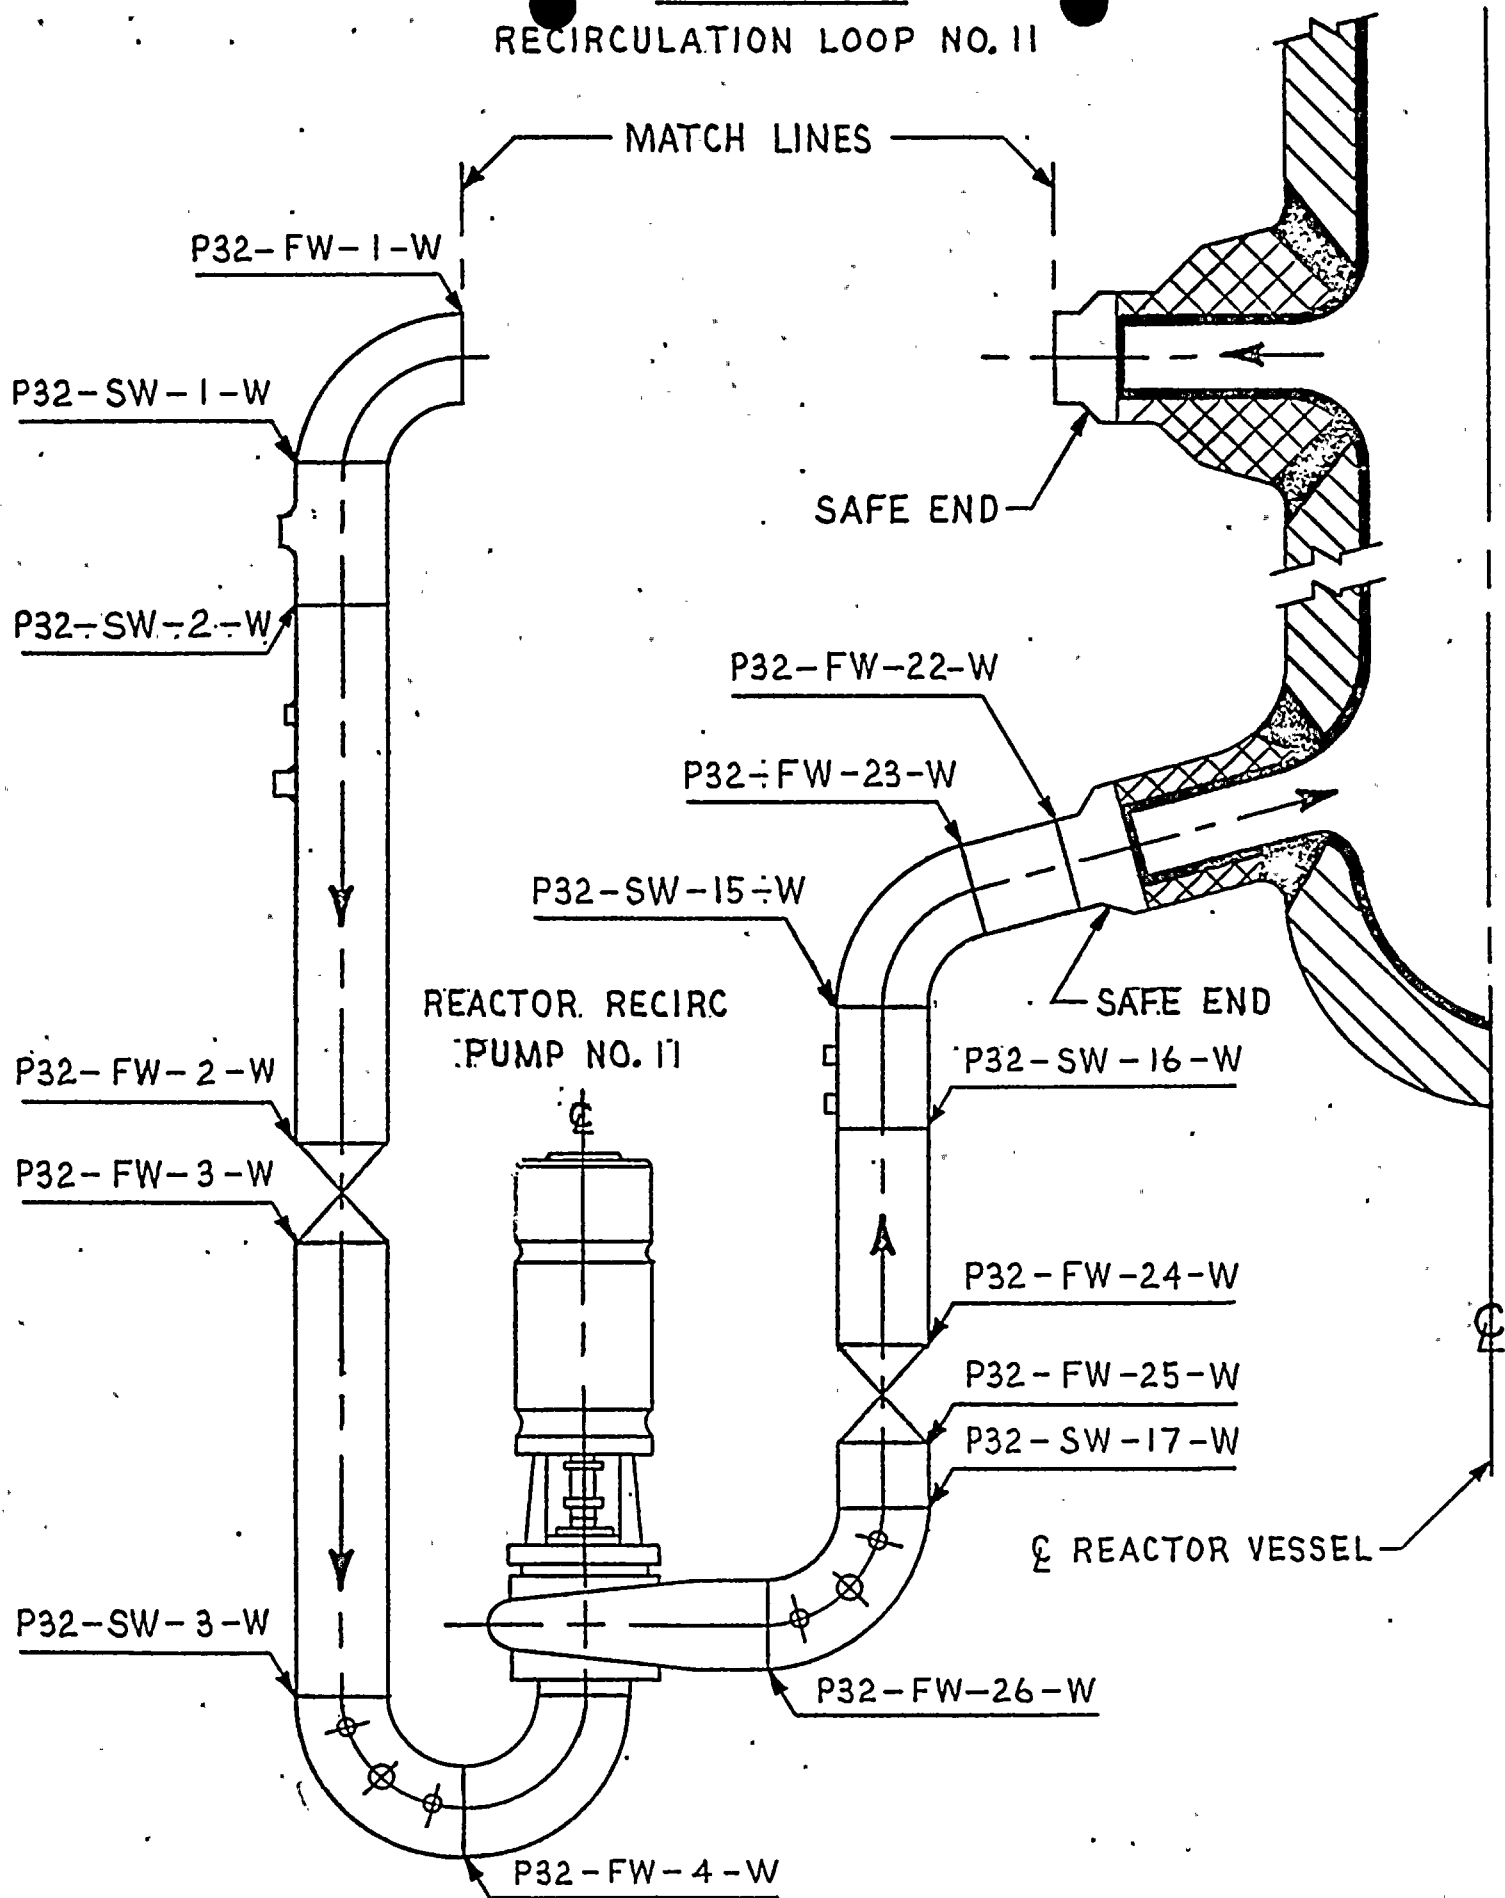
FIGURE 1
RECIRCULATION LOOP NO. II

<u>Weld No.</u>	<u>Ultrasonic Examination</u> <u>--(UT)--</u>	<u>Dye Penetrant Examination</u> <u>--(PT)--</u>	<u>Results⁽¹⁾</u>
<u>No. 11 Recirc. Loop</u>			
P32-FW-1-W		Not Inspected	
P32-SW-1-W		Not Inspected	
P32-SW-2-W	X	-	UT Indications (Increased Gain)
P32-FW-2-W	X	-	UT Indications (Increased Gain)
P32-FW-3-W	X	-	UT Indications (Increased Gain)
P32-SW-3-W	X	-	UT Indications (Increased Gain)
P32-FW-4-W	X	-	UT Indications (Increased Gain)
P32-FW-26-W	X	-	UT Indications (Increased Gain)
P32-SW-17-W		Not Inspected	
P32-FW-25-W		Not Inspected	
P32-SW-16-W		Not Inspected	
P32-SW-15-W		Not Inspected	
P32-FW-23-W		Not Inspected	
P32-FW-22-W		Not Inspected	
<u>No. 12 Recirc. Loop</u>			
P32-FW-5-W		Not Inspected	
P32-SW-4-W		Not Inspected	
P32-FW-6-W	X	-	UT Indications (Increased Gain)
P32-FW-7-W	X	-	UT Indications (Increased Gain)
P32-SW-5-W	X	-	UT Indications (Increased Gain)
P32-FW-8-W	X	-	UT Indications (Increased Gain)

P32-FW-31-W	X	-	UT Indications (Increased Gain)
P32-SW-20-W		Not Inspected	
P32-FW-30-W		Not Inspected	
P32-FW-29-W		Not Inspected	
P32-SW-19-W		Not Inspected	
P32-SW-18-W		Not Inspected	
P32-FW-28-W		Not Inspected	
P32-FW-27-W	X	-	Code UT Indications Plus Leaks

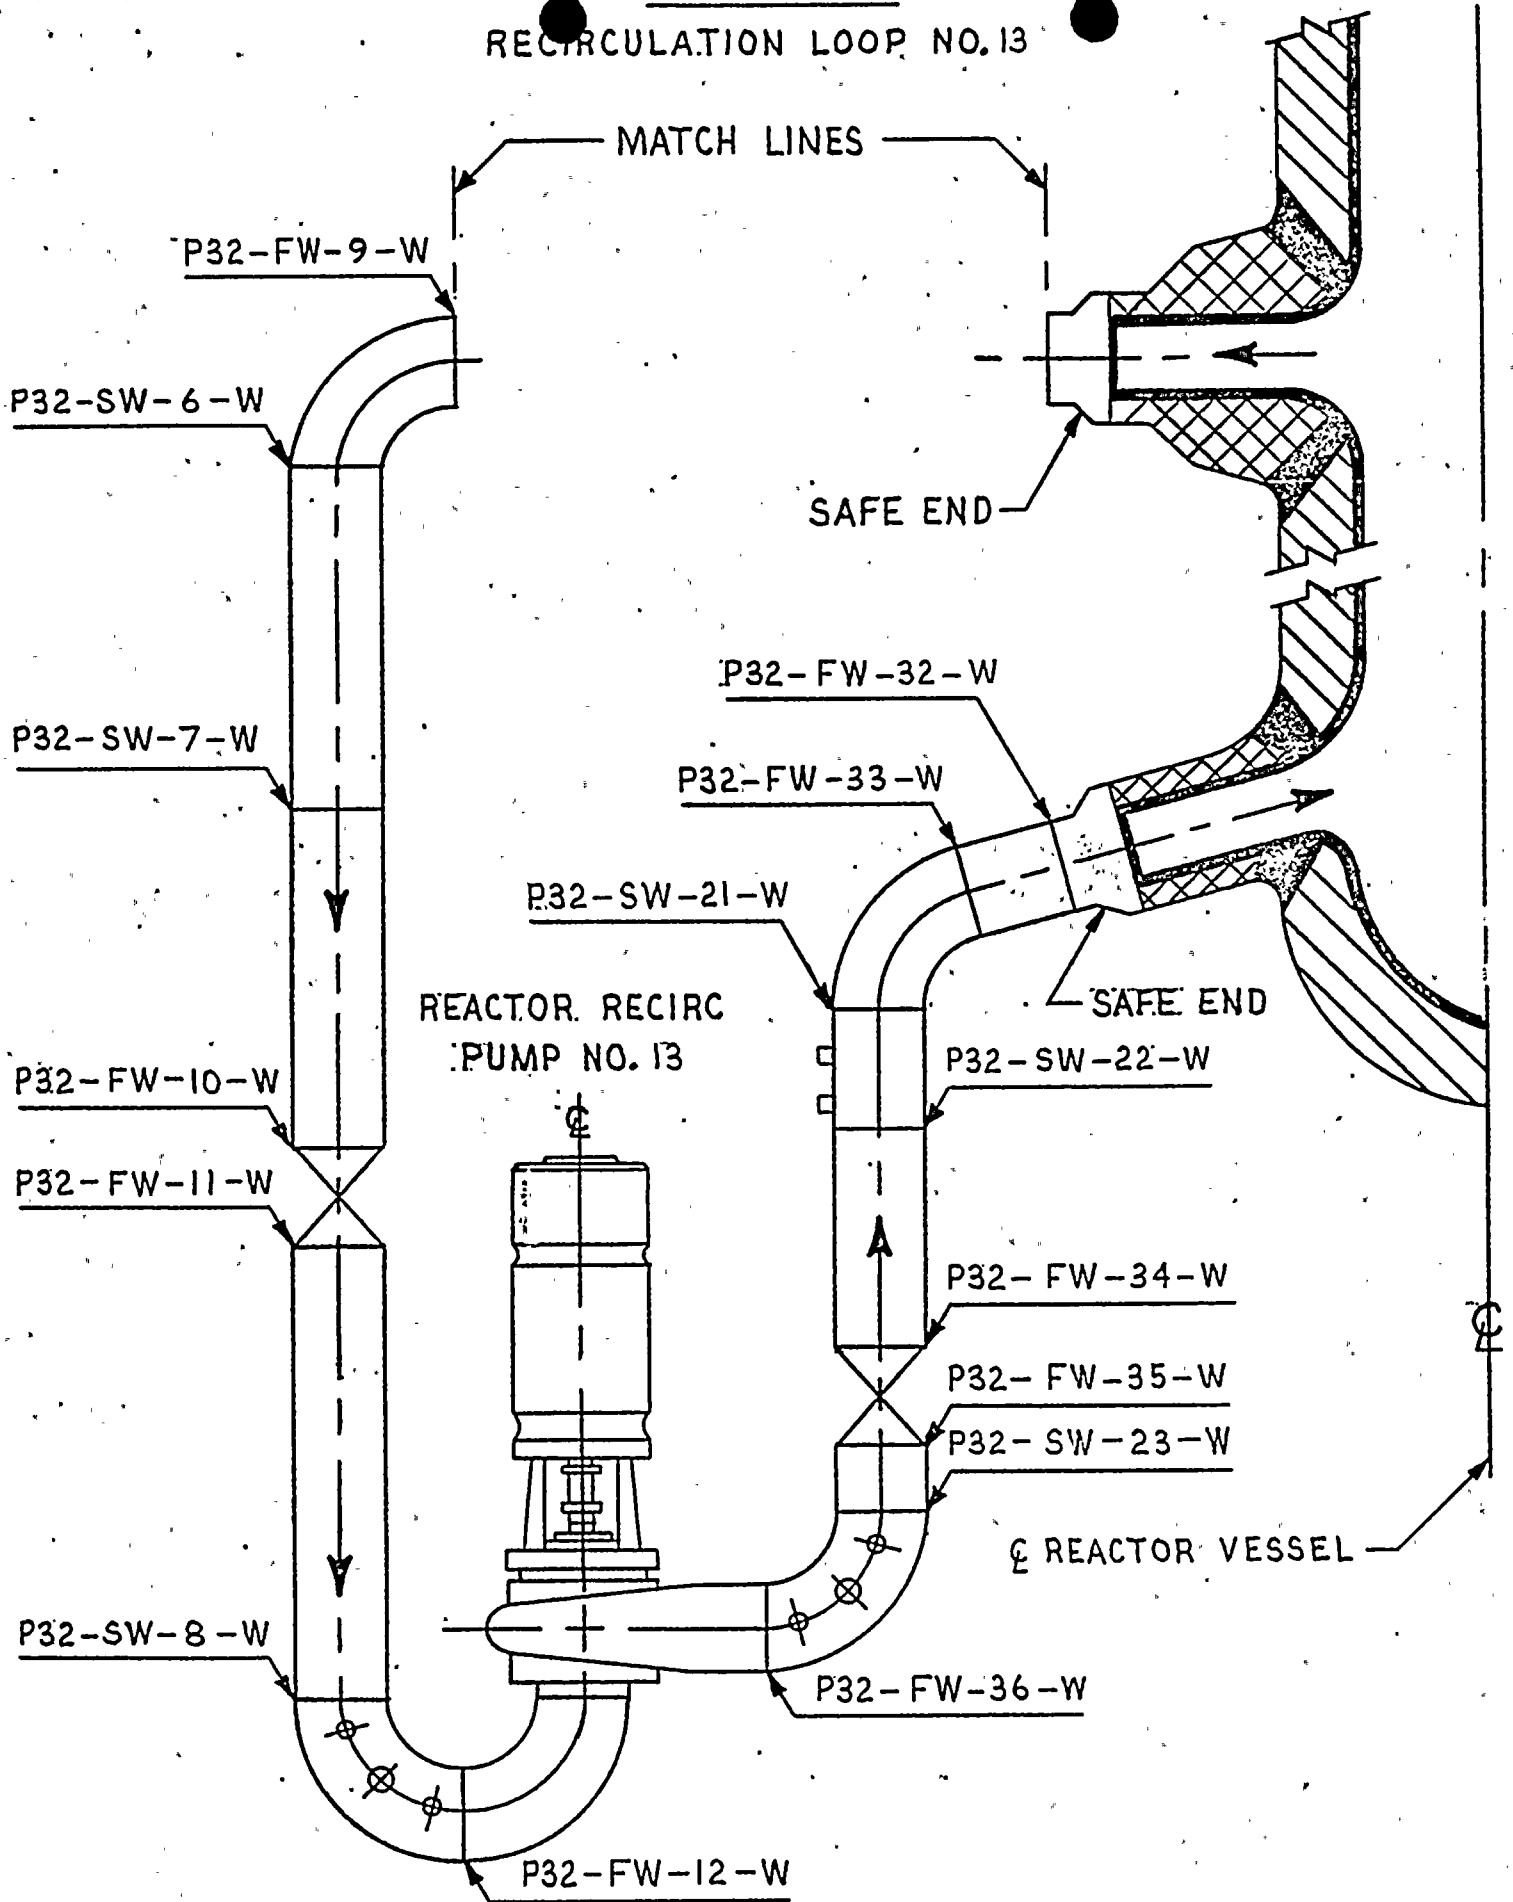
FIGURE 3
RECIRCULATION LOOP NO. 13

<u>Weld No.</u>	<u>Ultrasonic Examination ... (UT) ...</u>	<u>Dye Penetrant Examination ... (PT) ...</u>	<u>Results⁽¹⁾</u>
<u>No. 13 Recirc. Loop</u>			
P32-FW-9-W	Not Inspected		
P32-SW-6-W	Not Inspected		
P32-SW-7-W	X	-	UT Indications (Increased Gain)
P32-FW-10-W	X	-	UT Indications (Increased Gain)
P32-FW-11-W	X	-	UT Indications (Increased Gain)
P32-SW-8-W	X	-	UT Indications (Increased Gain)
P32-FW-12-W	X	-	UT Indications (Increased Gain)
P32-FW-36-W	X	X	UT Indications (Increased Gain) PT Indications
P32-FW-35-W	Not Inspected		
P32-FW-34-W	Not Inspected		
P32-SW-22-W	Not Inspected		
P32-SW-21-W	Not Inspected		
P32-FW-33-W	Not Inspected		
P32-FW-32-W	X	-	Code UT Indications
<u>No. 14 Recirc. Loop</u>			
P32-FW-13-W	Not Inspected		
P32-SW-9-W	Not Inspected		
P32-SW-10-W	X	-	UT Indications (Increased Gain)
P32-FW-14-W	X	-	UT Indications (Increased Gain)
P32-FW-15-W	X	-	UT Indications (Increased Gain)
P32-FW-11-W	X	-	UT Indications (Increased Gain)

P32-FW-16-W	X	-	UT Indications (Increased Gain)
P32-FW-41-W	X	-	UT Indications (Increased Gain)
P32-SW-26-W	Not Inspected		
P32-FW-40-W	Not Inspected		
P32-FW-39-W	Not Inspected		
P32-SW-25-W	Not Inspected		
P32-SW-24-W	Not Inspected		
P32-FW-38-W	Not Inspected		
P32-FW-37-W	Not Inspected

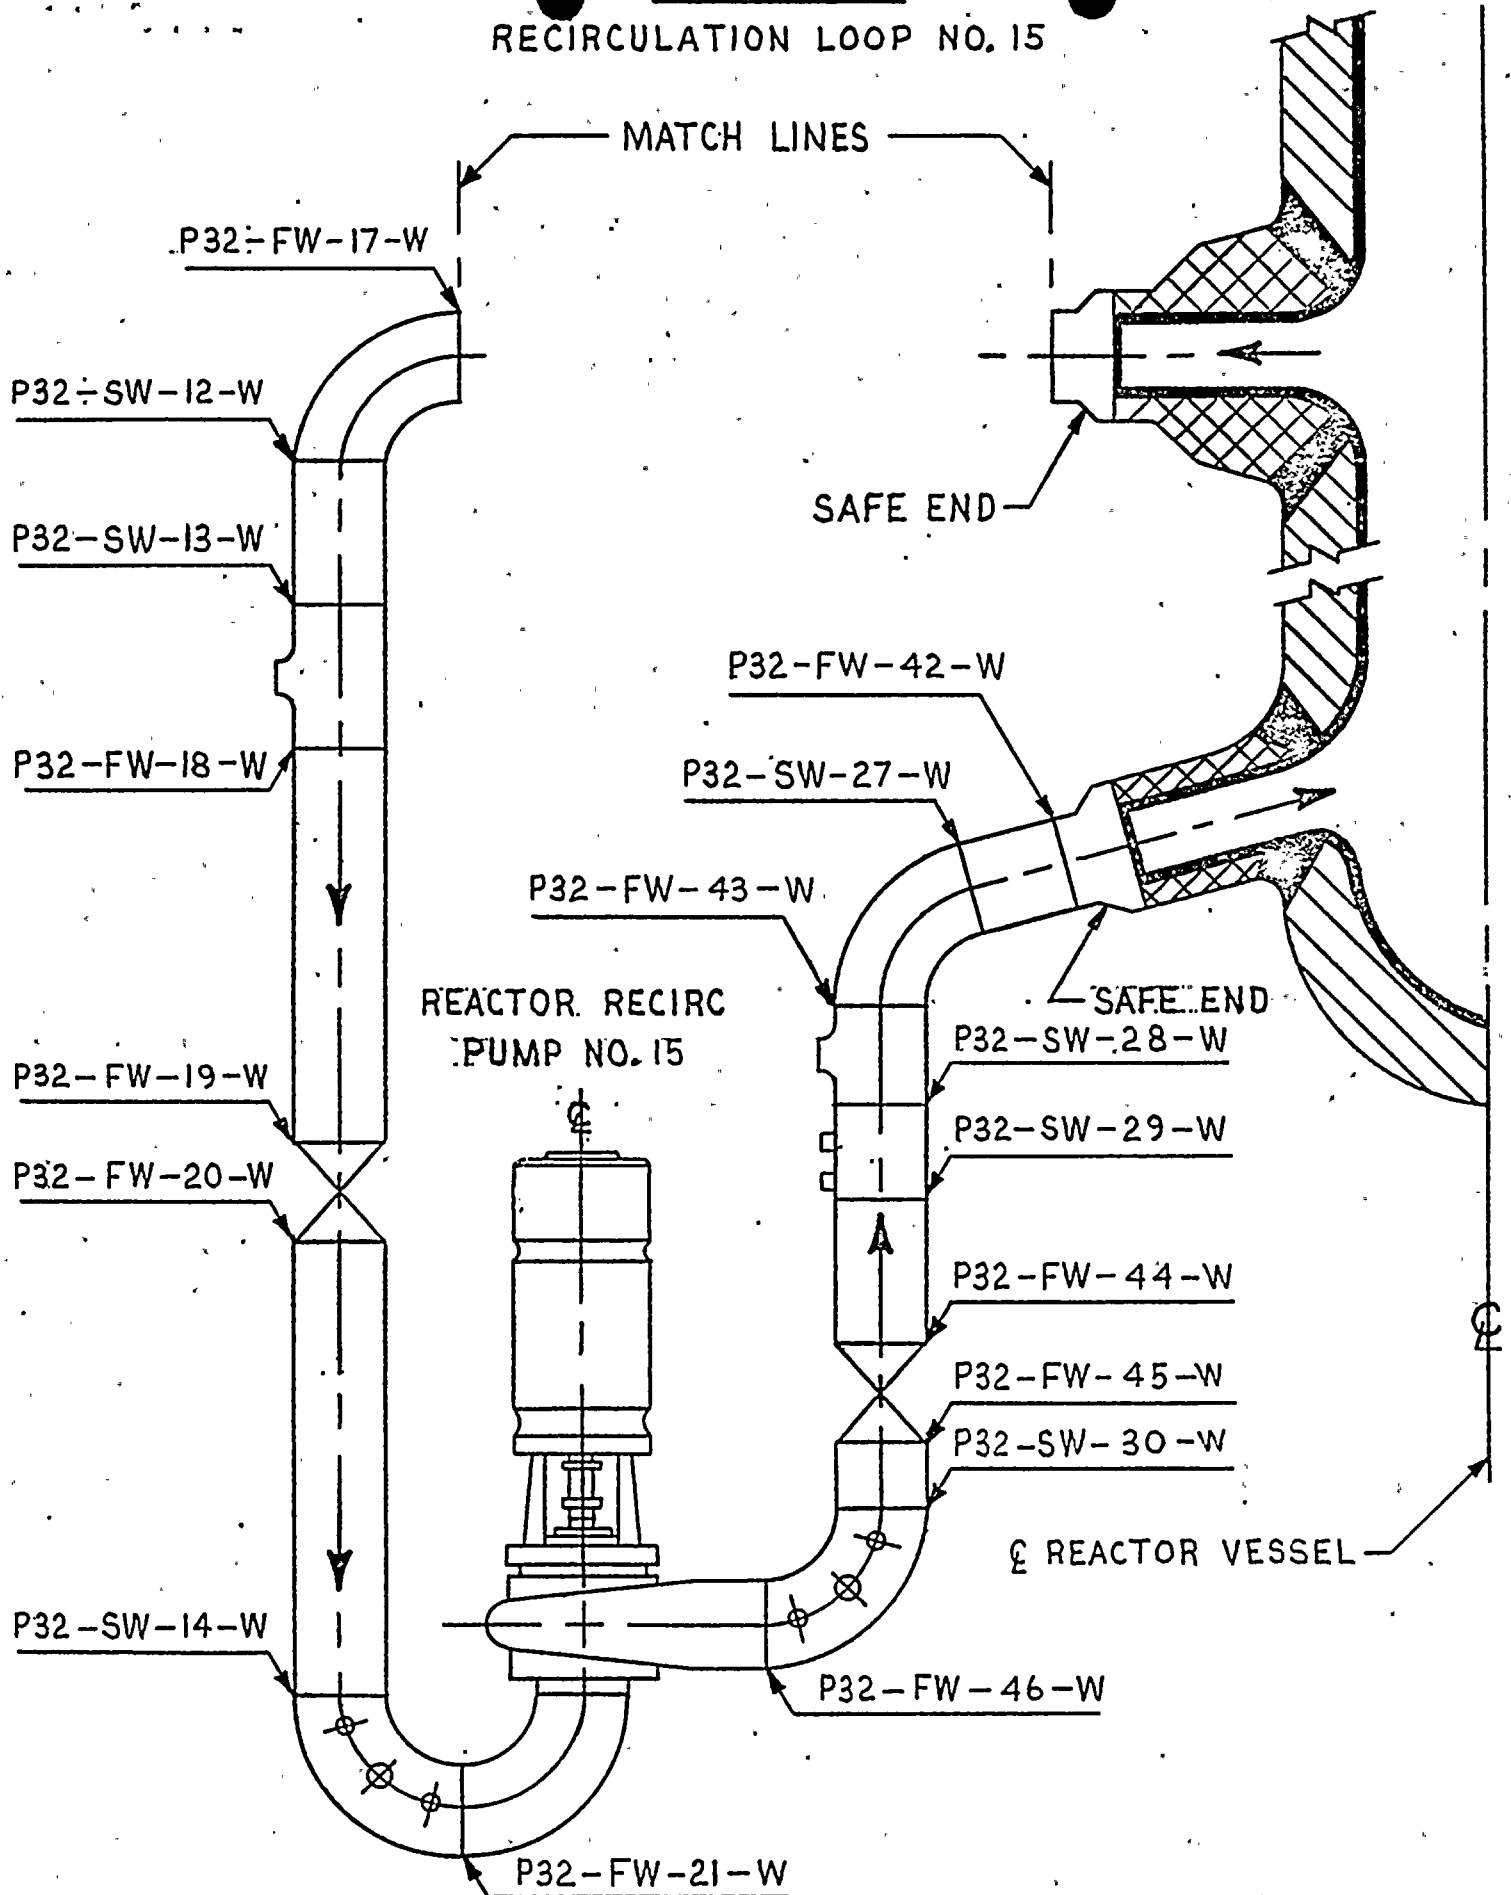
FIGURE 5
RECIRCULATION LOOP NO. 15

<u>Weld No.</u>	<u>Ultrasonic Examination</u> ... (UT) ...	<u>Dye Penetrant Examination</u> ... (PT) ...	<u>Results</u> ⁽¹⁾
<u>No. 15 Recirc. Loop</u>			
P32-FW-17-W		Not Inspected	
P32-SW-12-W	X		X
			UT Indications (Increased Gain) PT Verification After Removal
P32-SW-13-W	X		-
			UT Indications (Increased Gain)
P32-FW-18-W	X		-
			UT Indications (Increased Gain)
P32-FW-19-W	X		-
			UT Indications (Increased Gain)
P32-FW-20-W	X		-
			UT Indications (Increased Gain)
P32-SW-14-W	X		-
			UT Indications (Increased Gain)
P32-FW-21-W	X		-
			UT Indications (Increased Gain)
P32-FW-46-W	X		X
			Code UT Indications PT Indications
P32-SW-30-W		Not Inspected	
P32-FW-45-W		Not Inspected	
P32-FW-44-W		Not Inspected	
P32-SW-29-W		Not Inspected	
P32-SW-28-W		Not Inspected	
P32-FW-43-W		Not Inspected	
P32-SW-27-W		Not Inspected	
P32-FW-42-W		Not Inspected	
			Through Wall Crack (Leakage)
