ACCESSION NBR: 8211230330      DOC. DATE: 82/11/18      NOTARIZED: NO      DOCKET #  
 FACIL: 50-220 Nine Mile Point Nuclear Station, Unit 1, Niagara Powe      05000220  
 AUTH. NAME      AUTHOR AFFILIATION  
 MANGAN, C.V.      Niagara Mohawk Power Corp.  
 RECIP. NAME      RECIPIENT AFFILIATION  
 EISENHUT, D.G.      Division of Licensing

SUBJECT: Provides method & schedule to be utilized for nozzle repair  
 for miscut made during repairs at facility.

Re: Nine Mile Point Unit 1  
Docket No. 50-220  
DPR-63

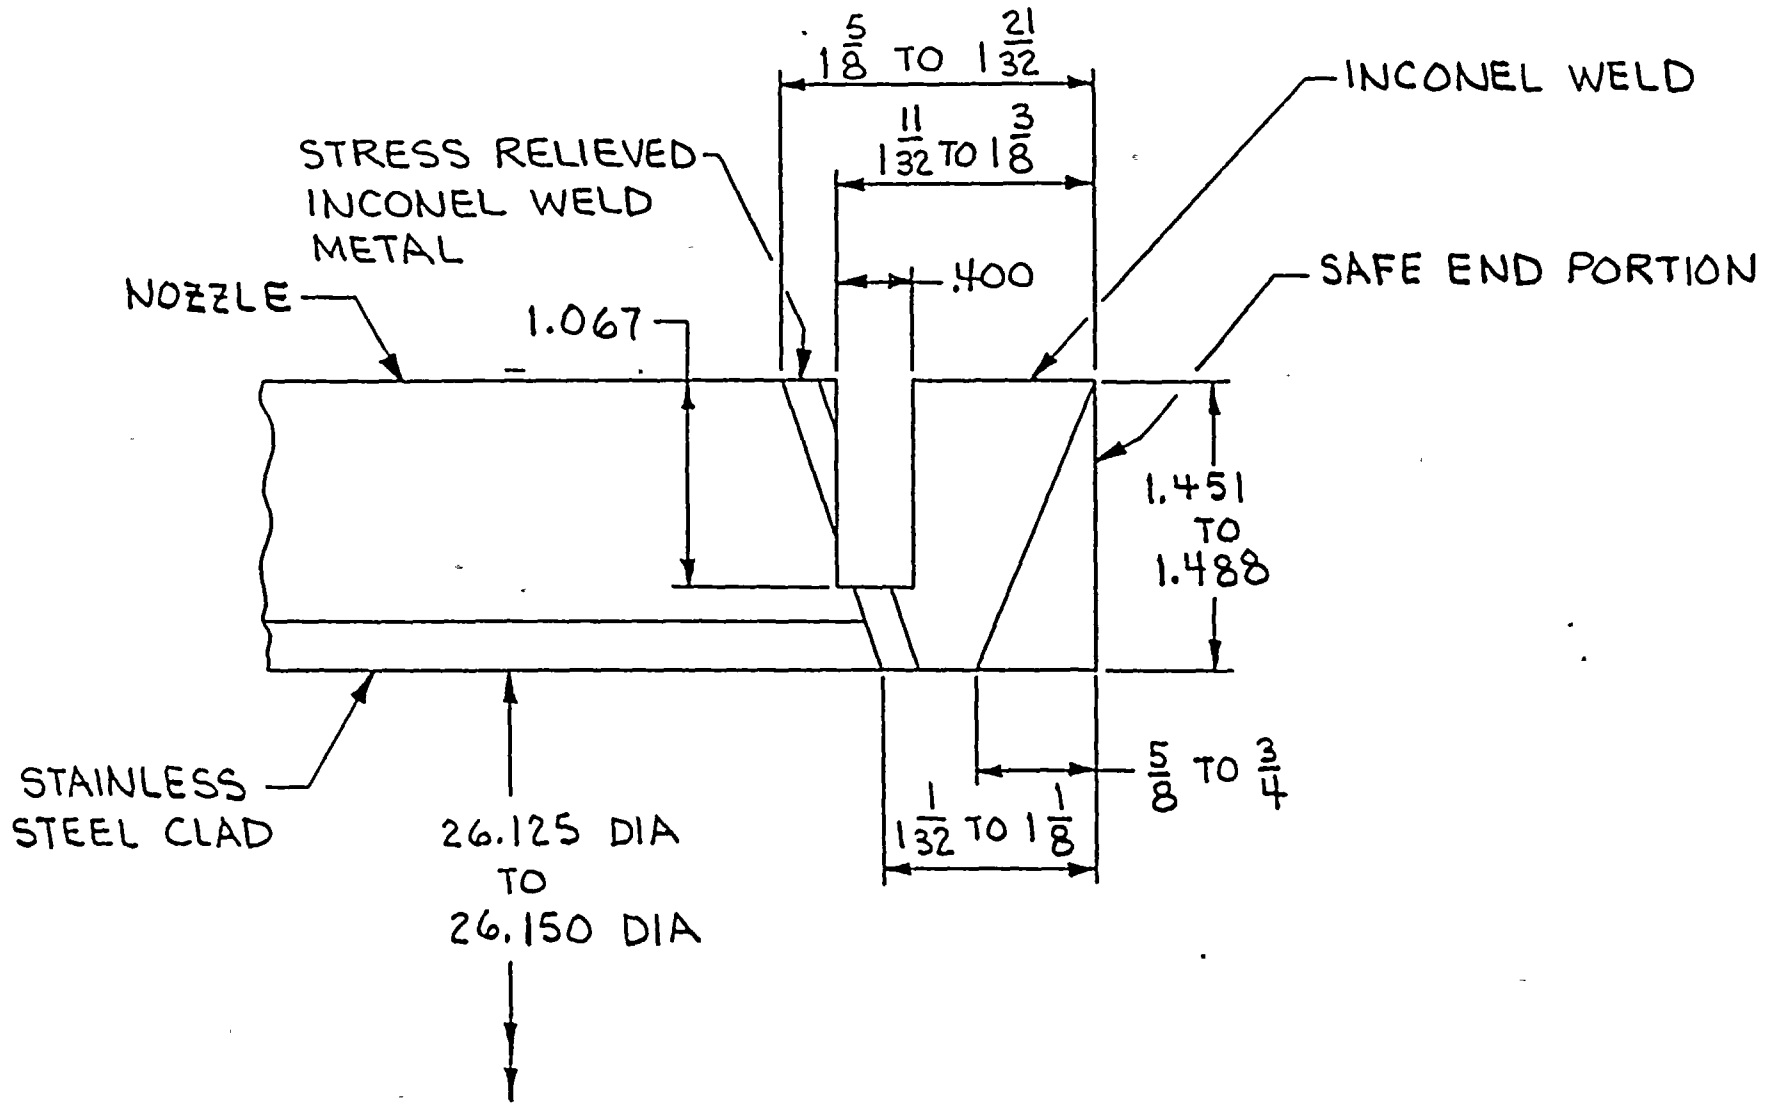
FIGURE 1

On June 21, 1982 Niagara Mohawk notified members of your staff of a miscut made during repairs at Nine Mile point Unit 1. The cut on number 15 recirculation safe end penetrated the edge of the nozzle material as shown on Figure 1. The purpose of this letter is to describe the method and schedule to be utilized for the nozzle repair.

ACTUAL FIRST CUT  
ACTUAL MEASUREMENTS

The repair on number 15 recirculation nozzle will be accomplished in accordance with the ASME Boiler and Pressure Vessel Code, Section III, Division 1, Article NB-2549, "Repair by Welding". Article NB-2549 invokes requirements of Article NB-2539. These in turn require that welding and welders must be qualified per Article NB-4000 and Section IX of the Code. Also, the repaired area must be examined by magnetic particle or liquid penetrant and then radiographed. In addition, the nozzle must be heat treated in accordance with Article NB-4640.
