UNITED STATES
NUCLEAR REGULATORY COMMISSION
WASHINGTON, D. C. 20555

SAFETY EVALUATION BY THE OFFICE OF NUCLEAR REACTOR REGULATION

NINE MILE POINT NUCLEAR STATION, UNIT 1

CONTROL ROD DRIVE PENTRATION LEAKAGE FROM STUB TUBE CRACKING

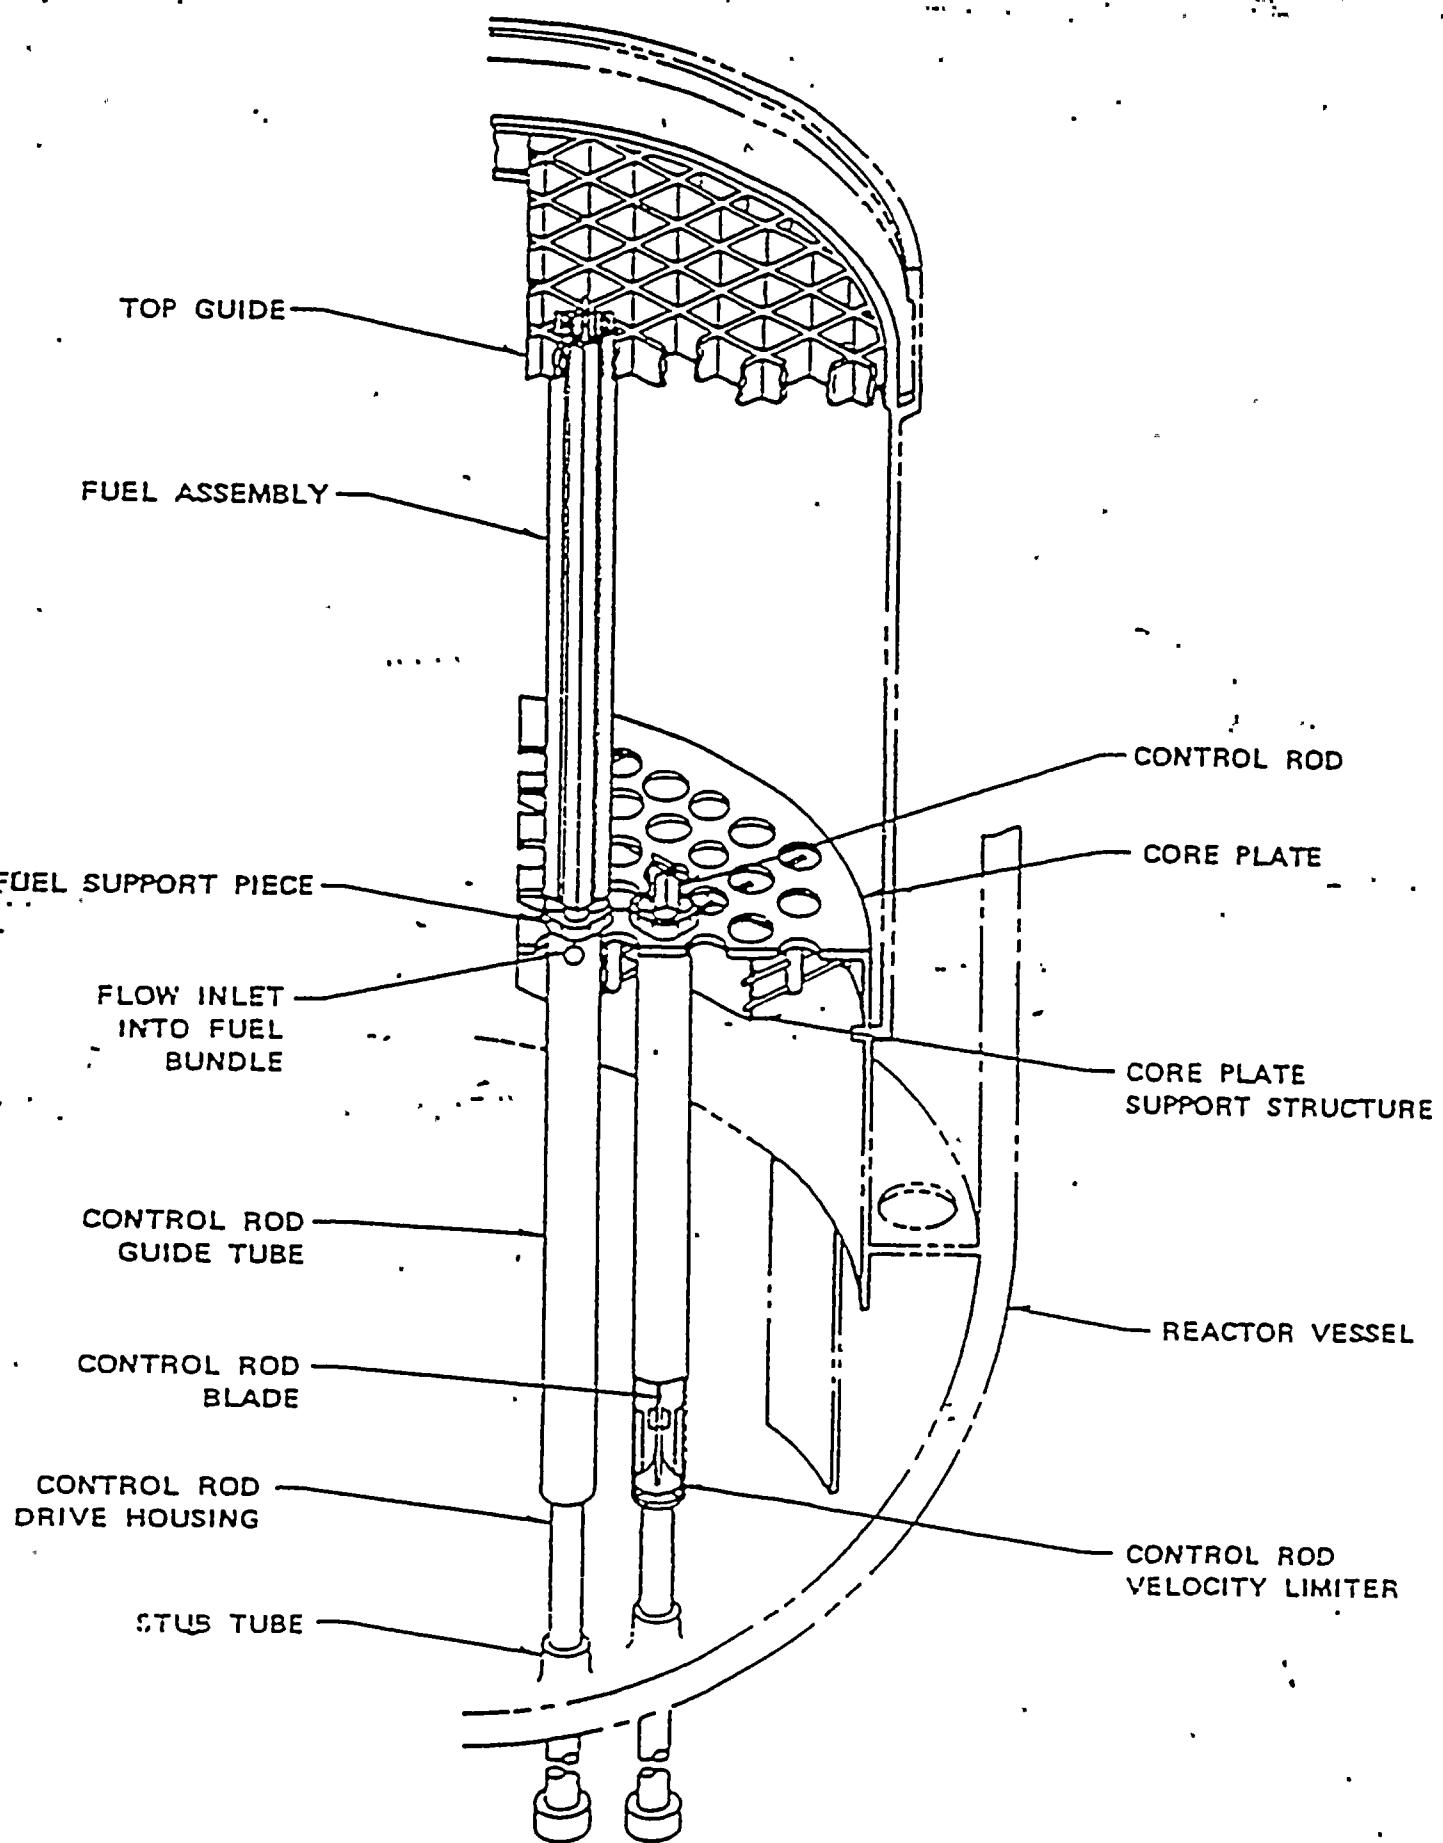
FIGURE 1

Relationship Between Stub Tube,
Reactor Pressure Vessel, and

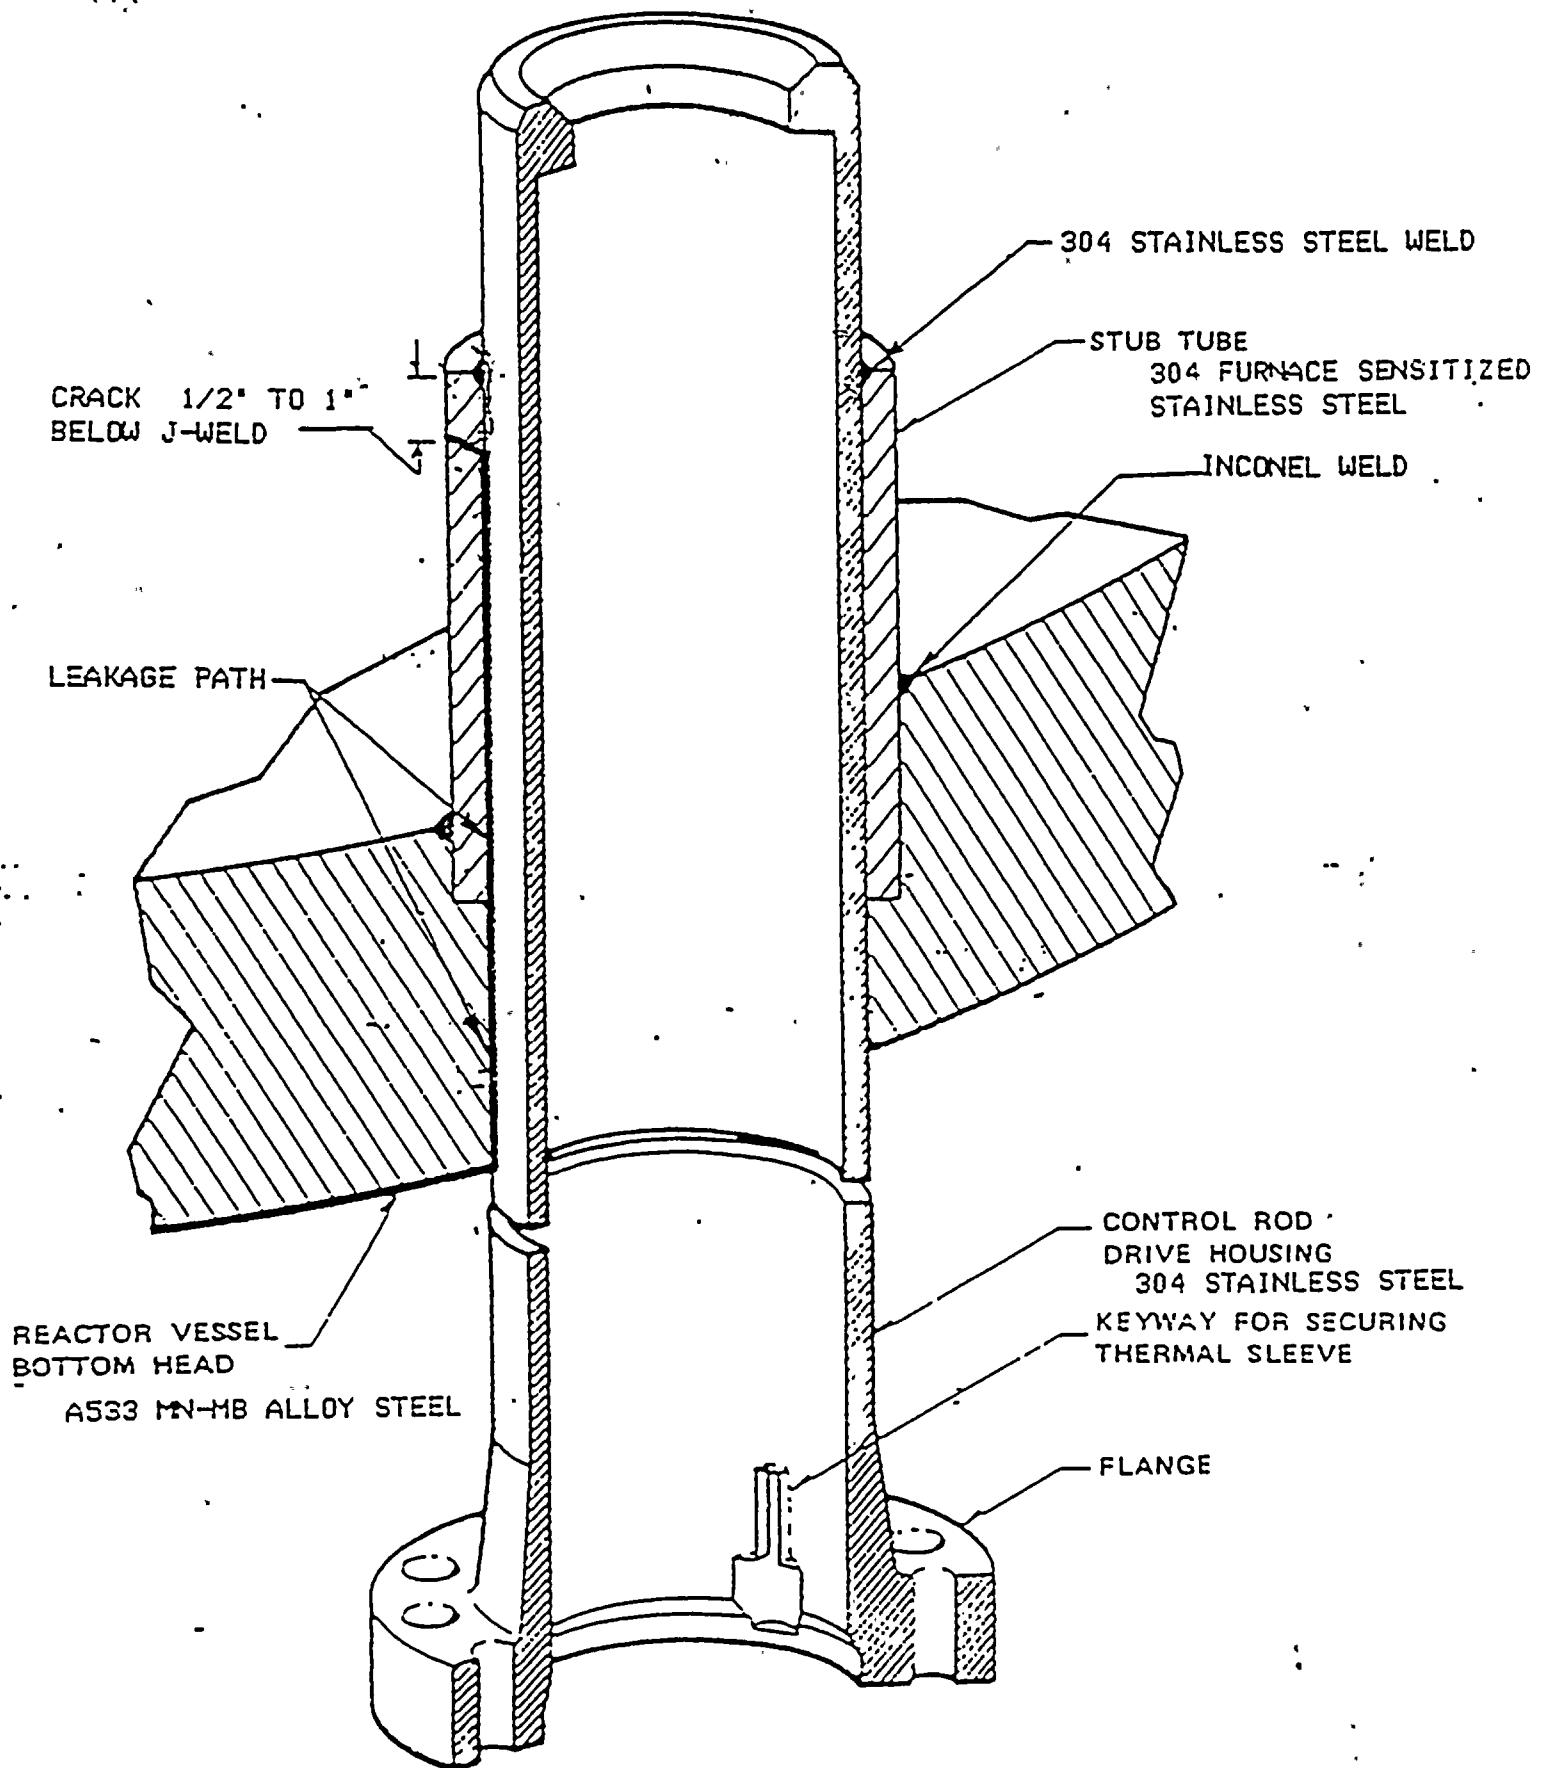
FIGURE-2

On March 27, 1984, during a refueling outage, an inspection was performed in the control rod drive (CRD) housings (Figure 1); at location 46-27, a small leak (see Figure 2) (approximately 15 drops per minute) was observed at the CRD housing flange. At location 14-11, water bead marks were observed at the top of the CRD housing flange. Additionally, there was either slight corrosion or film on the CRD housing at locations 30-07, 38-31, 42-39, 10-27 and 46-39. Because of these observations, additional examinations, visual (TV) and ultrasonic were scheduled. The visual (TV) examinations were performed on the stub tubes from the exterior of those tubes within the vessel and cracks were observed (see Table). The ultrasonic (UT) examinations were performed from the inside diameter of the control rod drive housing tubes both before and after the rolling repair. In neither UT examination were any reportable indications observed.
