SUBJECT: LER 86-003-01: on B61108, during core alterations, safety related radiation monitor removed from svc when Tech Spcc misinterpreted. Caused by personnel error. Workers reminded to inform supervisors of off-normal controls. W/B70505 ltr.

LICENSEE EVENT REPORT (LER)

FACILITY NAME (1) Nine Mile Point Unit 2										DOCKET NUMBER (2) 0 5 0 0 0 4 1 0 1 OF 0 4				PAGE (3) 1 OF 0 4										
TITLE (4) Partial Loss of Secondary Containment Isolation Actuation Instrumentation																								
EVENT DATE (5)			LER NUMBER (6)				REPORT DATE (7)			OTHER FACILITIES INVOLVED (8)														
MONTH	DAY	YEAR	YEAR	SEQUENTIAL NUMBER	REVISION NUMBER	MONTH	DAY	YEAR	FACILITY NAMES				DOCKET NUMBER(S)											
1	1	0	8	8	6	8	6	0	0	3	0	1	0	5	0	5	8	7	N/A				0 5 0 0 0	
OPERATING MODE (9) 5			THIS REPORT IS SUBMITTED PURSUANT TO THE REQUIREMENTS OF 10 CFR §: (Check one or more of the following) (11)																					
POWER LEVEL (10) 0 0 1 0			20.402(b)				20.405(c)				50.73(a)(2)(iv)				73.71(b)

FACILITY NAME (1) Nine Mile Point Unit 2	DOCKET NUMBER (2) 05000410	LER NUMBER (6)			PAGE (3)		
		YEAR	SEQUENTIAL NUMBER	REVISION NUMBER			
		86	003	01	02	OF	04

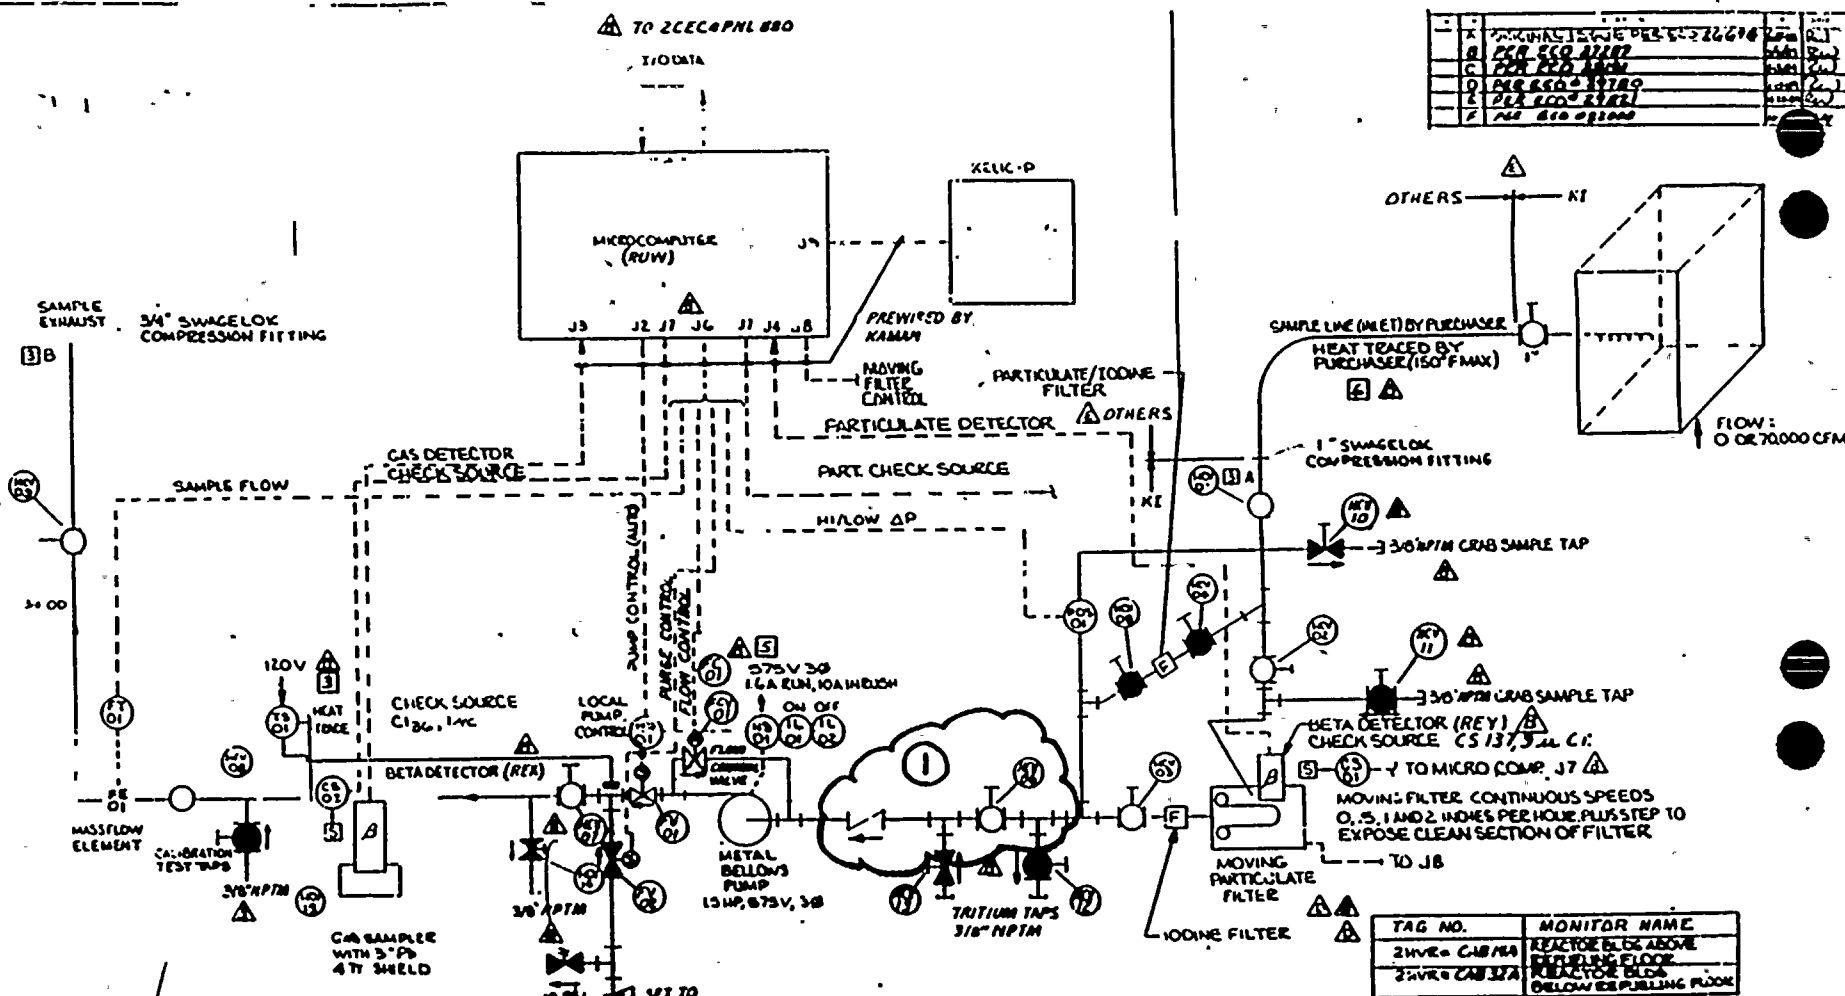
SKETCH #1

The contributing cause was the frequent low flow alarms from the sample cabinets. The cause of the low flow alarms has been determined to be the charcoal filter cartridge breakdown due to pressure perturbation induced by the metal bellows sample pump. The pressure perturbation was causing the charcoal granules to be liberated from the filter mesh assembly thus being deposited throughout the balance of the sample flow path. This charcoal filter degradation has been exhibited in two ways. When the filter was removed, it no longer contained charcoal, only the mesh screens remained. In a more dramatic failure, the charcoal was not only gone but the mesh screens were torn. In some cases, the screens were ripped from the filter assembly and were found blocking the sample flow path downstream of the filter. After charcoal had been liberated from the filter, it was drawn through the balance of the sample flow path. The distribution of charcoal has caused low flow alarms to be generated in two ways: (1) Charcoal built up in the mass flow meter caused erroneous low flow readings; (2) Charcoal was trapped in the positive displacement metal bellows pump valving preventing a positive seal and causing leakage during the compression stroke of the piston, thus resulting in low flow.

1 ACCUMULATOR ADDED IN THIS SECTION OF LINE
