ACCESSION NBR: 8705140357 DOC. DATE: 87/05/08 NOTARIZED: NO DOCKET #
 FACIL: 50-410 Nine Mile Point Nuclear Station, Unit 2, Niagara Moha 05000410
 AUTH. NAME AUTHOR AFFILIATION
 RANDALL, R. G. Niagara Mohawk Power Corp.
 LEMPGES, T. E. Niagara Mohawk Power Corp.
 RECIP. NAME RECIPIENT AFFILIATION

SUBJECT: LER 87-013-01: on 870209, during cold shutdown, momentary power loss to div 2 600-volt load ctr resulted in secondary containment isolation. Caused by personnel error. Training mod recommended. W/870508 ltr.

Engineered Safety Features Actuation due to Loss of Power to a Class 1E 600V Bus

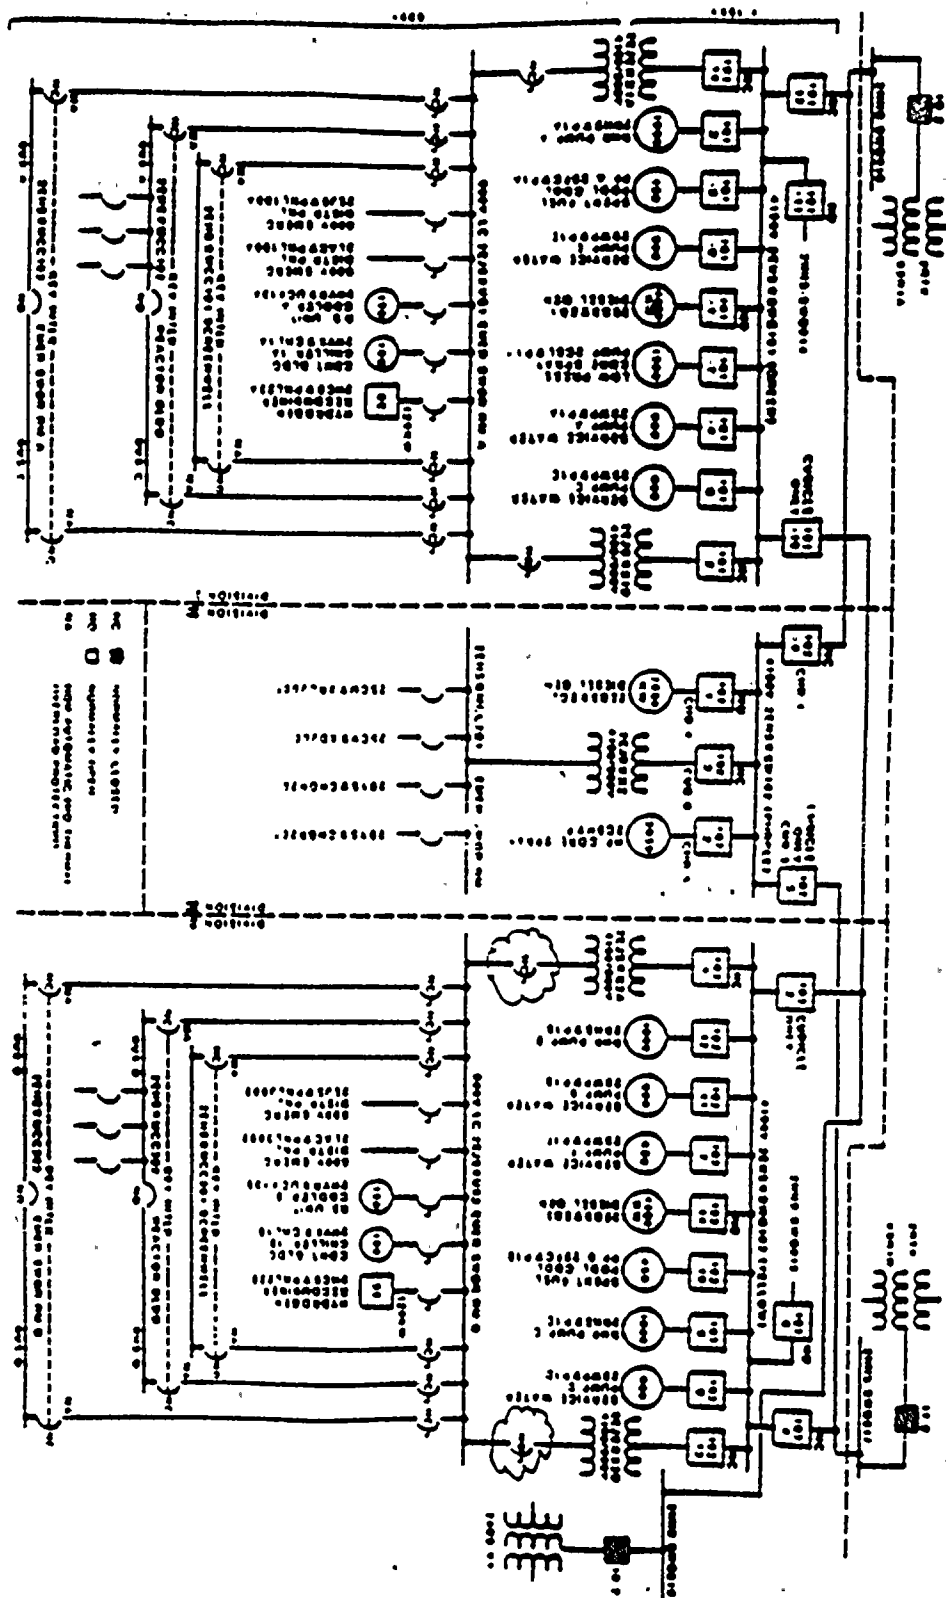
Figure 1 Rev. 0
Title:
EMERGENCY AC
POWER DISTRIBUTION

While in cold shutdown on February 9, 1987 at 0444 hours, a momentary loss of power to the Division 2 600V emergency load center resulted in a secondary containment isolation and the automatic start of a control room ventilation special filter train and an emergency reactor building recirculation unit. In addition, the running spent fuel pool cooling pump tripped on low flow due to its discharge valve failing closed on loss of power. The automatic actuation of these Engineered Safety Features (ESF) systems was due to personnel error. Prior to the event, the emergency load center was in an abnormal lineup being fed through its alternate supply breaker. At 0442 emergency load center status change computer points printed out in the control room, indicating that the normal supply breaker was closed and the alternate supply breaker was open. In response to the status computer points, the Niagara Mohawk licensed control room operator proceeded to verify breaker positions at the control panel. The operator found both normal supply breaker indicator lights out and the alternate supply breaker green indicator light lit (indicating breaker open). Three supply breaker indicator lights had burned out. This caused the operator to misread the breaker indication and momentarily open the breaker that was supplying power (normal supply), while attempting to realign the supply breakers.

Immediate corrective actions taken were to realign the emergency load center through its normal supply breaker and to return to normal all affected systems (see Attachment 1 for loads). This was accomplished by approximately 0515 hours. In addition, the burned out indicator lights were replaced.
