NUCLEAR REGULATORY COMMISSION  
OFFICE OF INSPECTION AND ENFORCEMENT  
WASHINGTON, D. C. 20555

IE Circular 77-06  
Date: April 5, 1977  
Page 1 of 1

EFFECTS OF HYDRAULIC FLUID ON ELECTRICAL CABLES

Reference: Quad-Cities Nuclear Power Station  
Docket No. 50-265, DPR-30, Unit 2

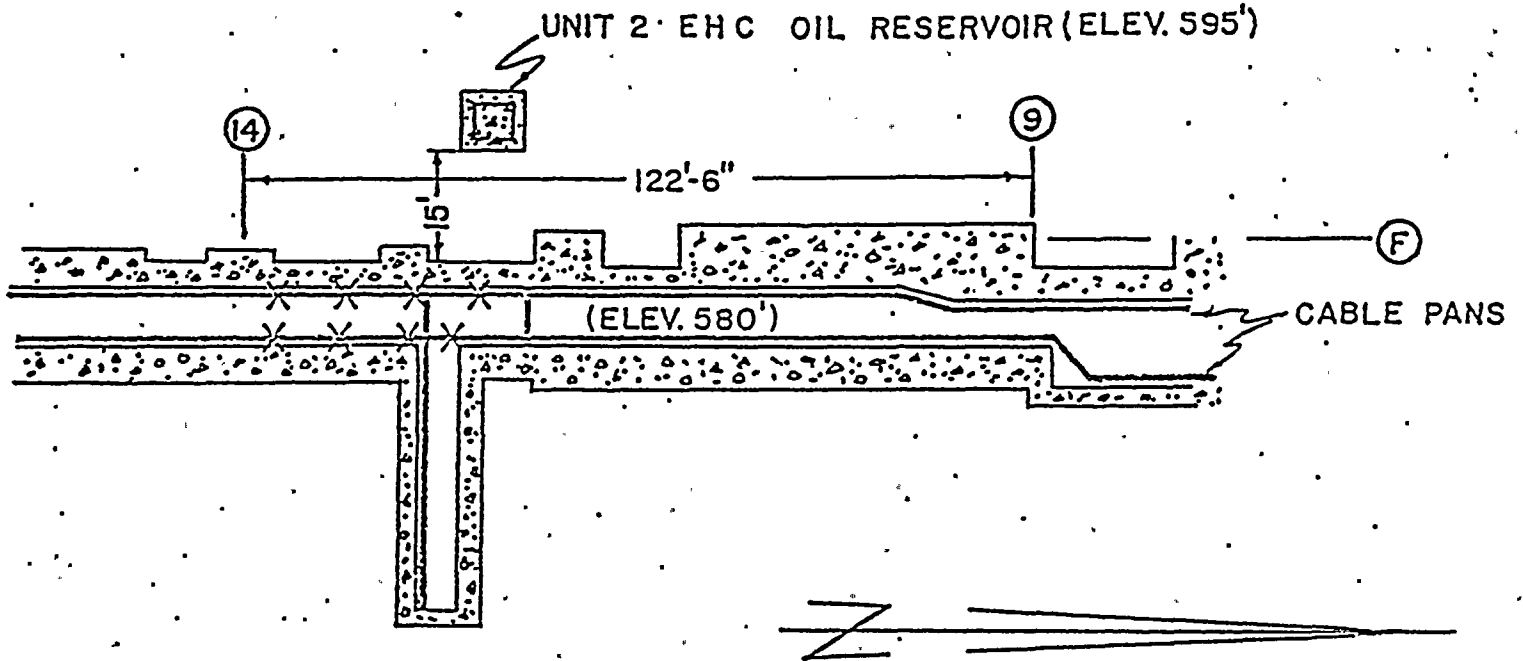
FIGURE. 1

Figure 1 shows the approximate locations where EHC fluid accumulated. Figure 2 illustrates the postulated path of EHC fluid migration from the EHC fluid reservoir to the Unit 2 cable tunnel area. The accumulation of EHC fluid around the EHC fluid reservoir foundation, and subsequent migration between the finish floor and rough slab, via small cracks in the concrete, is the postulated cause of the EHC fluid problem.

UNIT 2 CABLE TUNNEL  
PARTIAL PLAN

X- DENOTES AREAS WHERE THE EHC OIL HAD ACCUMULATED  
REFERENCE DRAWING - SARGENT & LUNDY M-5

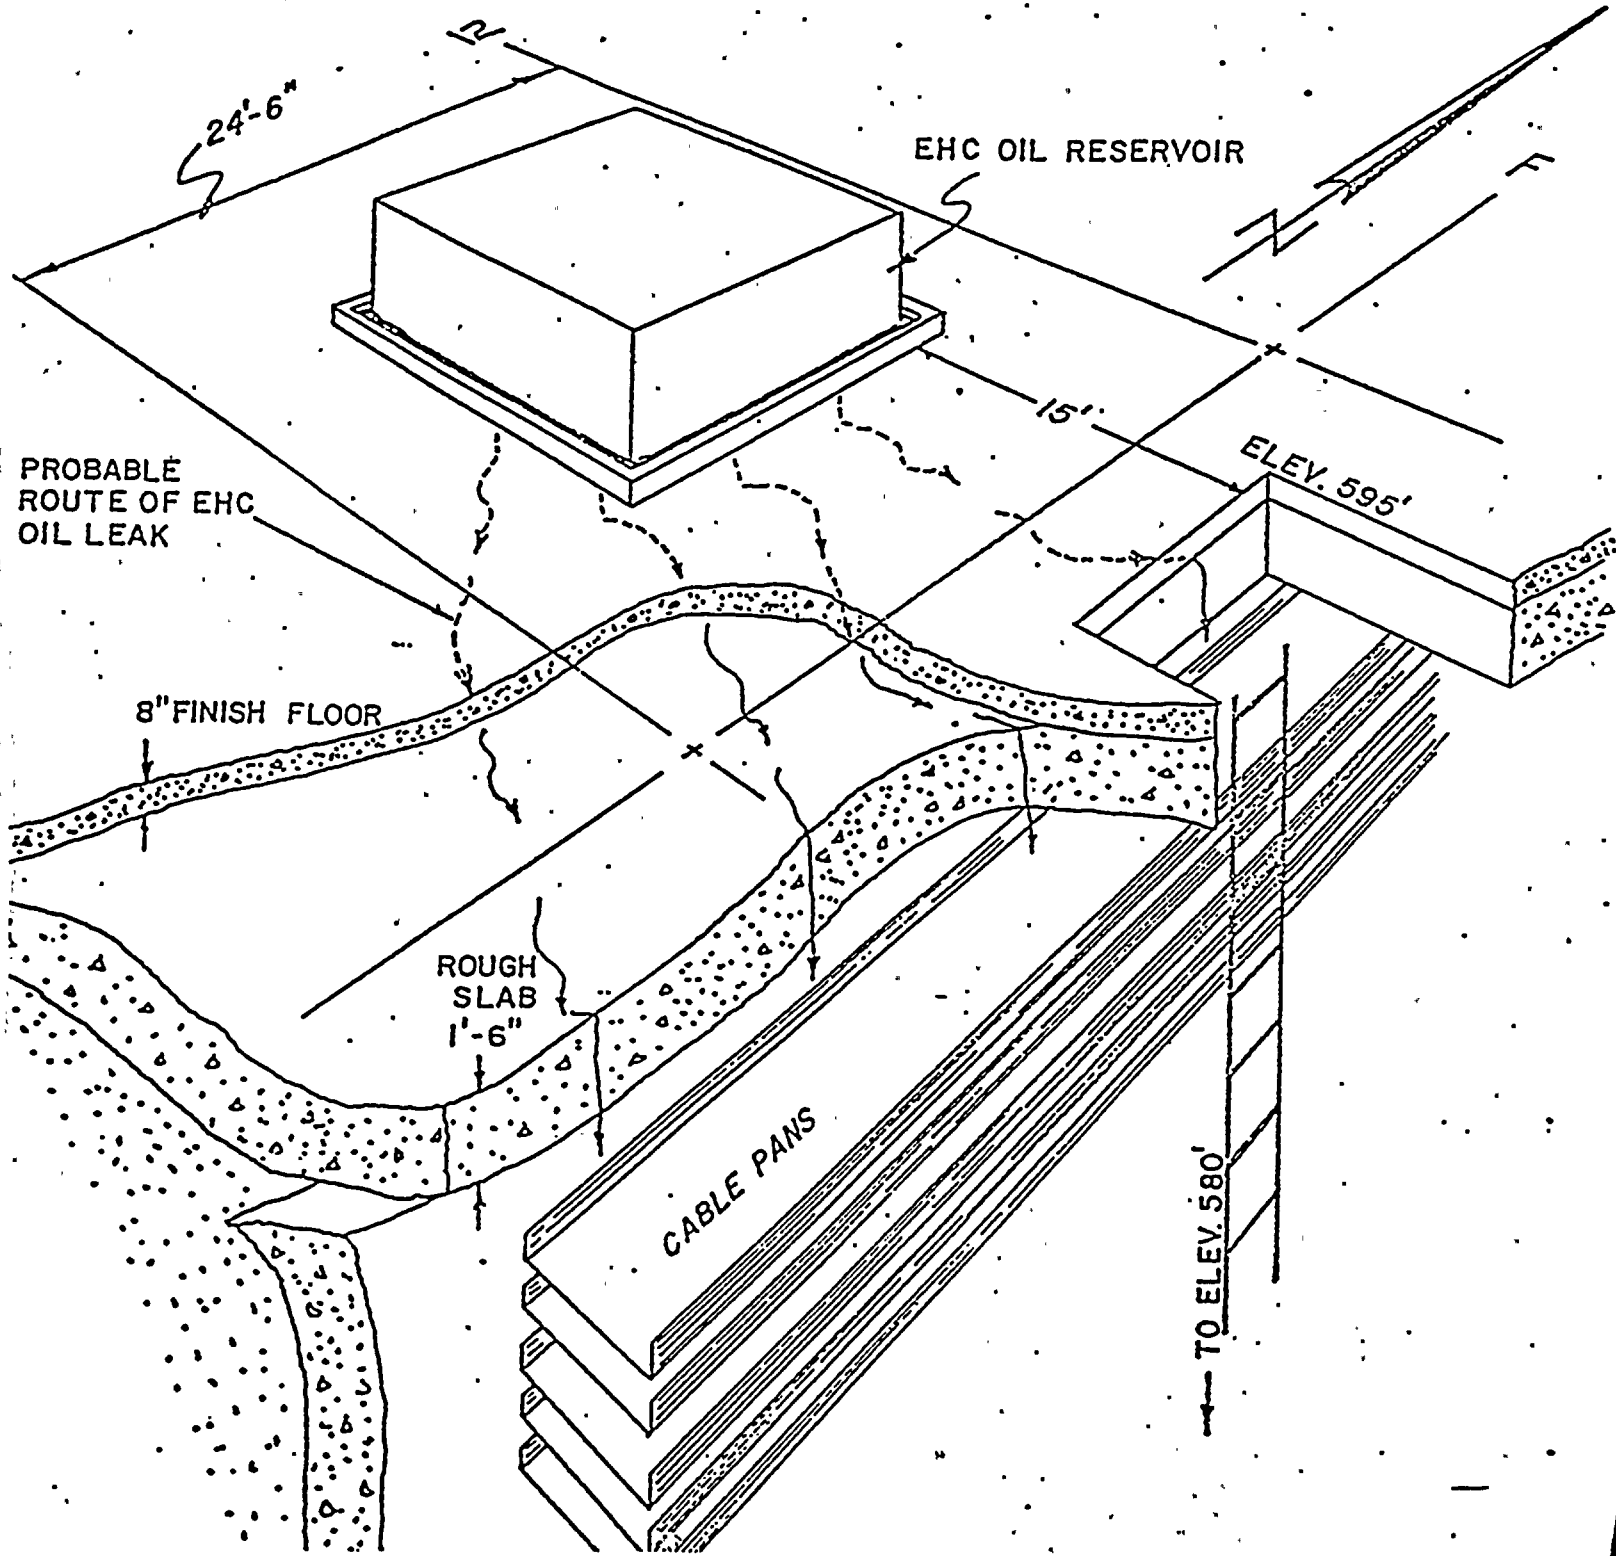
FIGURE. 2

The rough slab serves as the ceiling in the Unit 2 cable tunnel and minor small cracks in the ceiling served as a leak path out of the concrete and onto the cable trays and floor. Portions of cables within these trays thus became saturated with the EHC fluid.

The upper cable trays did not contain all of the EHC fluid, even though the pans in the cable tunnel were of solid bottom construction. This was because the EHC fluid had leaked through the cable pan connecting joints and thus all the cable pans below were subjected to the EHC fluid. The cables closest to the bottom of the cable pans were most affected by the EHC fluid because these cables were in constant saturation with EHC fluid.

UNIT 2 CABLE TUNNEL  
CUT-AWAY

At the present time, all the cables in the affected area of the Unit 2 cable tunnel are being protected from the continuing EHC fluid leakage. The leakage has subsided and once it has stopped the ceiling area will be cleaned and a protective sealer will be applied to prevent any possible leakages.

The EHC fluid reservoir foundation must also be sealed with the same protective sealer once leakages have been resolved. The sealer has been ordered from the Carboline Company, type 187 HFP, which is a recommended EHC fluid sealant.
