U. S. NUCLEAR REGULATORY COMMISSION
OFFICE OF INSPECTION AND ENFORCEMENT

Report No. 50-333/81-05

Facility Name: James A. FitzPatrick Nuclear Power Plant (JAF)

Inspection Conducted: February 9-13, 24-27, 1981

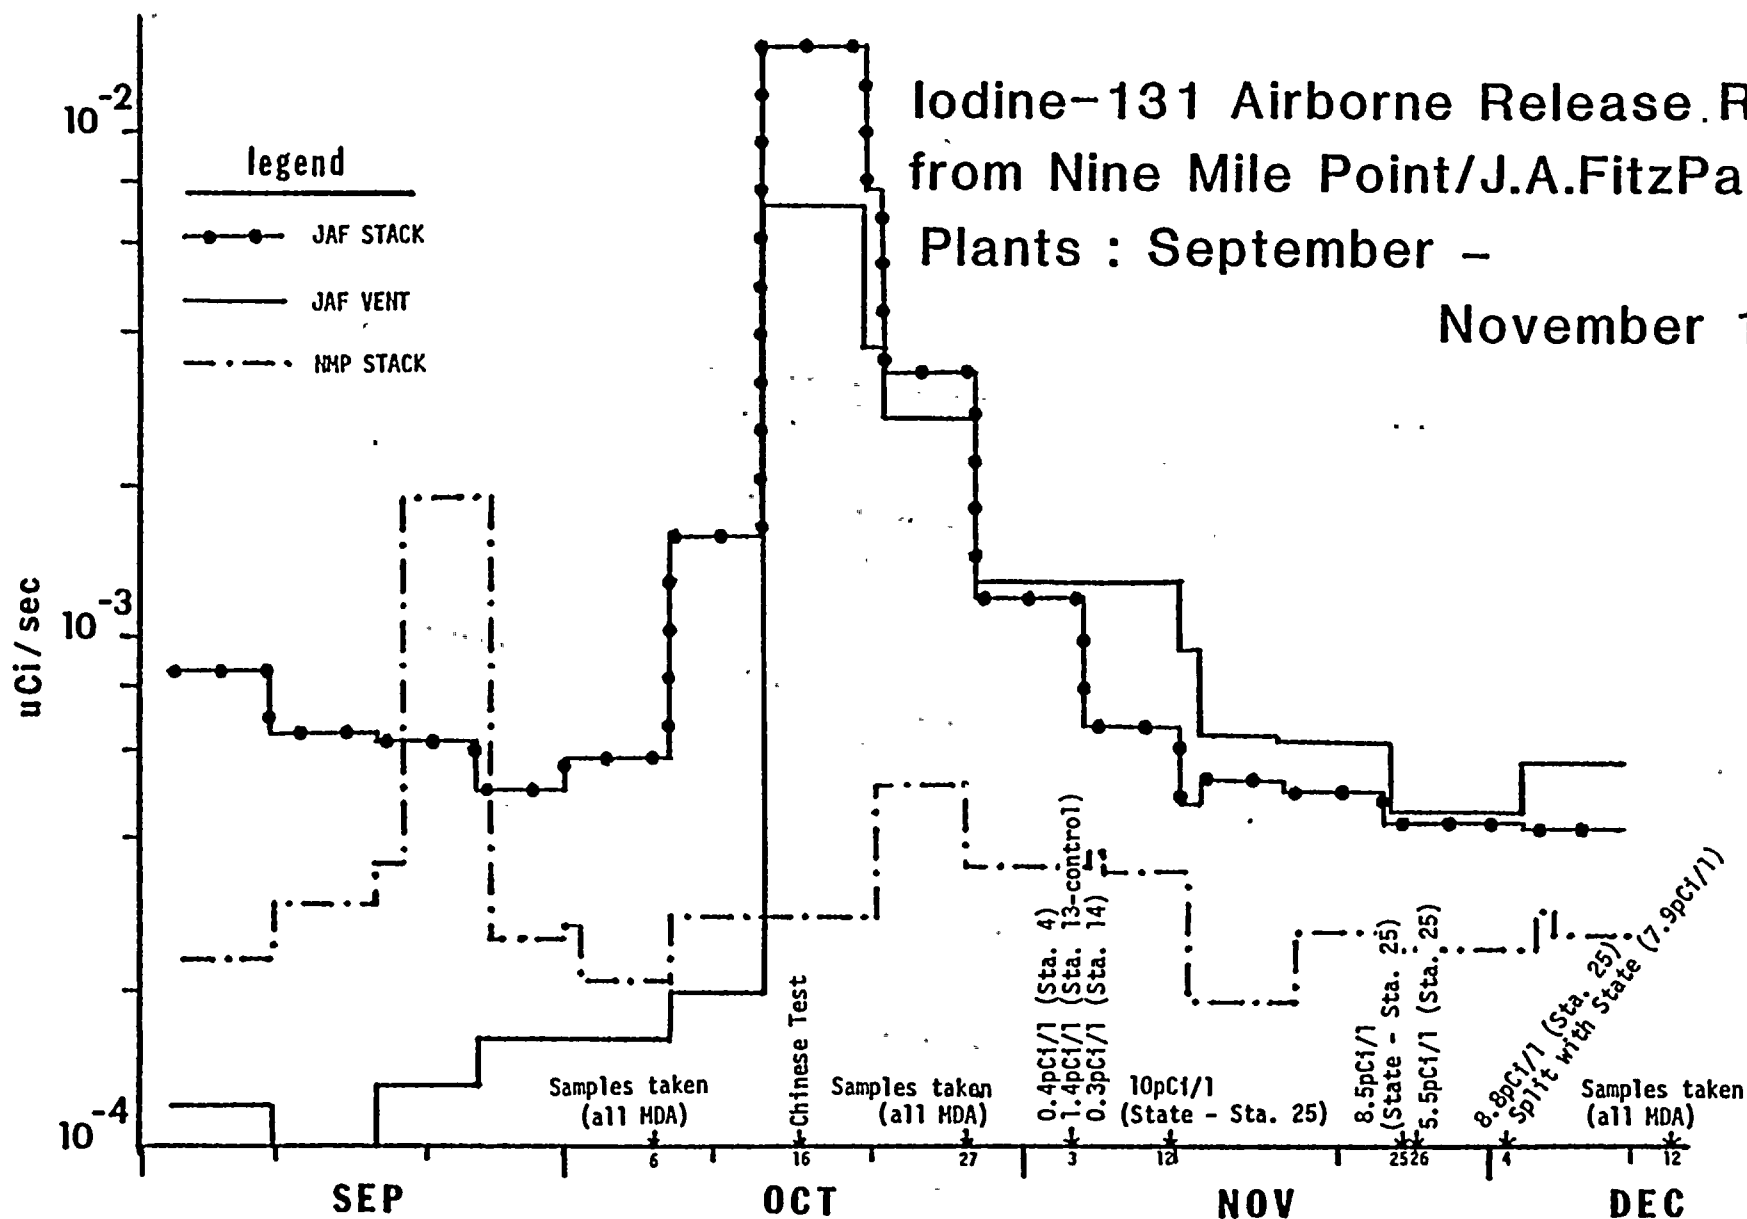
Iodine-131 Airborne Release Rates from Nine Mile Point/J.A.FitzPatrick Plants : September - November 1980

The attachment to this report illustrates the airborne iodine-131 releases from both the NMP and JAF sites during the interval September through November 1980. Also shown on the same plot are the date of the weapons test by the Peoples Republic of China on October 16, 1980, and the dates, locations and the I-131 results of all milk samples with positive values. The maximum airborne release rate (from JAF) for I-131 occurred during the week in which the weapons test occurred. Because of the near proximity of the JAF-NMP source to the sampled milk farms, any deposition from this source should have taken place within hours of the release. Deposition from the weapons test, on the other hand, would first be expected to occur approximately two weeks after the test because of the atmospheric diffusion and transport time. The deposition from the latter would also be distributed in time over several weeks.

Review of the milk data (as depicted in the attachment) has indicated that the first positive iodine measurements in milk occurred approximately two weeks following the weapons test at which time the iodine release rates from both NMP and JAF plants had decreased by a factor of about 10. These positive milk I-131 samples were collected from several locations including the control farm. Subsequent to this date (November 3, 1981), all sampled milk cattle in the area (with the exception of Sampling Station No. 25) were removed from pasture for the winter. Sample Station No. 25 showed an increase in I-131 levels in milk to 10 pCi/l and remained at about that level (about 8 pCi/l) until the end of November, while the NMP-JAF releases continued at about a factor of 20 below the peak release rate.

Consequently, while one cannot easily rule out that the NMP-JAF releases contributed to the I-131 activities measured in three milk samples, it appears at least highly unlikely that these releases were the sole source of the measured activity. Regardless of the source of the I-131 the expected dose consequences would be minor. Only one cow was present at Station No. 25 where the elevated levels were detected, and consumption of this cow's milk with 10 pCi/l of I-131 for the one month period

involved would produce 3.8 mrem to an infant thyroid, although no infant consumed milk from this farm (an adult would receive a thyroid dose of 0.5 mrem). The inspector had no further questions regarding the above releases and their consequences at this time. No items of noncompliance were identified in the above areas.
