LICENSEE: Niagara Mohawk Power Corporation  
FACILITY: Nine Mile Point Nuclear Station Unit No. 1  
SUBJECT: SUMMARY OF NOVEMBER 18, 1985 MEETING WITH NIAGRA MOHAWK  
POWER CORPORATION

NIAGARA MOHAWK POWER CORPORATION  
NINE MILE POINT UNIT 1  
CONTROL ROD DRIVE PENETRATION  
REPAIR PROGRAM

NINE MILE POINT UNIT 1  
STUB TUBE/CONTROL ROD DRIVE  
PENETRATION REPAIR PROGRAM

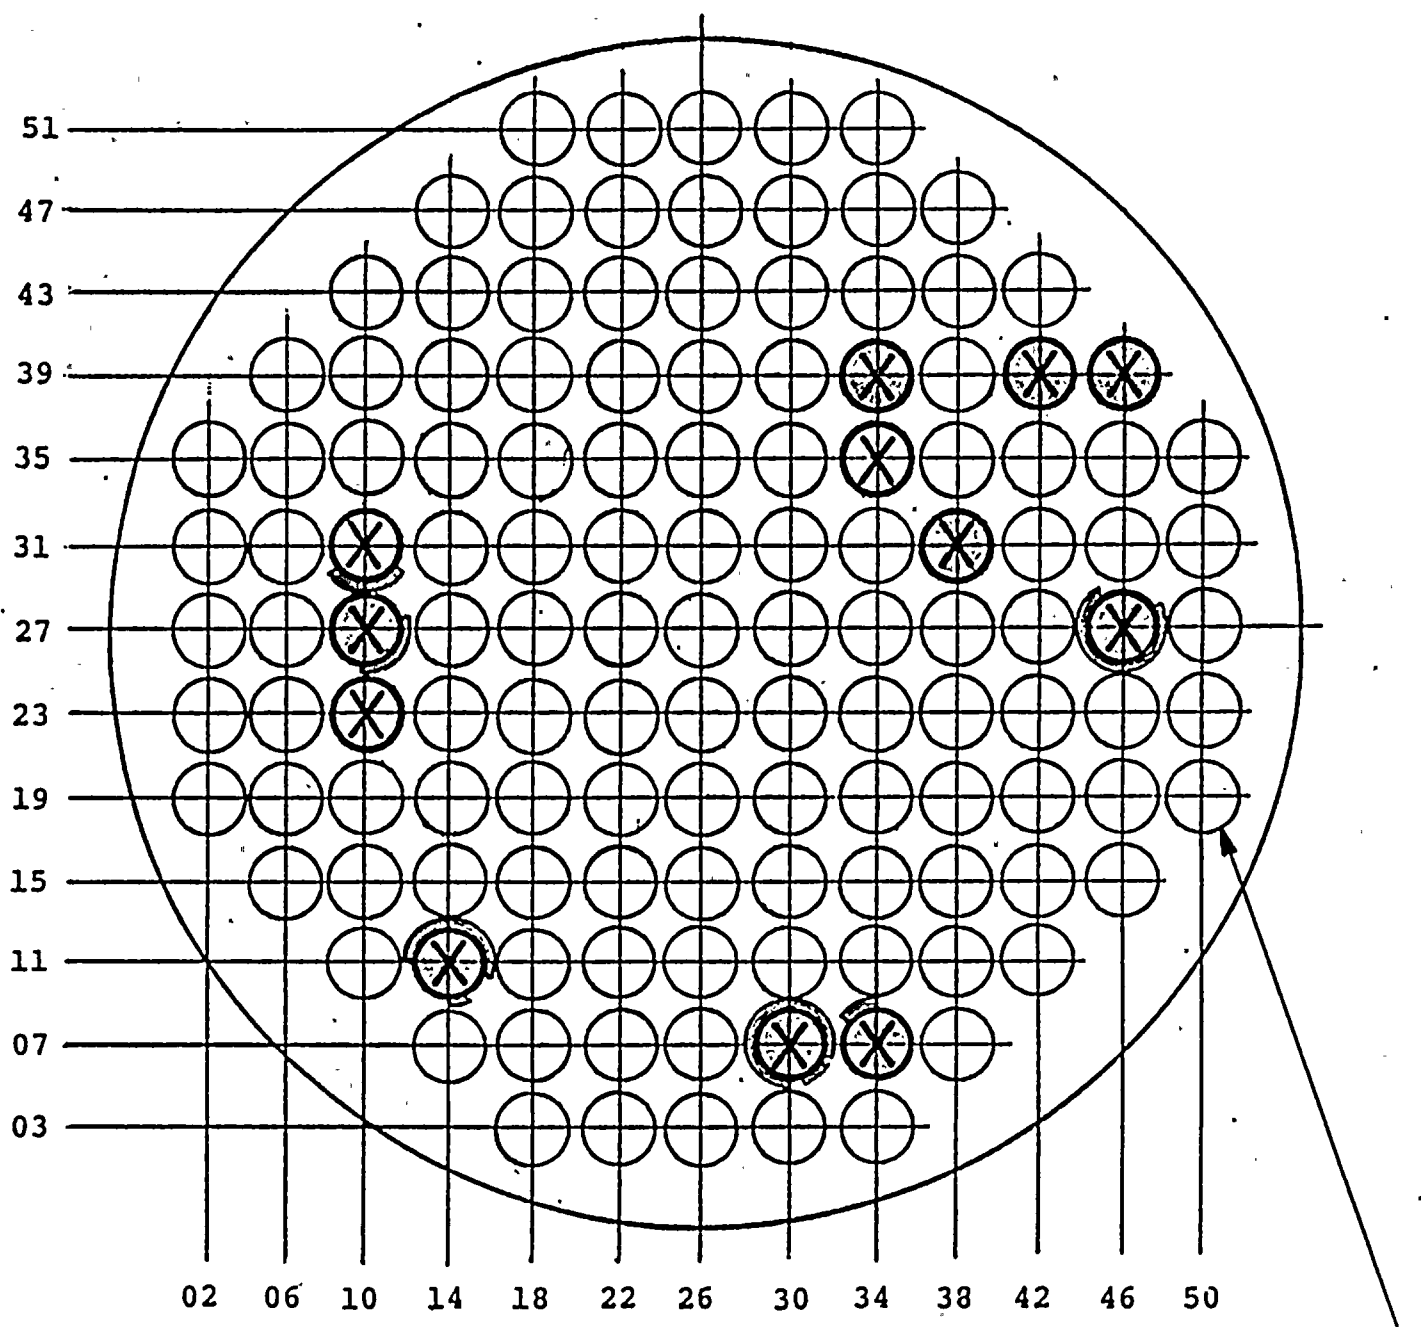
- A. CRD PENETRATION 46-27 FOUND LEAKING AT 15 DROPS PER MINUTE
- B. CRD PENETRATION 14-11 SHOWED SIGNS OF WETNESS
- C. SEVEN ADDITIONAL HOUSINGS SHOWED POSSIBLE EVIDENCE OF PRIOR LEAKAGE
- D. CLOSED CIRCUIT TV INSPECTION OF 12 PENETRATIONS REVEALED SIGNIFICANT CRACKING OF SIX STUB TUBES

# INSPECTION RESULTS

- A. INITIALLY, NINE CRD HOUSINGS WERE ROLL EXPANDED TO SUBSTANTIALLY REDUCE LEAKAGE
  - (1) PENETRATIONS WHICH LEAKED OR EXHIBITED POSSIBLE SIGNS OF PREVIOUS LEAKAGE
  - (2) ONE PENETRATION WITH OBSERVED STUB TUBE CRACKING, BUT NO SIGNS OF LEAKAGE, WAS NOT REPAIRED (31-10)
- B. DURING ISI HYDROTEST, AN ADDITIONAL PENETRATION (50-19) WAS FOUND LEAKING AND WAS SUCCESSFULLY REPAIRED BY ROLLING
- C. TOTAL OF TEN PENETRATIONS REPAIRED BY ROLLING OF CRD HOUSING
