LICENSEE EVENT REPORT (LER)

FACILITY NAME (1) <b>Nine Mile Point Unit 2</b>	DOCKET NUMBER (2) <b>0 5 0 0 0 4 1 1 0</b>	PAGE (3) <b>1 OF 1 2</b>
--	---	-----------------------------

TITLE (4)  
**Loss of Power to Group 2 Scram Solenoid Coils**

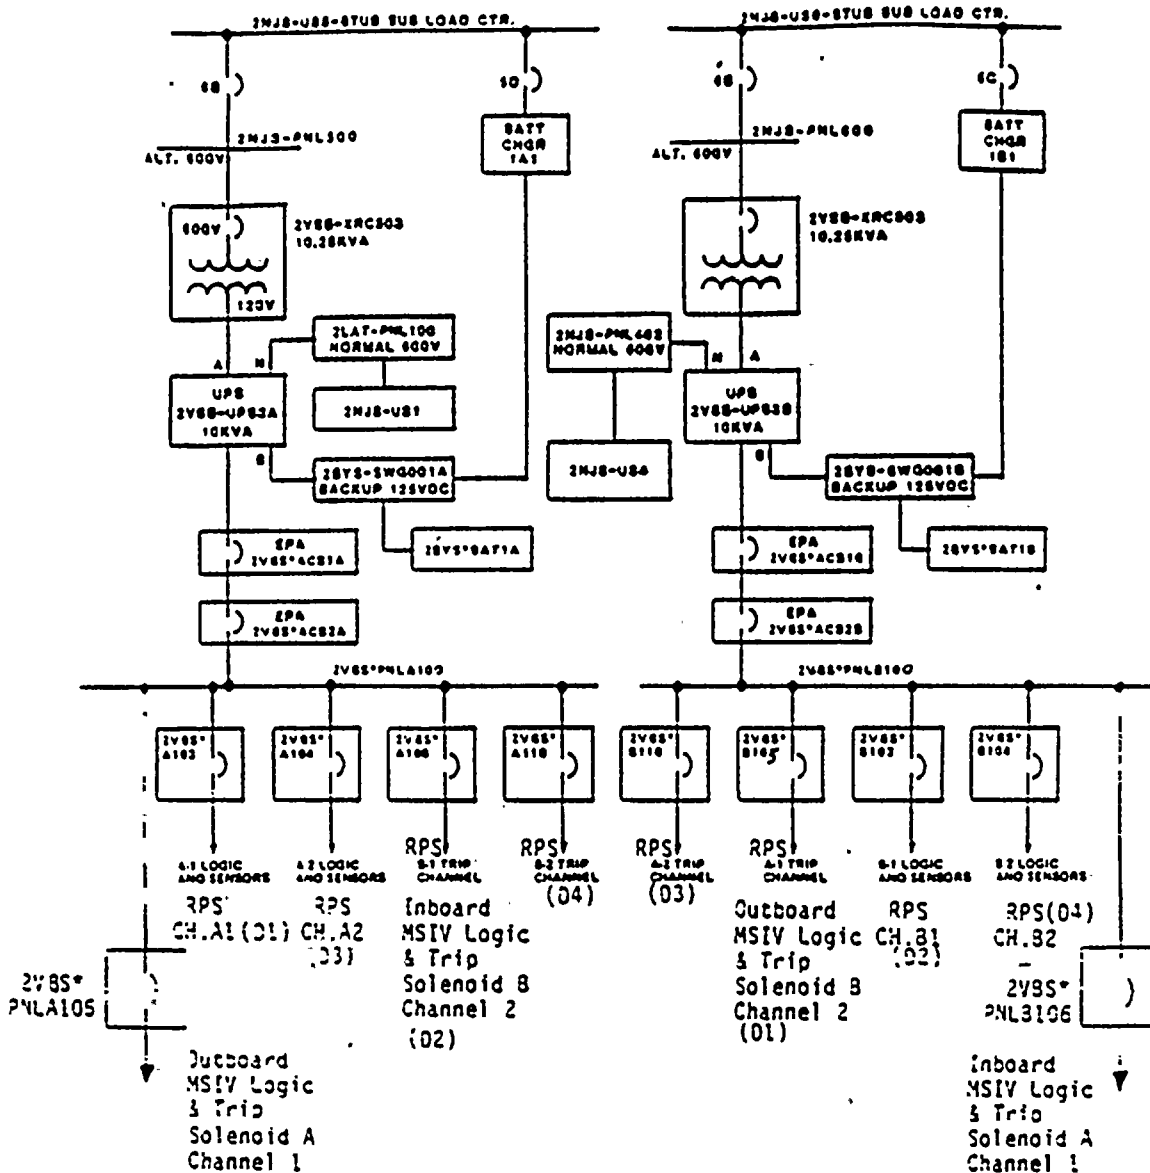
FIGURE 1

This event was caused by personnel error. Instead of opening selective circuit breakers on panel A106 to de-energize the MSIV logic circuits, the operator opened the main feeder breaker to panel A106. This action de-energized a portion of RPS A which satisfied the logic to scram the group 2 control rods, but did not satisfy the logic necessary to isolate the SDV. (A detailed technical explanation is given in the "Additional Information" section).

The group 2 control rods will scram when a scram signal is received from both RPS A division 2 and RPS B division 2. De-energizing a division will satisfy the logic to generate a scram signal from that division. A scram signal to the group 2 control rods will be generated if the K14K or K14P relays de-energize on RPS A along with the de-energization of the K14B or K14F relays on RPS B. This logic arrangement will de-energize both of the group 2 pilot scram solenoids (see figure 6) causing a scram of the control rods of that group. Once a scram signal is generated it seals in and needs to be reset by a reset control switch.

Since power was lost from UPS 3B, a scram signal from RPS B division 2 was present. (Both the K14B and the K14F relays were de-energized.) When panel A106 was de-energized, this de-energized RPS A division 2 generating a scram signal for that division. (Both the K14K and K14P relays were de-energized.) This resulted in the group 2 control rods receiving a scram initiation.

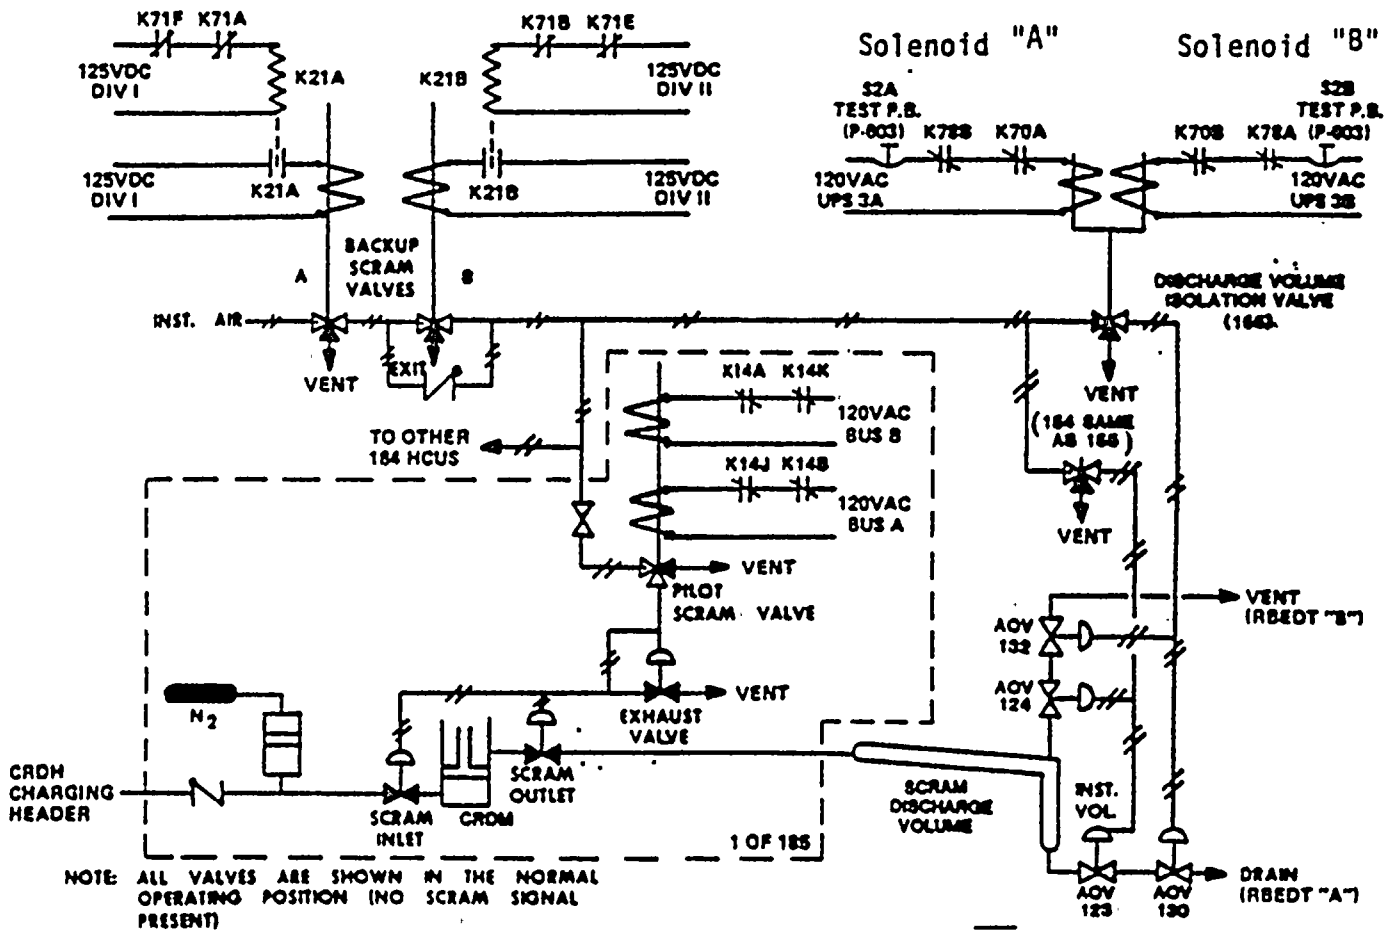
FIGURE 2

Normally during a scram the SDV vent and drain valves will close to isolate the SDV. These valves close when both the A and B pilot solenoids are de-energized (see Figure 2). These pilot solenoids will de-energize when the following conditions are satisfied: (1) Relays K70A or K78B are energized for pilot solenoid A, Relays K70B or K78A are energized for pilot solenoid B, or (2) if the solenoid test pushbutton is depressed.

Pilot solenoid B was also de-energized because it is powered from UPS 3B. But pilot solenoid A remained energized since there was not a scram signal on RPS A division 1 (relay K70A was de-energized) and because K78B was de-energized.

Since pilot solenoid A remained energized, the vent and drain valves did not close, causing the SDV to remain unisolated.

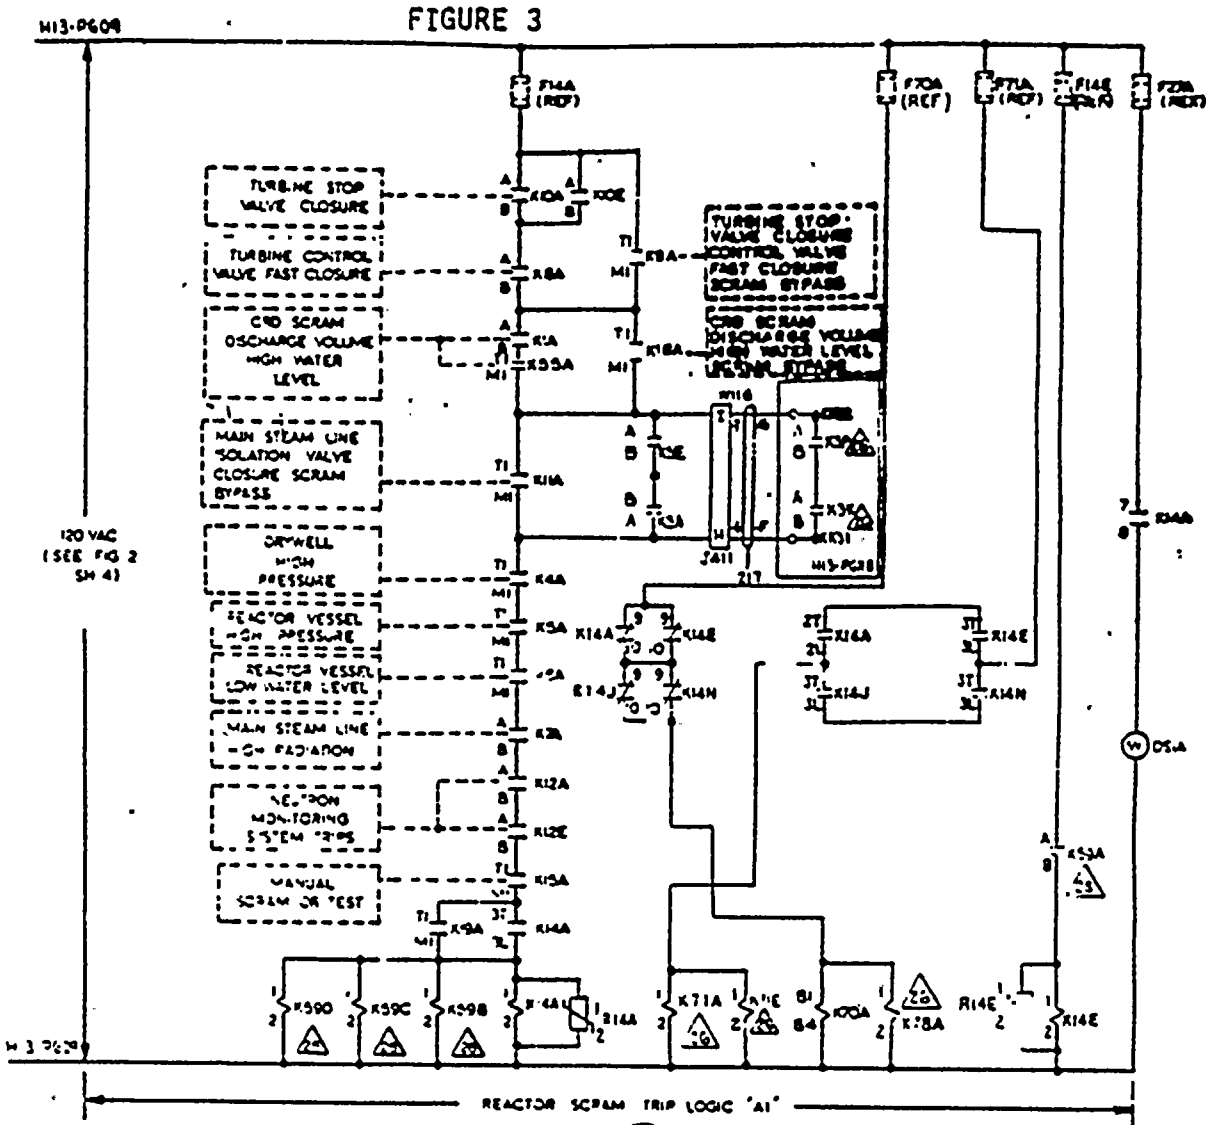
Relays K70A and K78A will energize if there is a scram signal on RPS A division 1. A scram signal on RPS A division 1 is present when the K14A or K14E and the K14J or K14N relays are de-energized. This satisfies the one out of two taken twice criterion for the RPS Logic. (See Figure 3)

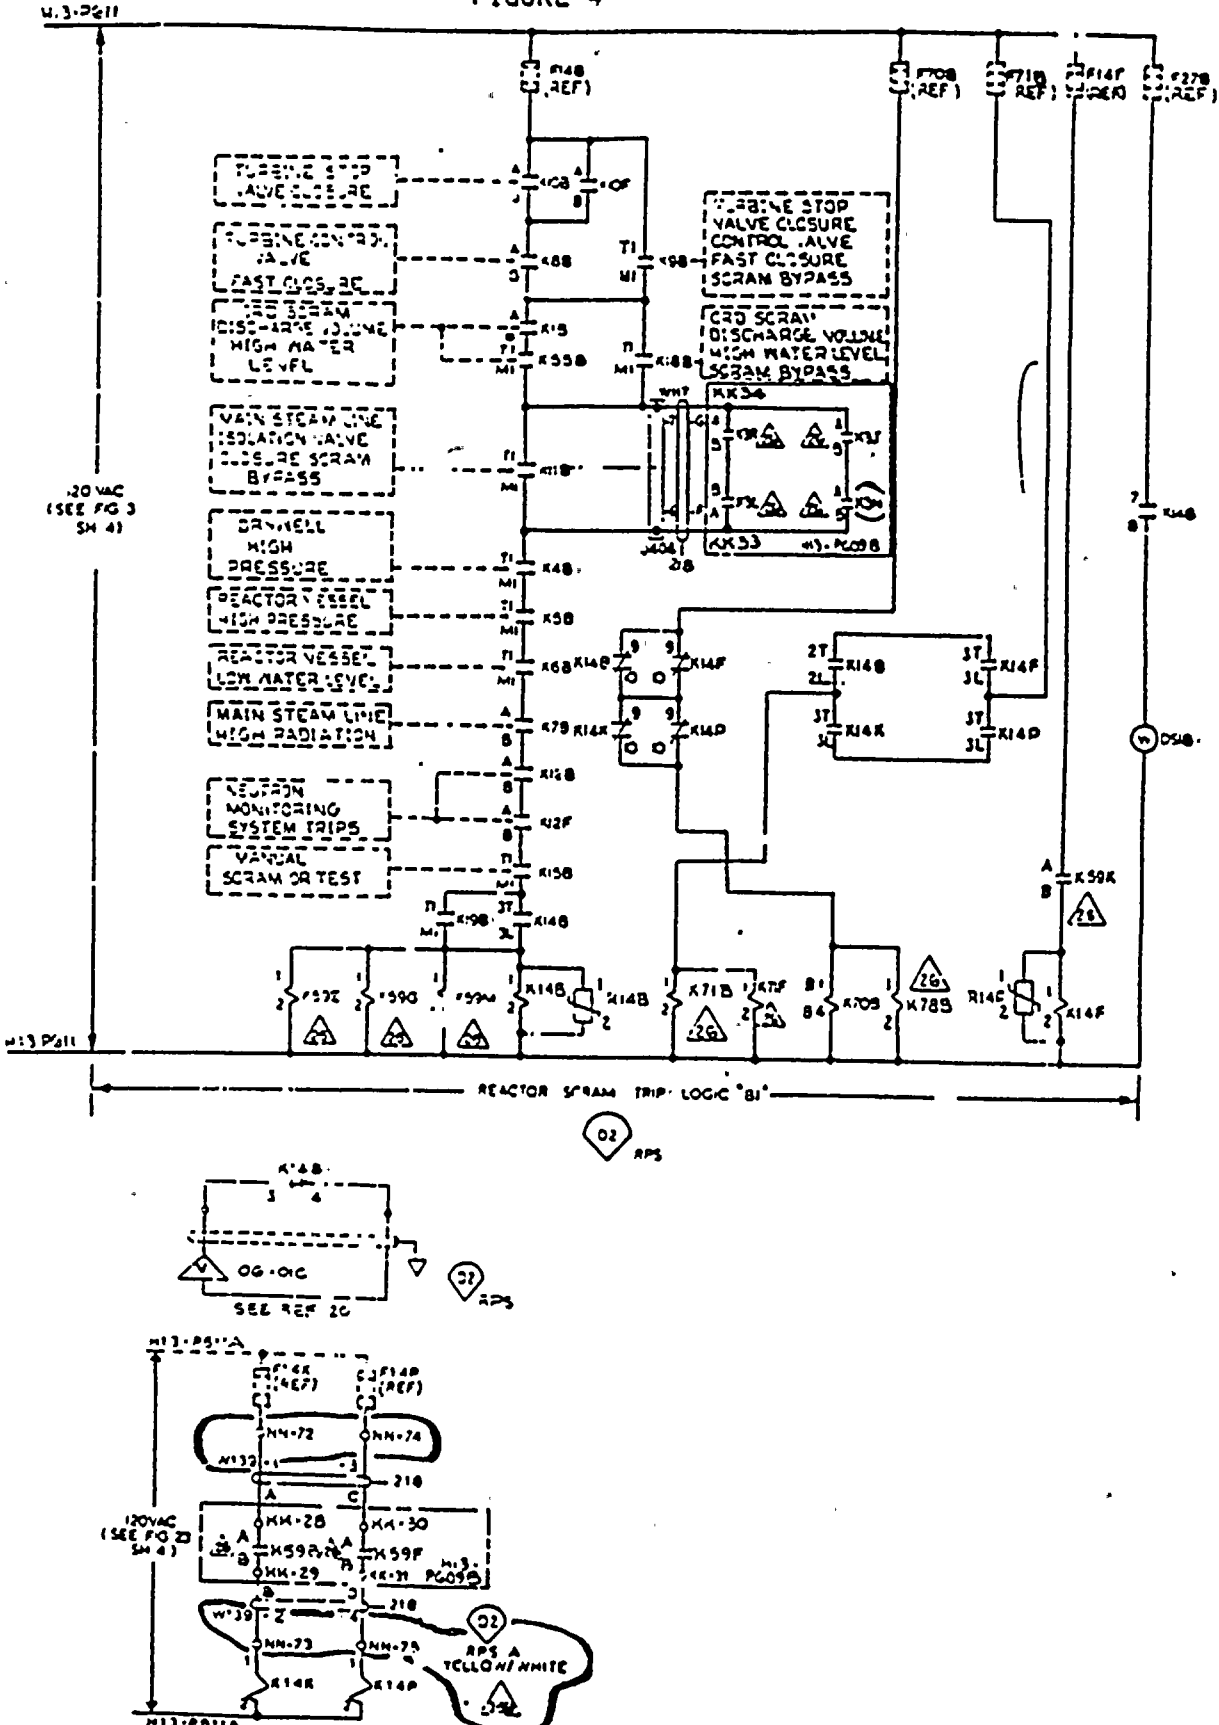
FIGURE 4

Relays K70B and K78B will energize if there is a scram signal on RPS B division 2. A scram signal on RPS B division 2 is present when the K14B or K14F and the K14K or K14P relays are de-energized. The logic criterion is similar to that described above. (see Figure 4).
