LICENSEE EVENT REPORT (LER)

FACILITY NAME (1) Nine Mile Point Unit 2	DOCKET NUMBER (2) 0 5 0 0 0 4 1 0 1	PAGE (3) 1 OF 0 6
--	---	-------------------------------

TITLE (4)
Reactor Scram and Containment Isolation

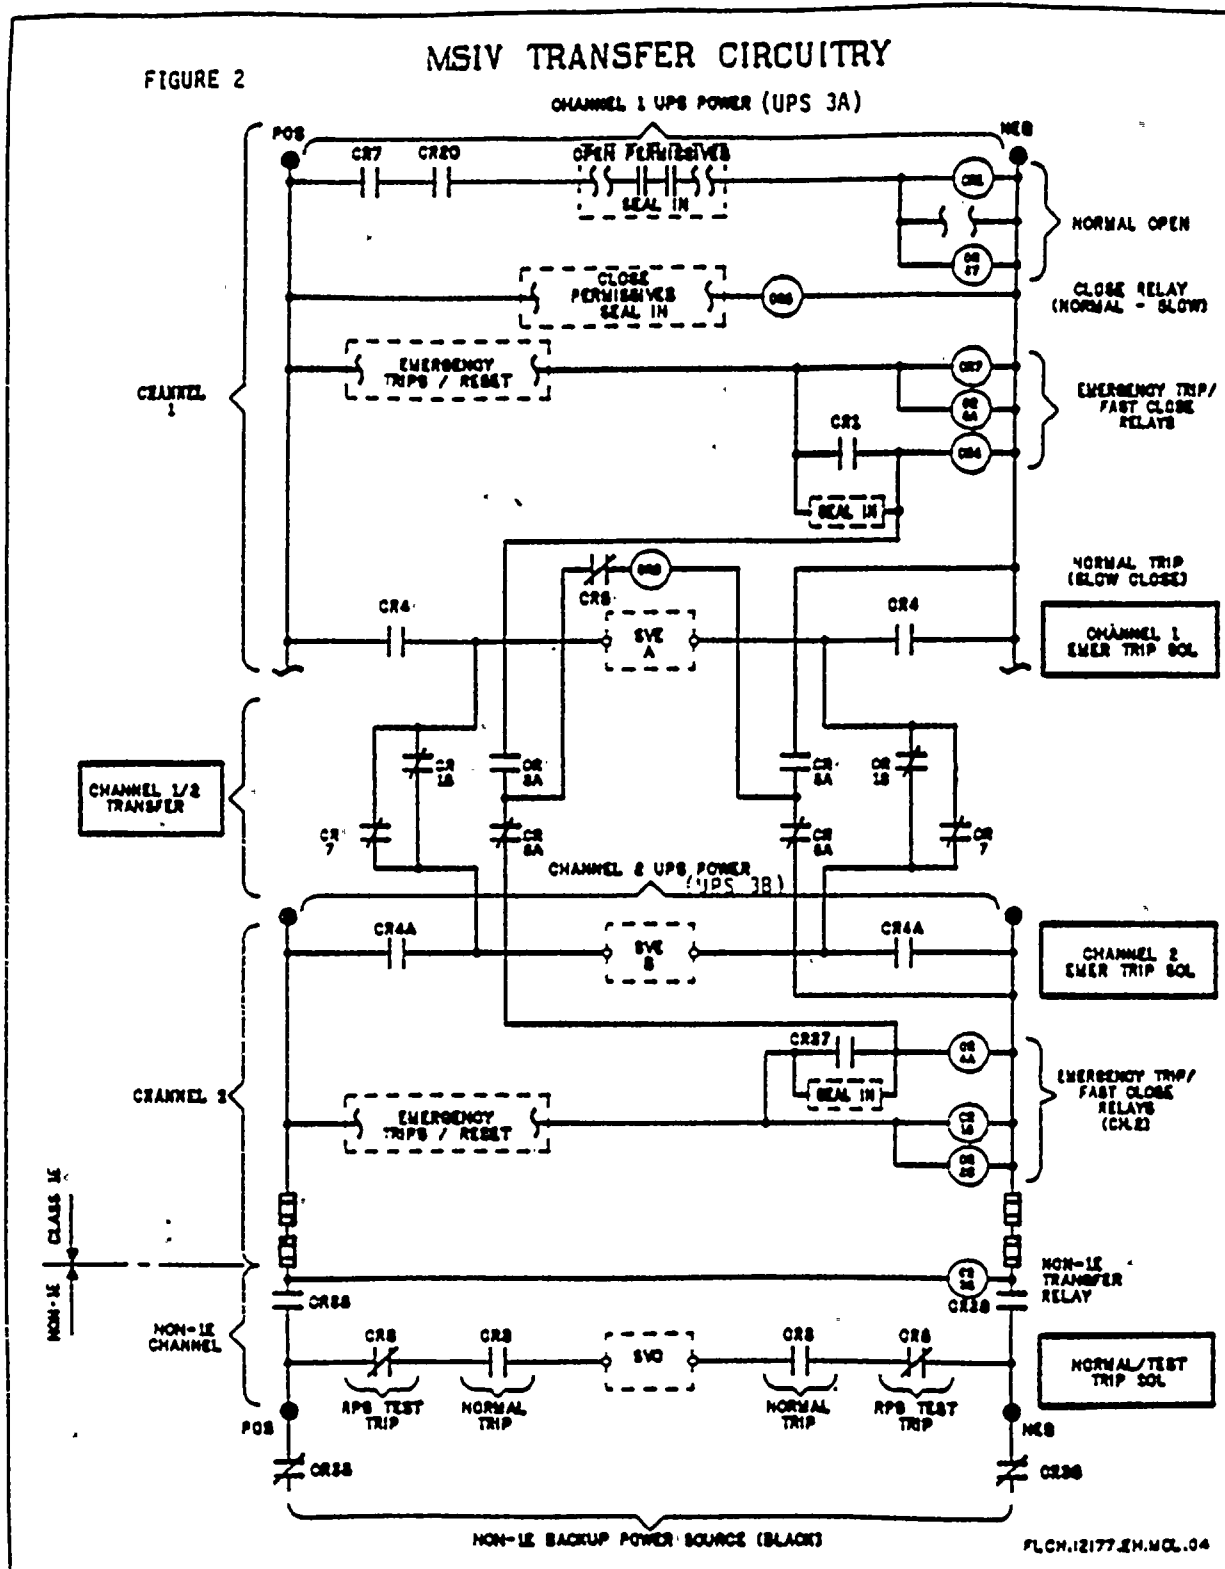
(Refer to Figures 1 and 2)

The cause of this event can be traced to a circuit design allowing the RPS channels A and B being momentarily cross connected in the Main Steam Isolation Valve (MSIV) panel.

The circuit checkout work provided temporary power to the CR-4 and CR-7 relays, while MSIV trip solenoid A was being energized from its normal power supply (UPS 3A). (Relays CR-4 and CR-7 swap power supplies to solenoid A upon loss of its normal power source. These relays actuate upon de-energization.) Removing the jumper supplying temporary power to relays CR-4 and CR-7 simulated a loss of power to solenoid A, when normal power to solenoid A was available. When the jumper was removed de-energizing CR-4 and CR-7, the 7-3 and 7-4 contacts closed while the 4-1 and 4-2 contacts apparently did not open in time. This allowed the cross connection of the MSIV channel 1 and MSIV channel 2 power supplies (UPS 3A and UPS 3B). Other cross connecting possibilities existed to cause the same event.

1. A design change initiated by E&DCR #M10032C and incorporated in Modification #PN2Y86MX118 has been built into the MSIV circuits to ensure RPS channels A and B will not be cross connected as described in this report.
2. A further investigation is being conducted on the loss of all annunciators.
