LICENSEE EVENT REPORT (LER)

FACILITY NAME (1) Nine Mile Point Unit 2		DOCKET NUMBER (2) 0 5 0 0 0 4 1 0	PAGE (3) 1 OF 0 5
---	--	--	----------------------------

TITLE (4)
Design of Manhole #5

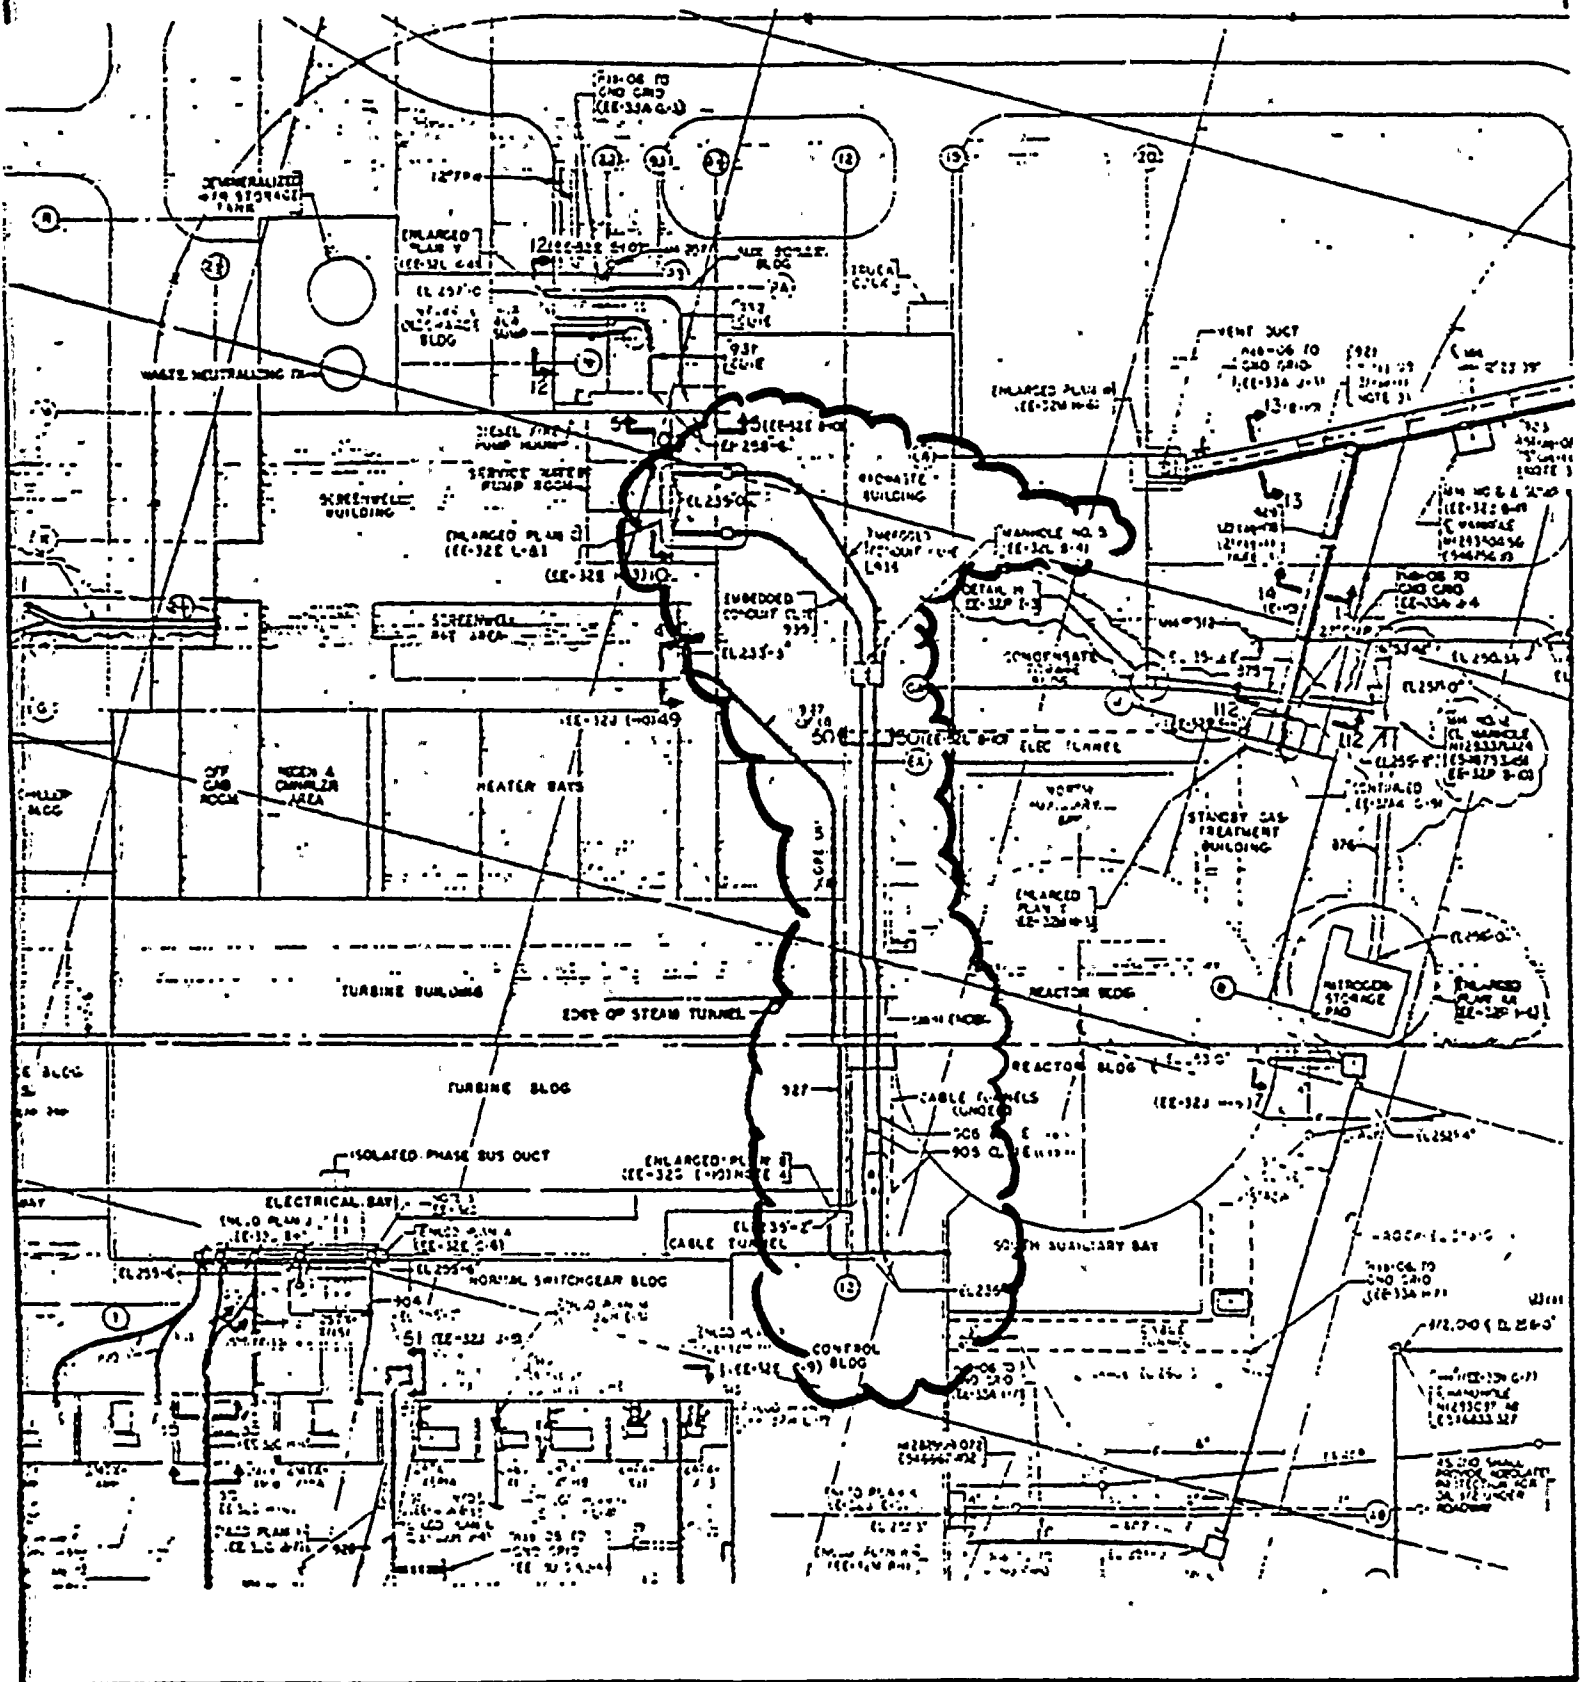
(Refer to Attached Figure)

On December 29, 1986 conduit seals inside manhole #5 were discovered to be in noncompliance with internal flooding criteria (as discussed in FSAR section 3.4.1.1.3) during an engineering design review of various plant penetrations.

If an internal flooding event occurred, such as a circulating water line break at the condenser the manhole would flood and a sufficient hydrostatic head would be developed to fail the conduit seals. Therefore, water could flow through the conduits and flood (assuming no other mitigating actions are taken) the control building elevations below elevation 261' and the service water pump bays. This would result in the Reactor Protection System (RPS) and Main Steam Isolation Valve (MSIV) logic power supplies being lost along with service water capability. Loss of the Service Water system could impair the ability of the station to attain a safe shutdown.

The root cause of this event is a design deficiency which allowed installation of conduit seals which were not in compliance with the internal flooding criteria as specified by FSAR section 3.4.1.1.3. However, this design deficiency is not generic. A review of similar manhole installations has verified that these installations are in compliance with the design criterion for the function they serve. Therefore, the non-compliance of the conduit seals in manhole #5 is an isolated case.

As stated, the conduit seals inside manhole #5 were not designed to provide a water tight seal in an internal flooding event.

1. It was decided that it would be more expedient to ensure that the manhole covers would provide adequate sealing rather than modify the conduit seals. Therefore, the two covers for manhole #5 have been modified by Engineering & Design Coordination Report C25578. The manhole installation is now in compliance with internal flooding criteria.
