FACILITY NAME (1) Nine Mile Point Unit 2	DOCKET NUMBER (2) 0 5 1 0 1 0 0 4 1 1 0	PAGE (3) 1 OF 4
--	---	---------------------------

TITLE (4)
Main Steam Isolation Valve Trip Due to Surveillance Testing

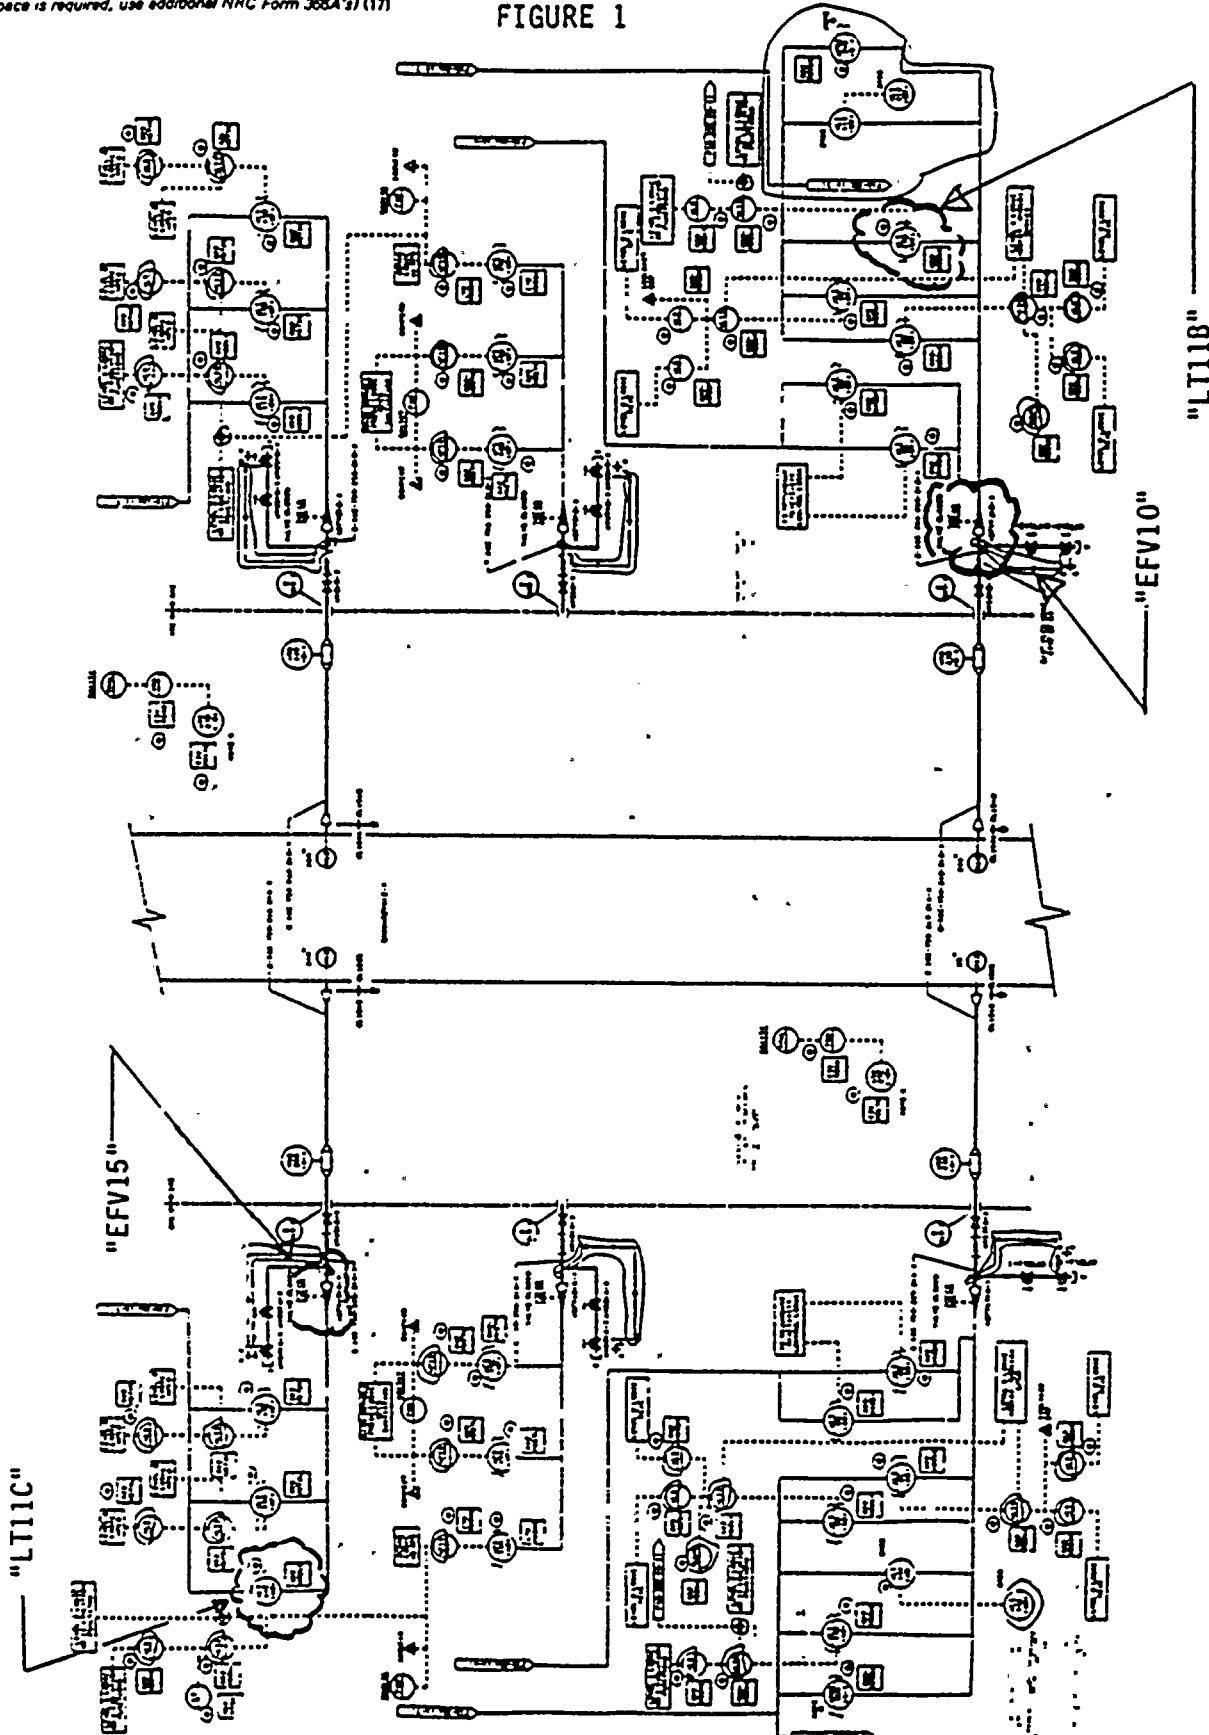
FIGURE 1

The sequence of events are as follows: (Refer to Figure 1)

On February 2, 1987 at 0150 while performing surveillance on excess flow check valve 2ISC*EFV10, level transmitter 2ISC*LT11B momentarily tripped on a low-low-low (level 1) reactor vessel (RPV) water level. (This signal was a byproduct of the surveillance testing and not representative of the actual RPV water level. The actual RPV water level was being maintained at a high level point which was greater than level 8.) This momentary trip, which automatically cleared four seconds later, caused one channel of the MSIV trip logic to seal in. The MSIV's did not close at this time.

At 0516 the same day, while performing surveillance on excess flow check valve 2ISC*EFV15, level transmitter 2ISC*LT11C momentarily tripped on a low-low-low (level 1) RPV water level. (This signal was also a byproduct of testing and not representative of the actual RPV water level). This second device trip in conjunction with the earlier trip satisfied the logic to isolate the MSIV's.
