SUBJECT: LER 87-031-00: on 870612, scram occurred due to cold water excursion when feedwater level control valve failed open. Caused by feedback arm unbolting which allow valve to ramp open. Valve repaired & bolt lockwired. W/870710 ltr.

LICENSEE EVENT REPORT (LER)

FACILITY NAME (1) Nine Mile Point Unit 2	DOCKET NUMBER (2) 0 5 0 0 0 4 1 0	PAGE (3) 1 OF 015
---	--	----------------------

TITLE (4) Scram due to Cold Water Excursion when Feedwater Level Control Valve Failed Open

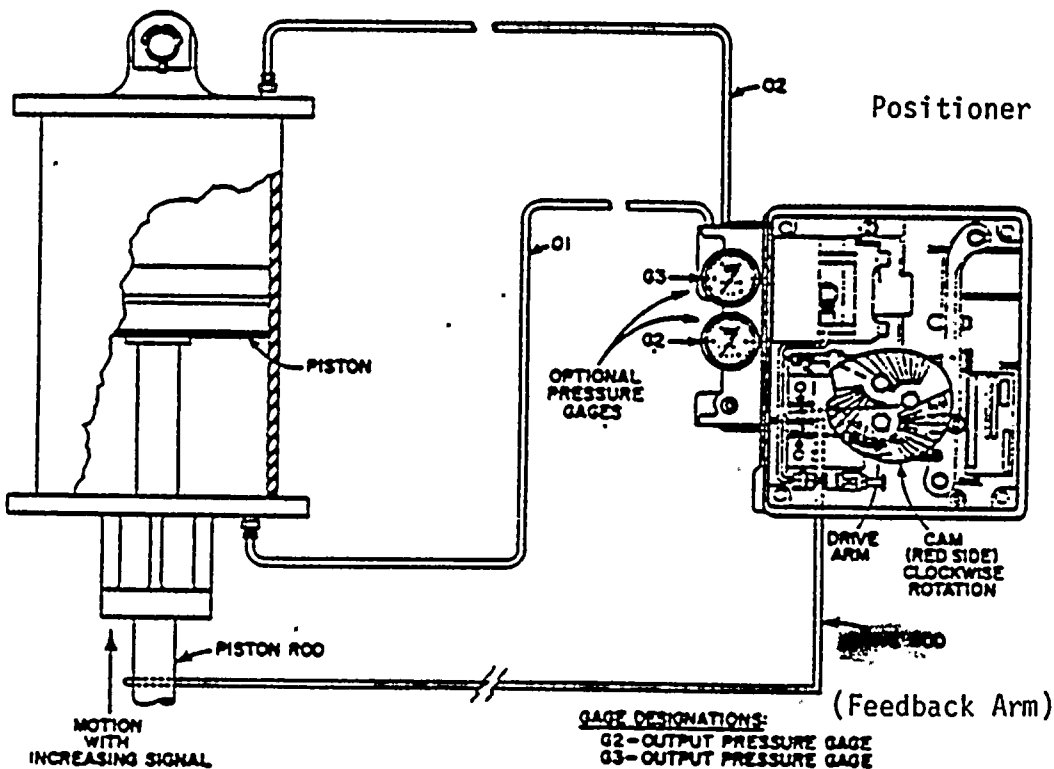
ATTACHMENT 1

Operations then conducted an inspection of 2FWS-LV55A to determine the cause of failure. The inspection revealed that the mounting bolt securing the feedback arm to the valve stem had fallen out allowing the feedback arm greater freedom of movement. The feedback arm was found "caught-up" on the position mounting bracket prohibiting both movement and an accurate feedback signal. The inaccurate signal, thus, caused the valve to ramp open. (NOTE: A mechanical linkage is provided between the valve positioner and valve stem to provide a position feedback signal - See Attachment One).

The mechanism by which the feedback arm mounting bolt became loose and eventually fell out is uncertain. With information gathered from involved plant staff, the following is the most probable sequence leading to valve failure.

1. Vibration allowed the mounting bolts (one from feedback arm to valve stem - one from feedback arm to support bracket) to loosen slightly allowing some rotation of the feedback arm.
2. Due to the small clearance between the positioner mounting bracket and feedback arm motion, this additional rotation caused the feedback arm to rub and bind against the bracket. Additional vibration and stress could have been placed on the bolt every time the valve was repositioned. Paint scraped off the positioner bracket supports this theory.
3. The mounting bolt (from feedback arm to valve stem) eventually loosens to the point where it fell out and allowed greater movement of the feedback arm and stem. The arm then became bound under the positioner support bracket prohibiting both movement and an accurate feedback signal rendering the valve inoperable.

Corrective action has been taken to repair 2FWS-LV55A per work request (WR 120932). The mechanical linkage parts were realigned and retightened and the valve verified operable by Operations. The feedback arm of 2FWS-LV55B was inspected and found to be satisfactory. The bolt which came loose on 2FWS-LV55A (from feedback arm to valve stem) has been lockwired on both 2FWS-LV55A and LV55B to prevent a similar event from occurring. The mounting bolt securing feedback arm to support bracket has been "double nutted".

The mounting bracket will be modified by cutting a portion of it that protrudes beyond the edge of the valve yoke. This work will be completed per FDDR K61-0807 and preclude a similar event from occurring.
