LICENSEE EVENT REPORT (LER)

FACILITY NAME (1) Nine Mile Point Unit 2	DOCKET NUMBER (2) 0 5 0 0 0 4 1 0	PAGE (3) 1 OF 08
--	---	----------------------------

TITLE (4) **Two ESF Actuations Consisting of Standby Gas Treatment Initiations Caused by Inadequate Administrative Policy and Personnel Error**

EVENT DATE (5)			LER NUMBER (6)			REPORT DATE (7)			OTHER FACILITIES INVOLVED (8)		
MONTH	DAY	YEAR	YEAR	SEQUENTIAL NUMBER	REVISION NUMBER	MONTH	DAY	YEAR	FACILITY NAMES		DOCKET NUMBER(S)
07	29	87	87	045	00				N/A		0 5 0 0 0
									N/A		0 5 0 0 0

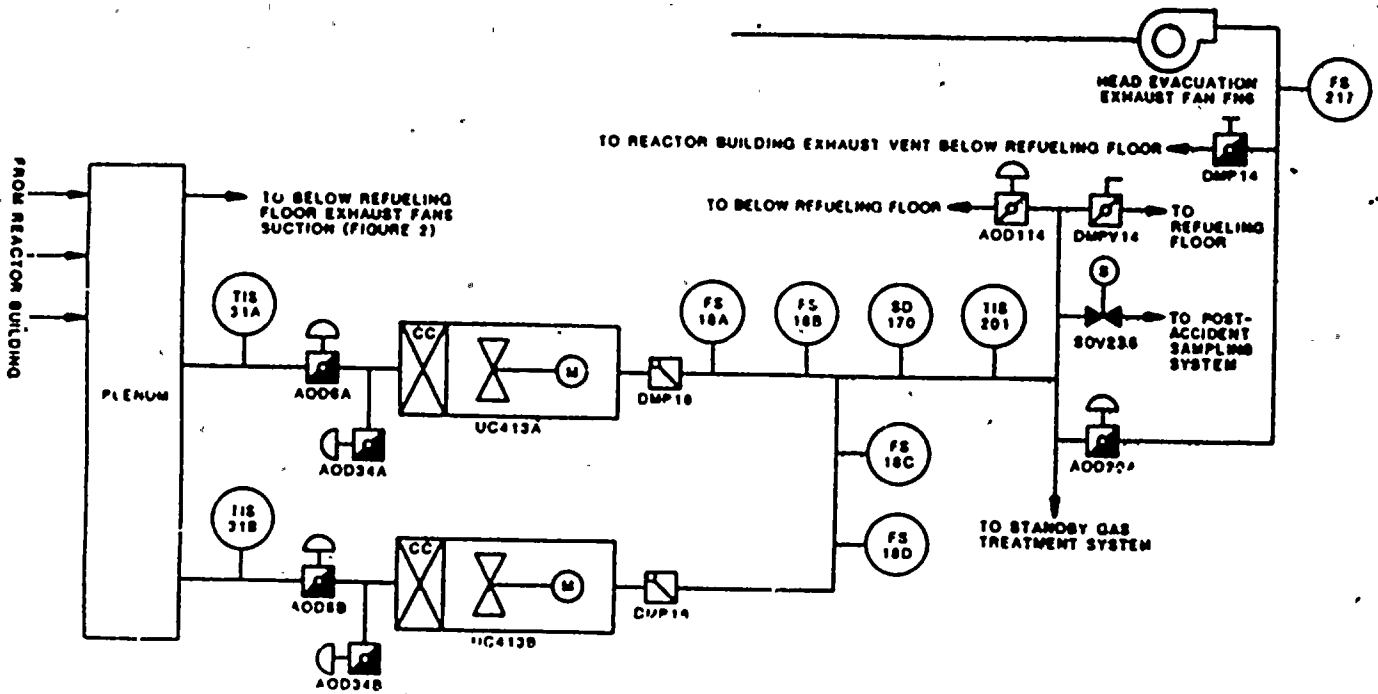
FIGURE 1

The first event occurred at 1023 hours. Jumpers had been installed per N2-RSP-RMS-M108 to prevent a Division I secondary containment isolation upon energization of the associated trip relay. Per procedure, a high radiation signal was then simulated into the trip relay for 2HVR*RE14A. This caused the inlet test damper to 2HVR*UC413A (2HVR*AOD34A) to close and the normal inlet damper (2HVR*AOD6A) to open. This resulted in 2HVR*UC413A taking suction on the Below Refuel Floor Exhaust Plenum which is a common suction with the Below Refuel Floor Exhaust Fans 2HVR*FN2A and B. Thus both the emergency recirculation unit, 2HVR*UC413A, and the Below Refuel Floor Exhaust Fan 2HVR*FN2A were drawing suction on their common exhaust plenum. The common fan suction duct for Below Refueling Floor Exhaust Fans 2HVR*FN2A and B, is equipped with two flow switches 2HVR*FS37A and B. These switches actuate on low flow. With 2HVR*UC413A drawing suction on the same plenum as the exhaust fan 2HVR*FN2A and recycling air back into the reactor building an air flow imbalance was created. In this case more air was being supplied to the reactor building than was being exhausted. The flow imbalance caused the reactor building pressure to increase from -0.78 to +0.32 inches of water gauge pressure before the flow switches 2HVR*FS37A and B actuated on low flow. This resulted in a secondary containment isolation and subsequent auto-start of GTS Train B (Train A was already running) which restored reactor building pressure to normal. The total duration of the event was approximately 90 seconds.

The root cause of the first event has been attributed to inadequate administrative controls. There is no policy to prohibit concurrent performance of surveillance procedures which affect the same system or closely related systems. If operators in the control room had not allowed both surveillance tests to be run simultaneously, the event would not have occurred.

REACTOR BUILDING VENTILATION - EMERGENCY RECIRCULATION SUBSYSTEM

1. A policy shall be established that prohibits concurrent performance of surveillance procedures which affect the same system or closely related systems unless explicitly stated in the procedures.

2. Steps shall be added to the applicable procedures which were involved in the first event to prohibit their concurrent performance.
3. A note shall be added to the "Lessons Learned" book in the Control Room detailing the system lineups required before restoring the HVR back into service and emphasizing the need to strictly adhere to the operating procedure when doing so.

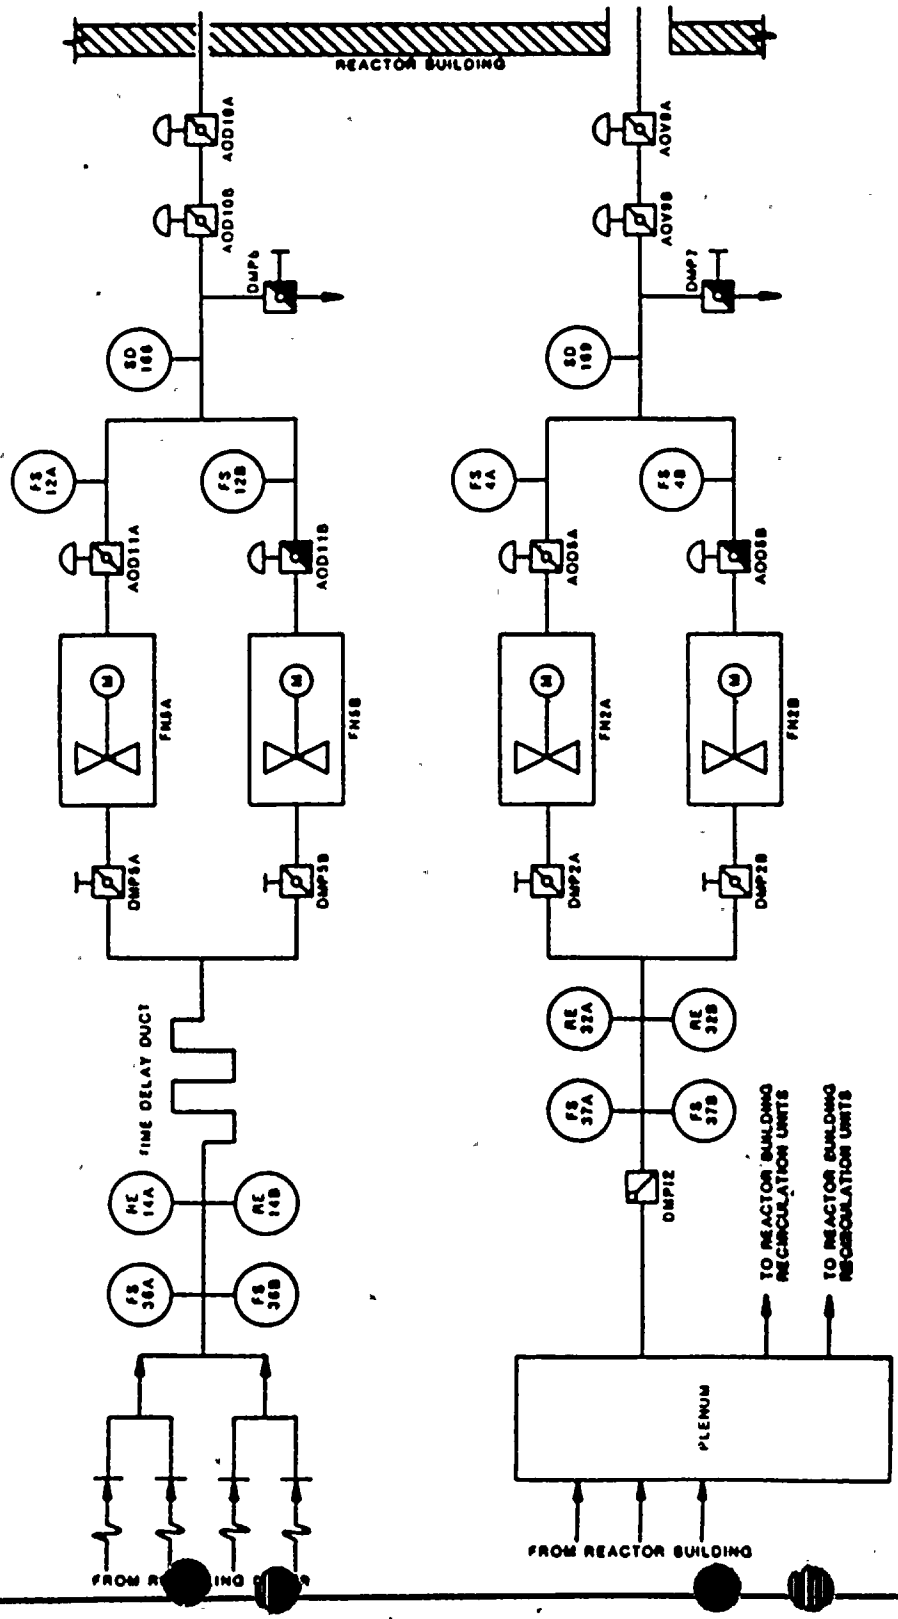
FIGURE 2

The second event occurred at 1058 hours. While attempting to restore Reactor Building Ventilation system back to normal operation from the first event another secondary containment isolation occurred. GTS Train B had been restored to normal prior to the event. The Niagara Mohawk licensed operator at the remote panel started a normal supply (2HVR*FN1A) and a normal Below Refuel Floor Exhaust Fan (2HVR*FN2B). He then started another supply fan and the normal Above Refuel Floor Exhaust Fan (2HVR*FN5A). He then noticed that the Below Refuel Floor Exhaust Fan he had previously started (2HVR*FN2B) had tripped. A start of the Standby Below Refuel Floor Exhaust Fan (2HVR*FN2A) was attempted but this fan tripped on motor electrical fault. Thus, with two supply fans and one exhaust fan running, the reactor building overpressurized causing all reactor building supply fans to trip off and a subsequent low flow secondary containment isolation. A Niagara Mohawk licensed operator in the control room noticed reactor building inside /outside differential pressure approaching its high setpoint (greater than 3 inches water gauge pressure) and had manually started GTS System Train B to assist in restoring pressure to normal. This action did not prevent the Reactor Building from equaling its high differential pressure setpoint of +3.00 inches of water gauge.

The cause of the second event was cognitive personnel error by the operator who was restoring the HVR back to normal operation. Operating Procedure N2-OP-52, "Reactor Building Ventilation", gives detailed instruction for the startup of the normal reactor building ventilation system. A low flow trip of the below refuel floor exhaust fan (2HVR*FN2A) was caused by the emergency recirculation unit 2HVR*UC413A operating in its normal mode with the normal damper 2HVR*A0V6A open and the test damper 2HVR*A0V34A closed. This resulted in 2HVR*UC413A and 2HVR*FN2A drawing suction on a common plenum. With both units competing for air from the same plenum their flow rates fell causing a low flow trip signal from 2HVR*FS37A and B.

REACTOR BUILDING NORMAL EXHAUST VENTILATION

4. An Independent Safety Evaluation Group (ISEG) recommendation has been implemented which requests that an evaluation independent of the original designers and startup engineers be performed to reduce unwanted GTS initiations. The focus of this evaluation shall be to enhance GTS auto initiation logic to reduce unnecessary challenges to the GTS from the Radiation Monitoring System (RMS) and the HVR. Modifications and/or procedure changes shall be made as determined by this independent evaluation.
