ACCESSION NBR: 8709040467 DOC. DATE: 87/09/01 NOTARIZED: NO DOCKET #
 FACIL: 50-220 Nine Mile Point Nuclear Station, Unit 1, Niagara Powe 05000220
 AUTH. NAME AUTHOR AFFILIATION
 MAZZAFERRO, P. A. Niagara Mohawk Power Corp.
 LEMPGES, T. E. Niagara Mohawk Power Corp.
 RECIP. NAME RECIPIENT AFFILIATION

SUBJECT: LER 87-013-00: on 870802 reactor bldg emergency ventilation initiation occurred. Caused by pneumatic timing relay failure. Reactor protection sys Bus 11 transferred to maint bus & one-half scram reset. W/870901 ltr.

TITLE (4)
Reactor Building Emergency Ventilation Initiation Caused By Relay Failure

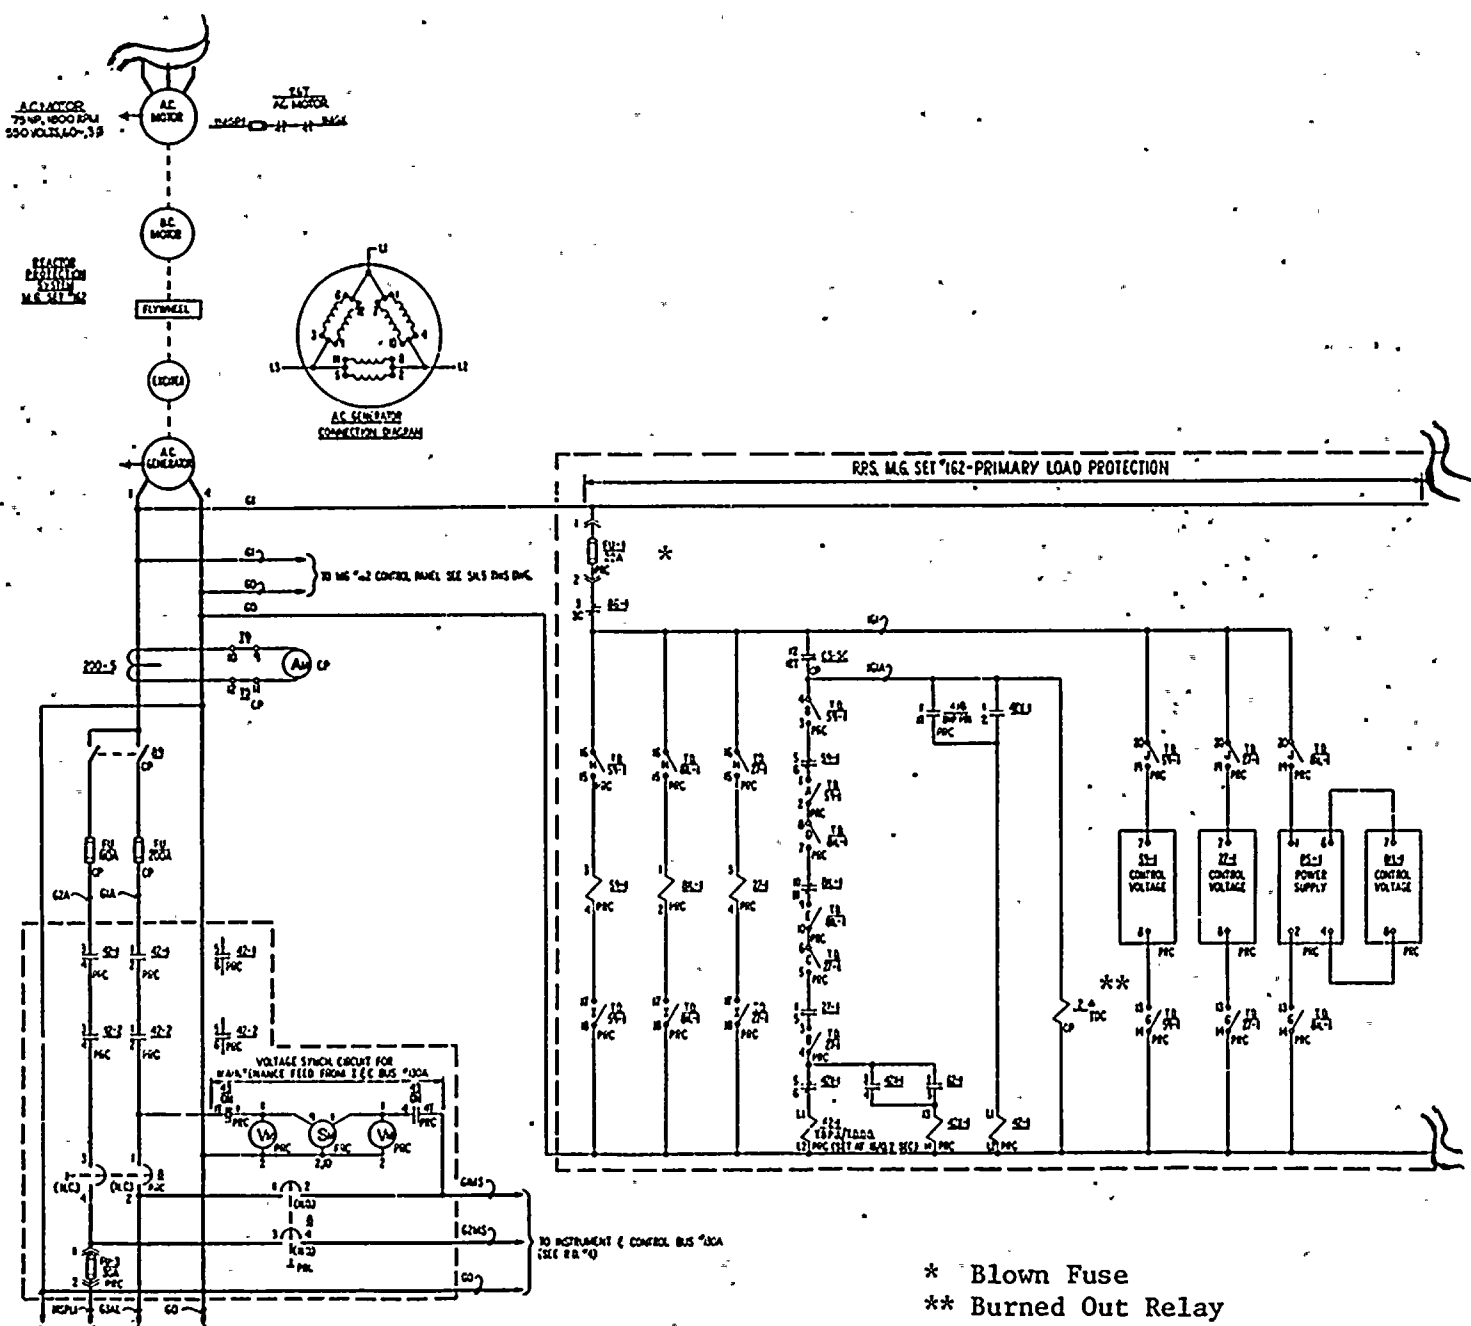
On August 2, 1987, Nine Mile Point Unit 1 (NMP1) was operating at 89% power with the mode switch in the "RUN" position. At 1300 hours the unit experienced a trip of Reactor Protection System (RPS) Motor Generator (MG) Set 162. Subsequently, RPS Bus 11 was deenergized. This resulted in a one-half scram, Reactor Building Emergency Ventilation (RBEV) initiation, Control Room Emergency Ventilation (CREV) initiation, and an isolation of the Reactor Water Cleanup System (RWCU). Upon investigation, it was found that the coil of the pneumatic timing relay (2/TDC) in the primary protective relaying circuit of MG Set 162 had failed. This caused the fuse (FU-1/20A) in that circuit to blow, deenergizing one of two series contactors (42-1) and isolating RPS Bus 11 from its power supply (see electrical diagram on page 4 of this report).

Each of the two RPS MG Sets have a protective relaying scheme consisting of a primary and an alternate channel. Each channel controls the action of one of two series contactors (42-1 and 42-2) which isolate the associated RPS channel from the MG set. The two channels of protective relaying are separately fused. Deenergizing either of the two contactors will isolate the associated RPS bus, causing a one-half scram when the mode switch is in the "RUN" position. Deenergizing either channel of the RPS, under any position of the mode switch, will result in a RBEV initiation, a CREV initiation, and a RWCU isolation because the logic for these systems is noncoincident.

The cause of the fuse failure was a physical fault due to the burned out coil of the pneumatic timing relay in the primary protective relaying circuit of MG Set 162. The most likely root cause of the coil failure was degradation resulting from aging during normal service of the relay. The relay was damaged by the coil failure, rendering examination for further analysis impractical.

Subsequent corrective action consisted of replacing the failed timing relay and the blown fuse, under Station Work Request #126052, and returning MG Set 162 to service.
