SUBJECT: Forwards corrected LER 87-045-00, incorporating inadvertently omitted date on cover ltr & rept.

FACILITY NAME (1) Nine Mile Point Unit 2	DOCKET NUMBER (2) 0 5 0 0 0 410	PAGE 3 1 OF 08
--	---	--------------------------

TITLE (4) **TWO ESF Actuations Consisting of Standby Gas Treatment Initiations Caused by Inadequate Administrative Policy and Personnel Error**

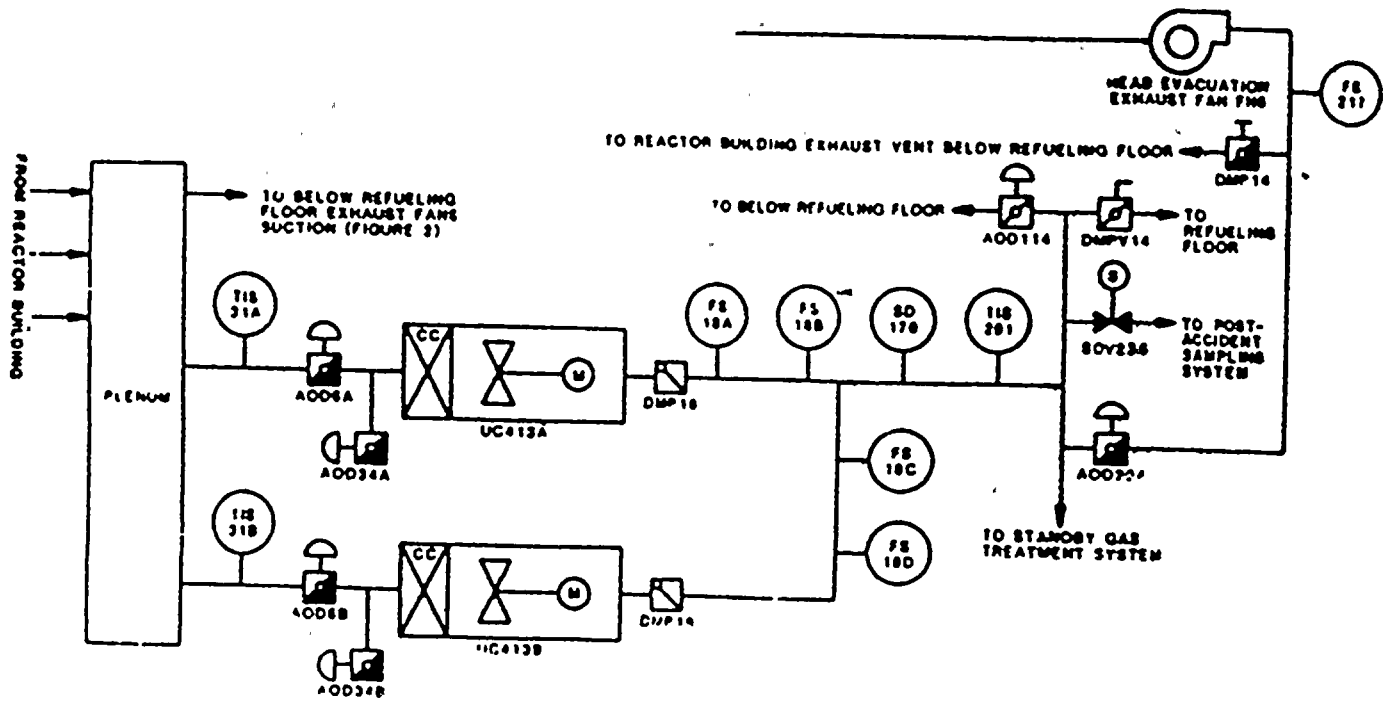
FIGURE 1
REACTOR BUILDING VENTILATION - EMERGENCY RECIRCULATION SUBSYSTEM

The first event occurred at 1023 hours. Jumpers had been installed per N2-RSP-RMS-M108 to prevent a Division I secondary containment isolation upon energization of the associated trip relay. Per procedure, a high radiation signal was then simulated into the trip relay for 2HVR*RE14A. This caused the inlet test damper to 2HVR*UC413A (2HVR*AOD34A) to close and the normal inlet damper (2HVR*AOD6A) to open. This resulted in 2HVR*UC413A taking suction on the Below Refuel Floor Exhaust Plenum which is a common suction with the Below Refuel Floor Exhaust Fans 2HVR*FN2A and B. Thus both the emergency recirculation unit, 2HVR*UC413A, and the Below Refuel Floor Exhaust Fan 2HVR*FN2A were drawing suction on their common exhaust plenum. The common fan suction duct for Below Refueling Floor Exhaust Fans 2HVR*FN2A and B, is equipped with two flow switches 2HVR*FS37A and B. These switches actuate on low flow. With 2HVR*UC413A drawing suction on the same plenum as the exhaust fan 2HVR*FN2A and recycling air back into the reactor building an air flow imbalance was created. In this case more air was being supplied to the reactor building than was being exhausted. The flow imbalance caused the reactor building pressure to increase from -0.78 to +0.32 inches of water gauge pressure before the flow switches 2HVR*FS37A and B actuated on low flow. This resulted in a secondary containment isolation and subsequent auto-start of GTS Train B (Train A was already running) which restored reactor building pressure to normal. The total duration of the event was approximately 90 seconds.

The root cause of the first event has been attributed to inadequate administrative controls. There is no policy to prohibit concurrent performance of surveillance procedures which affect the same system or closely related systems. If operators in the control room had not allowed both surveillance tests to be run simultaneously, the event would not have occurred.

1. A policy shall be established that prohibits concurrent performance of surveillance procedures which affect the same system or closely related systems unless explicitly stated in the procedures.

2. Steps shall be added to the applicable procedures which were involved in the first event to prohibit their concurrent performance.
3. A note shall be added to the "Lessons Learned" book in the Control Room detailing the system lineups required before restoring the HVR back into service and emphasizing the need to strictly adhere to the operating procedure when doing so.

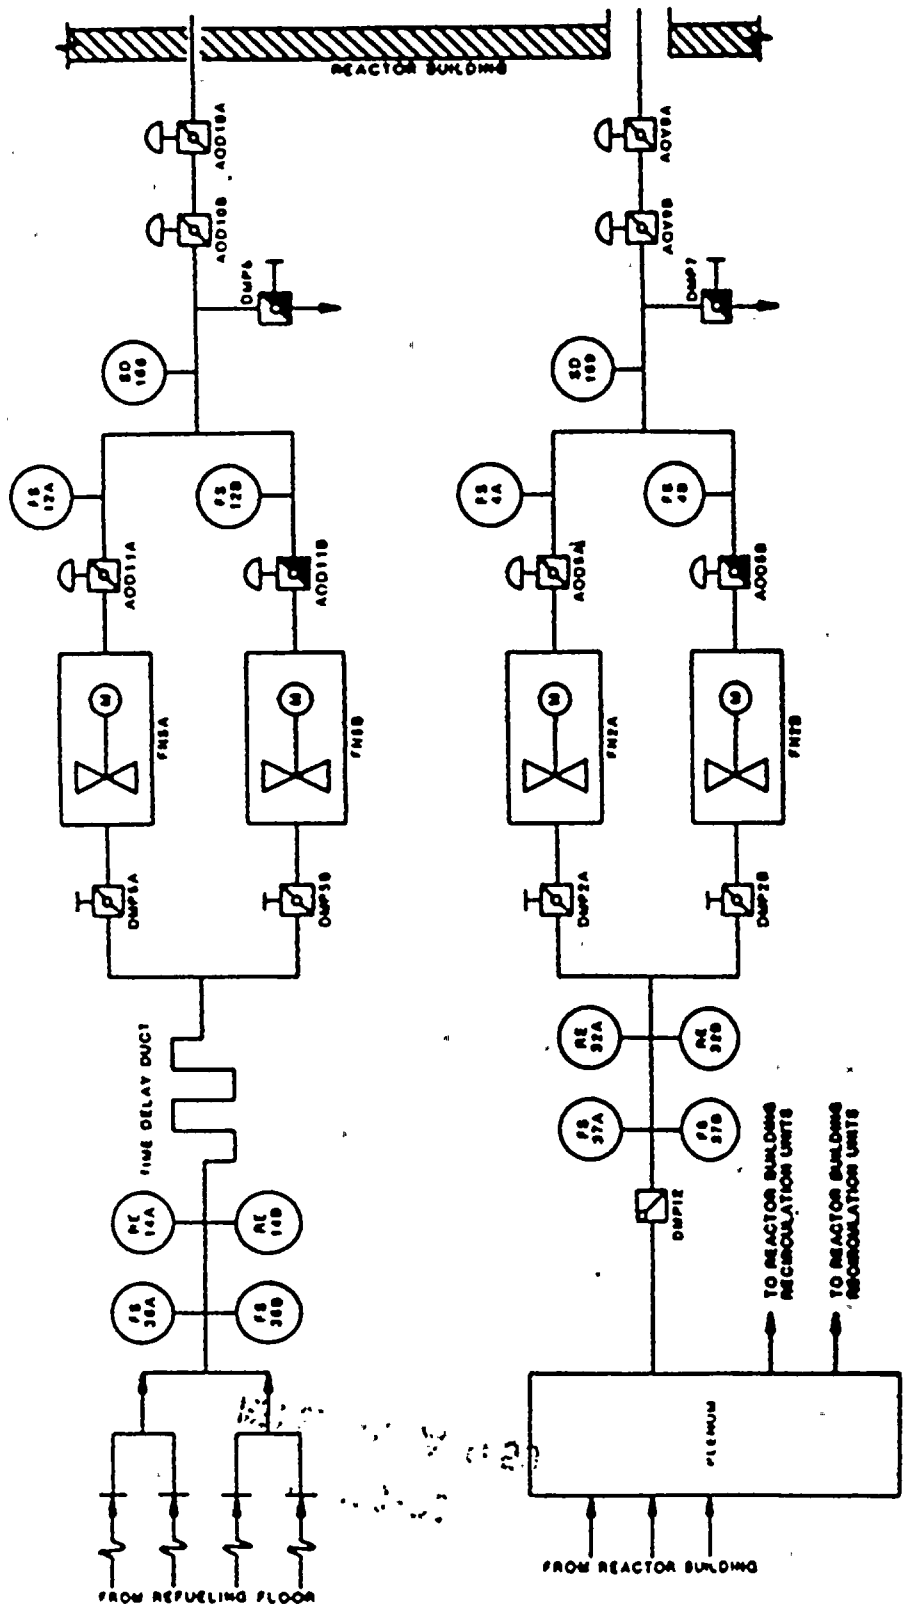
FIGURE 2
REACTOR BUILDING NORMAL EXHAUST VENTILATION

The second event occurred at 1058 hours. While attempting to restore Reactor Building Ventilation system back to normal operation from the first event another secondary containment isolation occurred. GTS Train B had been restored to normal prior to the event. The Niagara Mohawk licensed operator at the remote panel started a normal supply (2HVR*FN1A) and a normal Below Refuel Floor Exhaust Fan (2HVR*FN2B). He then started another supply fan and the normal Above Refuel Floor Exhaust Fan (2HVR*FN5A). He then noticed that the Below Refuel Floor Exhaust Fan he had previously started (2HVR*FN2B) had tripped. A start of the Standby Below Refuel Floor Exhaust Fan (2HVR*FN2A) was attempted but this fan tripped on motor electrical fault. Thus, with two supply fans and one exhaust fan running, the reactor building overpressurized causing all reactor building supply fans to trip off and a subsequent low flow secondary containment isolation. A Niagara Mohawk licensed operator in the control room noticed reactor building inside /outside differential pressure approaching its high setpoint (greater than 3 inches water gauge pressure) and had manually started GTS System Train B to assist in restoring pressure to normal. This action did not prevent the Reactor Building from equaling its high differential pressure setpoint of +3.00 inches of water gauge.

The cause of the second event was cognitive personnel error by the operator who was restoring the HVR back to normal operation. Operating Procedure N2-OP-52, "Reactor Building Ventilation", gives detailed instruction for the startup of the normal reactor building ventilation system. A low flow trip of the below refuel floor exhaust fan (2HVR*FN2A) was caused by the emergency recirculation unit 2HVR*UC413A operating in its normal mode with the normal damper 2HVR*A0V6A open and the test damper 2HVR*A0V34A closed. This resulted in 2HVR*UC413A and 2HVR*FN2A drawing suction on a common plenum. With both units competing for air from the same plenum their flow rates fell causing a low flow trip signal from 2HVR*FS37A and B.
