SUBJECT: LER 87-038-00: on 870807, RCIC primary containment valve isolation occurred. Caused by design deficiency. Work request issued to investigate event & track corrective actions. W/870904 ltr.

LICENSEE EVENT REPORT (LER)

FACILITY NAME (1) Nine Mile Point Unit 2	DOCKET NUMBER (2) 0 5 0 0 0 410	PAGE (3) 1 OF 05
--	---	----------------------------

TITLE (4) **Reactor Core Isolation Cooling Steam Supply Isolation Valve Closed due to Design Deficiency**

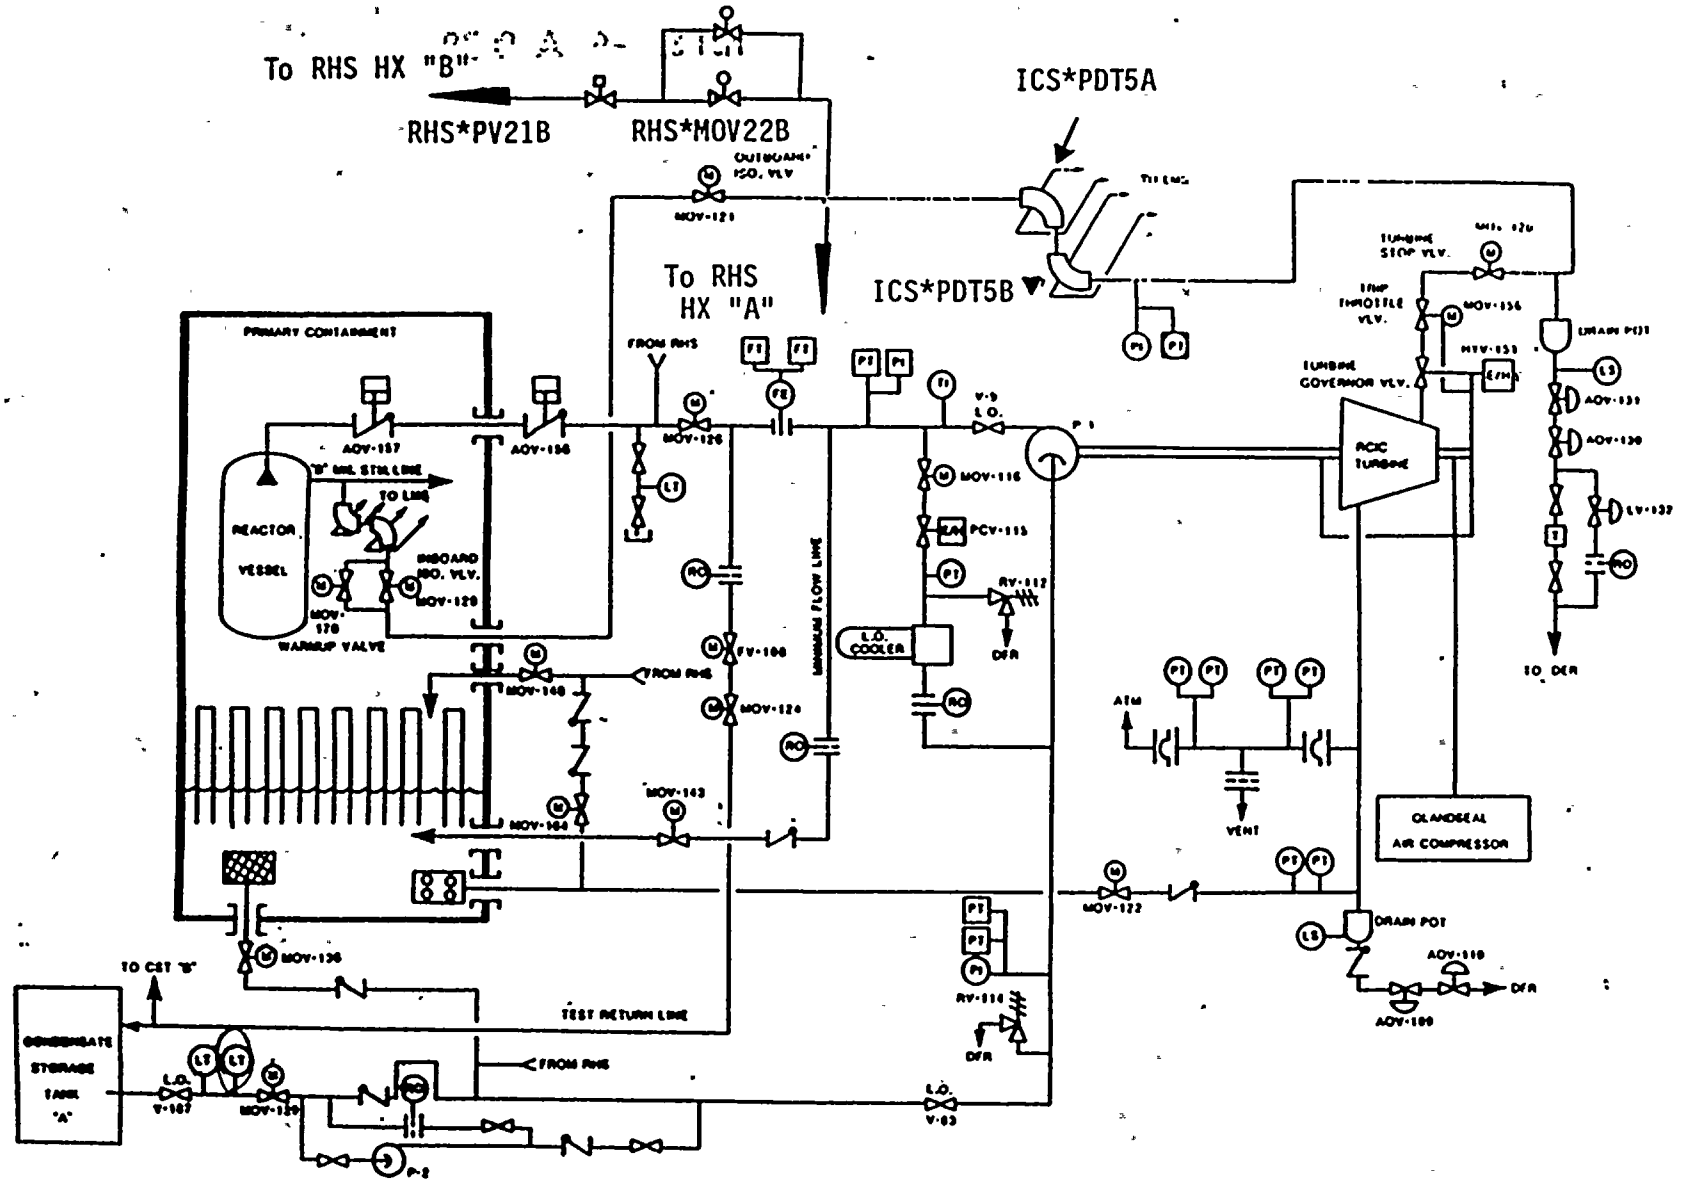
Alarm #323 PNL601, "Div I RCIC Steam Line Diff Press High" receives its input from 2ICS*PDT5A. Associated trip units are E31-N683A, (high differential pressure) and E31-N690A (negative differential pressure). Initial evaluation indicated E31-N683A had tripped and caused the subsequent RCIC valve isolation. The trip was considered spurious since there was no steam flow past the flow elbow sensing lines for the affected trip unit (see attachment).

NOTE - Residual Heat Removal (RHR) valve 2RHS-PV21B provides pressure control of steam entering the RHR heat exchanger. On August 9, 1987, two days after the event, 2RHS*PV21B was found to be sticking due to its packing being too tight. Erratic action of this valve could have induced pressure oscillations (see attachment).
