SUBJECT: LER 87-047-00: on 870806, RWCU sys isolations occurred. Caused by const & design deficiencies. RWCU suction flow element properly oriented. Flex hoses will be removed & blocking globe valves reoriented & element relocated. W/870904 ltr.

FACILITY NAME (1) Nine Mile Point Unit 2	DOCKET NUMBER (2) 0 5 0 0 0 4 1 0	PAGE (3) 1 OF 07
--	---	----------------------------

TITLE (4) **Two Reactor Water Cleanup System Isolations on a Flow Differential Signal due to Construction and Design Deficiencies**

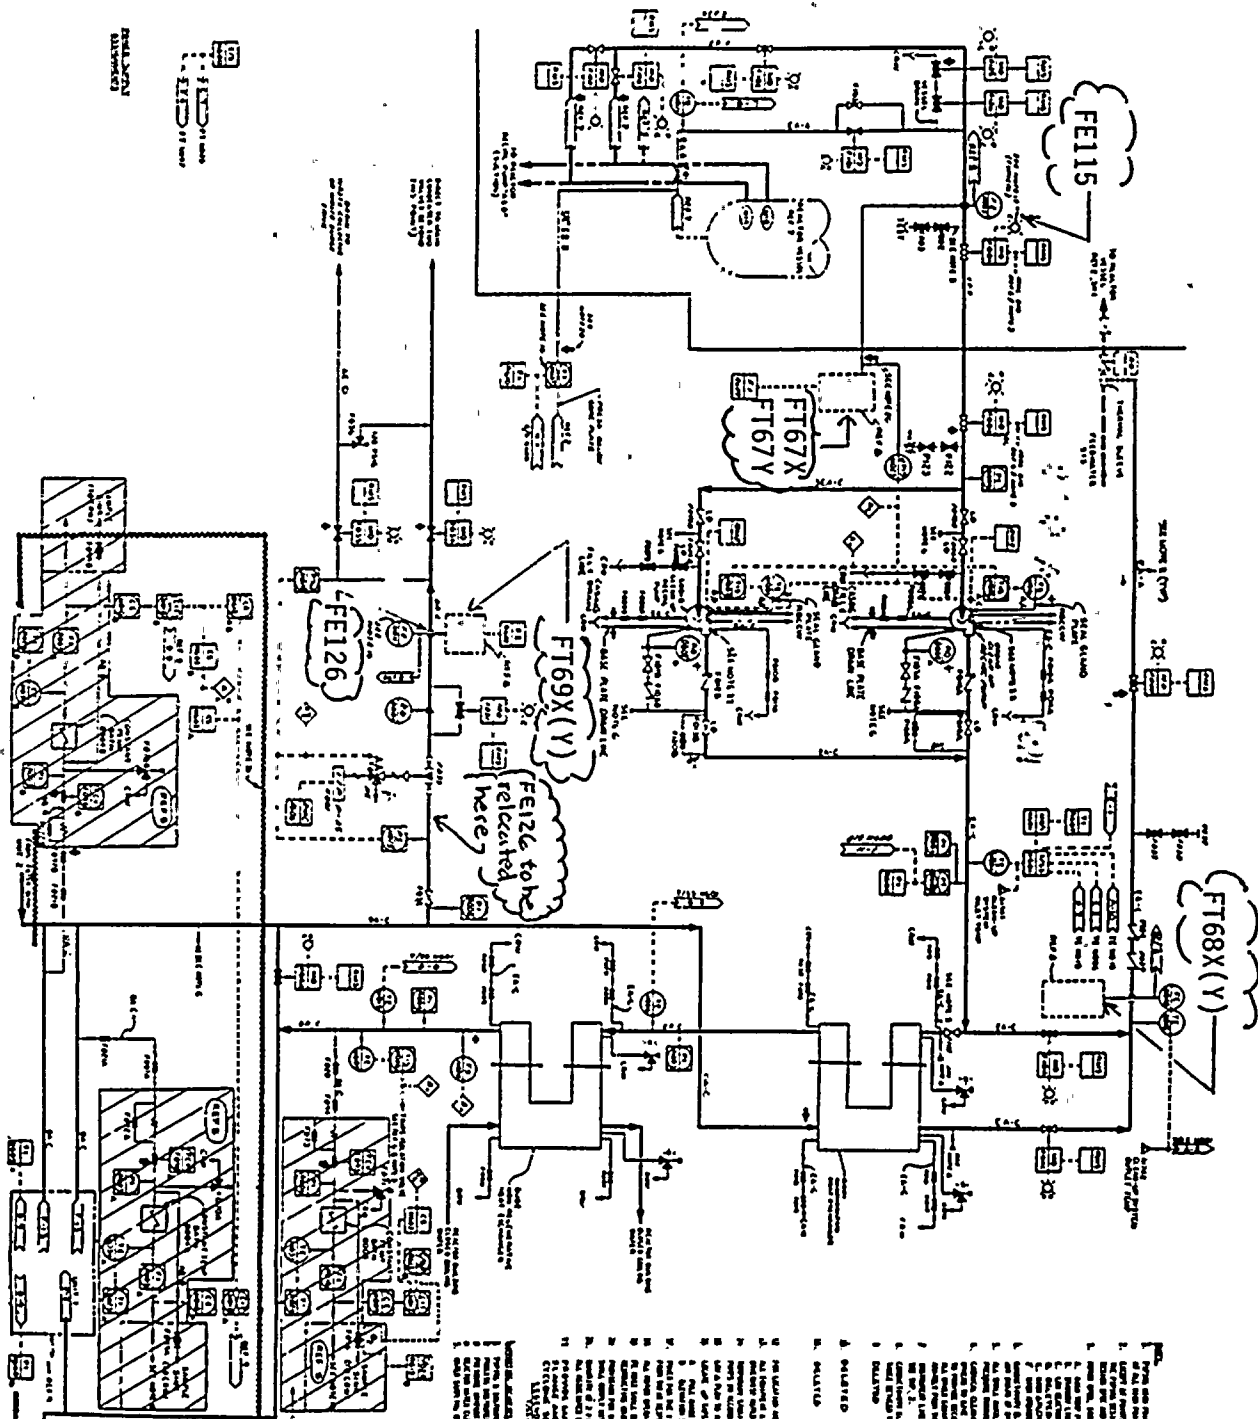
FIGURE 1

Refer to Figure 1

Upon starting the RWC cleanup pump (at 2044 hours) and opening its discharge valve, erratic flow indications were observed on the RWC suction and blowdown flow indicators. These erratic flow signals were interpreted by the Leak Detection System to be a flow differential (see note). As a result, an RWC system isolation was automatically initiated. The isolation signal was reset by Operations at 2108 after verifying the plant status as normal, and the RWC system was successfully restarted at 2207. The duration for this event, from the isolation initiation to its reset, was 23 minutes.

Flow oscillations from the RWCU Blowdown Flow Transmitters (2WCS*FT69X(Y)) are attributed to the location of the Flow Element (2WCS*FE126), which is an identified design deficiency. Modification PN2Y87MX119 has been prepared by Niagara Mohawk to relocate this flow element when the Power Ascension schedule permits. This modification, when implemented, should mitigate future erratic flow indications.

3. A special task force has been assigned to evaluate and troubleshoot the RWCU transmitter problems.
4. Modification PN2Y87MX119 will incorporate the suggested design changes from General Electric Service Information Letter (SIL) 450. SIL 450 recommends that the RWCU Blowdown Flow Element (2WCS*FE126) be placed upstream of 2WCS-FV135 to prevent erratic flow indications from the RWCU Blowdown Flow Transmitters (2WCS*FT69X(Y)) and unnecessary RWCU isolations. This modification is scheduled to be completed during the Test Condition 2 outage. (See Figure 1)
