SUBJECT: LER 87-048-00: on 870809, Div 1 shutdown cooling (SDC)
 isolation occurred during performance of startup test. Caused
 by procedural deficiency. Isolation signal reset & SDC
 operation restored. Procedures to be revised. W/870904 ltr.

FACILITY NAME (1) Nine Mile Point Unit 2	DOCKET NUMBER (2) 0 5 0 0 0 4 1 0	PAGE (3) 1 OF 04
--	---	----------------------------

TITLE (4)
Shutdown Cooling Isolation due to Procedural Deficiency

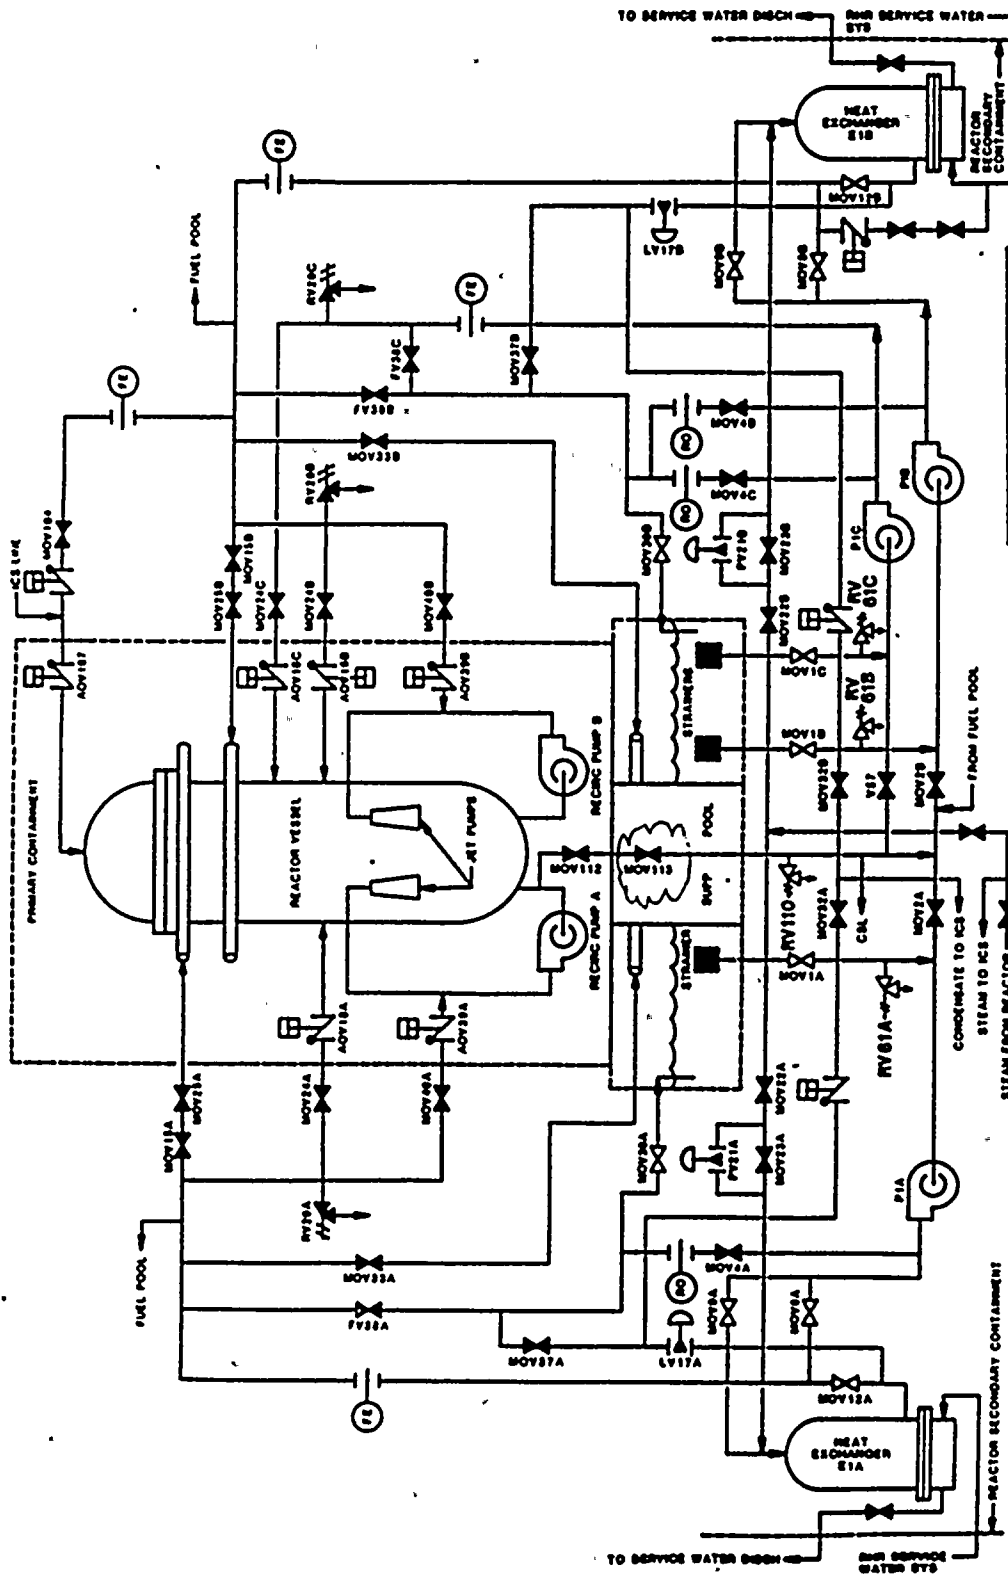
Figure 1 - Rev. 2
Title: RESIDUAL HEAT REMOVAL SYSTEM

During performance of the "Shutdown from Outside the Main Control Room" startup test on August 9, 1987 at 2004 hours, a Division 1 Residual Heat Removal System (RHR)-Shutdown Cooling (SDC) isolation occurred. The unit was in Mode 3 (hot shutdown), with reactor pressure at 11 psig and coolant temperature at 240°F. Reactor cooldown operations were in progress in accordance with the cooldown demonstration instructions in the startup test. The RHR system Loop A was operating in suppression pool cooling mode, while the B loop was operating in the SDC mode. Refer to Attachment 1 for system configuration.
