SUBJECT: LER 87-051-00: on 870813, shutdown cooling sys isolated during performance of electrical protection assemblies calibr surveillance procedure. Caused by procedural deficiency. Monitor reactor coolant temp per Tech Specs. W/870911 ltr.

FACILITY NAME (1) <b>Nine Mile Point Unit 2</b>	DOCKET NUMBER (2) <b>0   5   0   0   0   410</b>	PAGE (3) <b>1 OF 08</b>
--	---	----------------------------

TITLE (4) **Shutdown Cooling Isolation and LCO Exceeded due to Equipment Failure and Design Deficiency**

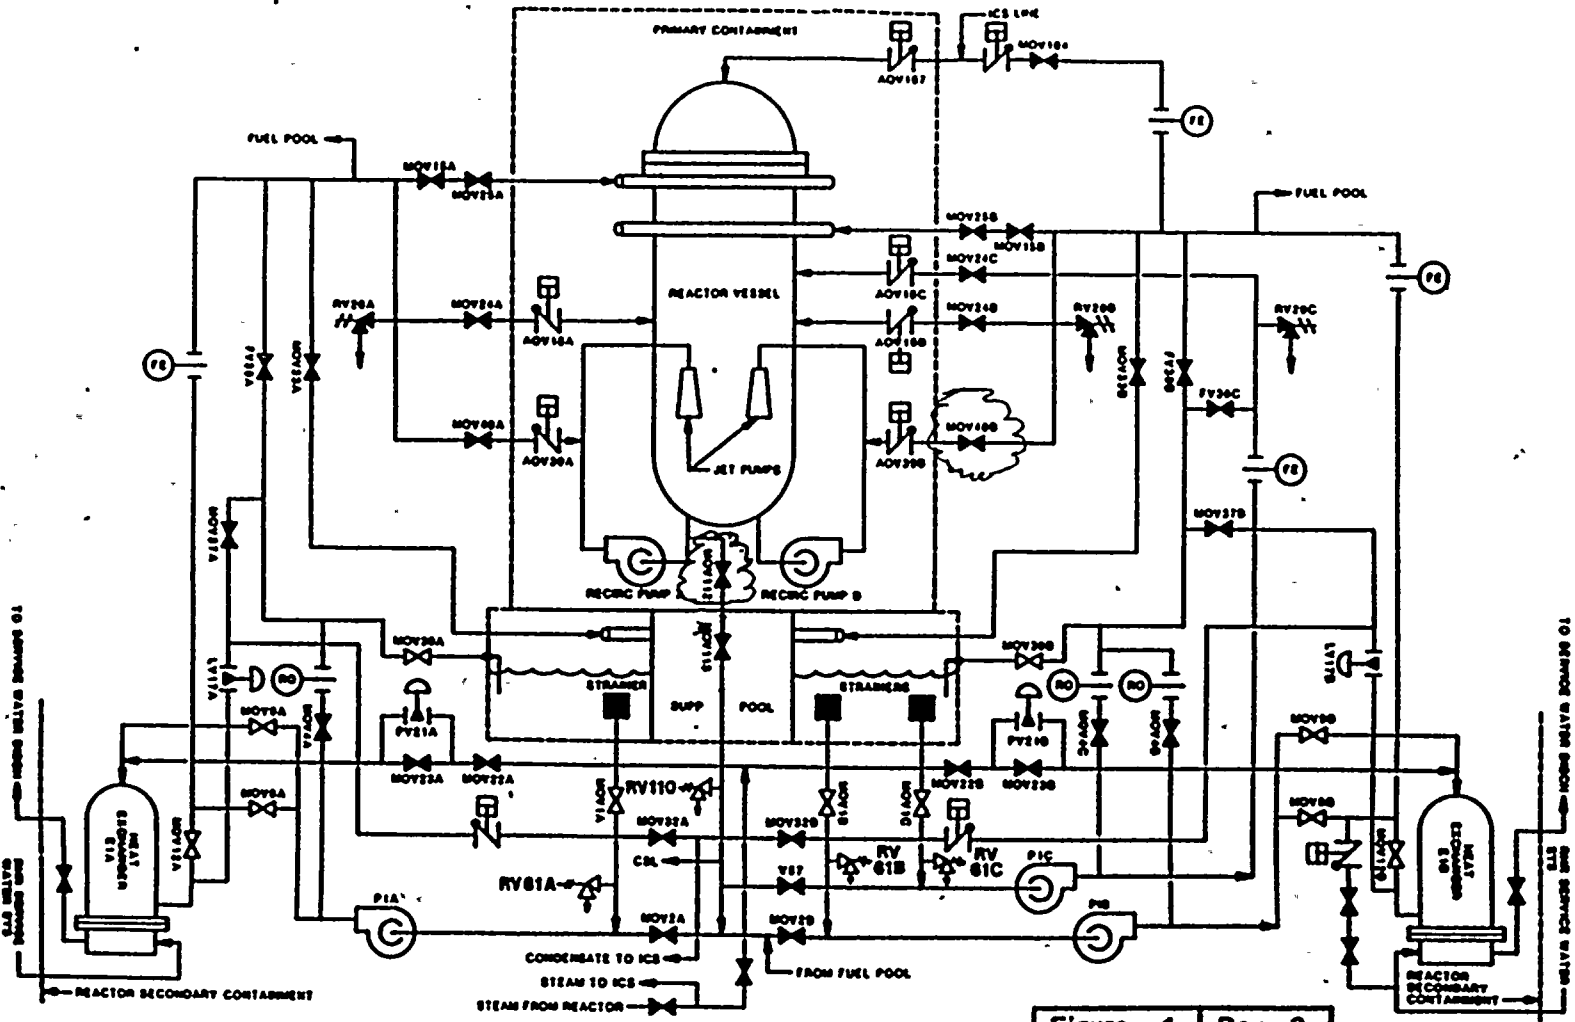
Figure 1. Rev. 2  
Title: RESIDUAL HEAT REMOVAL SYSTEM

Refer to Attachment 1 for the Residual Heat Removal System (RHR/RHS)-SDC subsystem configuration. Refer to Attachment 2 for RPS logic power supply configuration.

At 0322 hours, EPA 1A was tripped by NMPC Meter and Test (M&T) personnel in accordance with the surveillance procedure to perform the necessary channel calibrations. The expected Division 1 half scram and primary containment isolations (outboard containment isolation valves) were received. However, an unexpected result was the receipt of a Division 2 SDC isolation. Consequently, the inboard SDC suction isolation (2RHS\*MOV112) and SDC Loop B injection (2RHS\*MOV40B) valves closed. The other Division 2 SDC valves were already closed. Subsequently, the running SDC pump (2RHS\*PIB) tripped due to the suction valve closure, and normal SDC was interrupted at 0323 hours.

Prior to tripping the EPA, NMPC licensed control room operators and the Station Shift Supervisor (SSS) made a conscientious effort to take the necessary measures to prevent isolation of systems such as SDC, Reactor Water Cleanup (WCS) and normal reactor building ventilation (HVR). In addition, measures were taken to prevent auto initiation of Engineered Safety Features (ESF) systems such as Standby Gas Treatment (GTS). Except for the Main Steam Isolation Valves (MSIVs), the Nuclear Steam Supply Shutoff System (NS<sup>4</sup>) isolation circuits are designed to isolate one of the two isolation valves on a loss of either divisional power supply (i.e. Division 1 isolates outboards and Division 2 isolates inboards). However, the SDC isolation circuit is also an exception to this general design. A loss of any divisional power supply will result in a complete isolation of the SDC system (both inboard and outboard valves). The purpose for this unique design feature is to protect the SDC system from overpressurization. Due to procedural deficiencies and a lack of knowledge of this unique feature of the SDC isolation circuit, the operators' measures to prevent SDC isolations did not include preventing closure of 2RHS\*MOV112 or 40B. Thus, SDC isolated when the EPA was tripped.

Immediate corrective actions were to monitor reactor coolant temperatures per TS 3.4.9.2 and to re-establish normal SDC by manually opening 2RHS\*MOV112 and 40B and restarting the tripped SDC pump. In addition, an emergency work request was generated to replace the defective EPA output breaker. Operators also began raising reactor water level in an attempt to improve natural circulation.

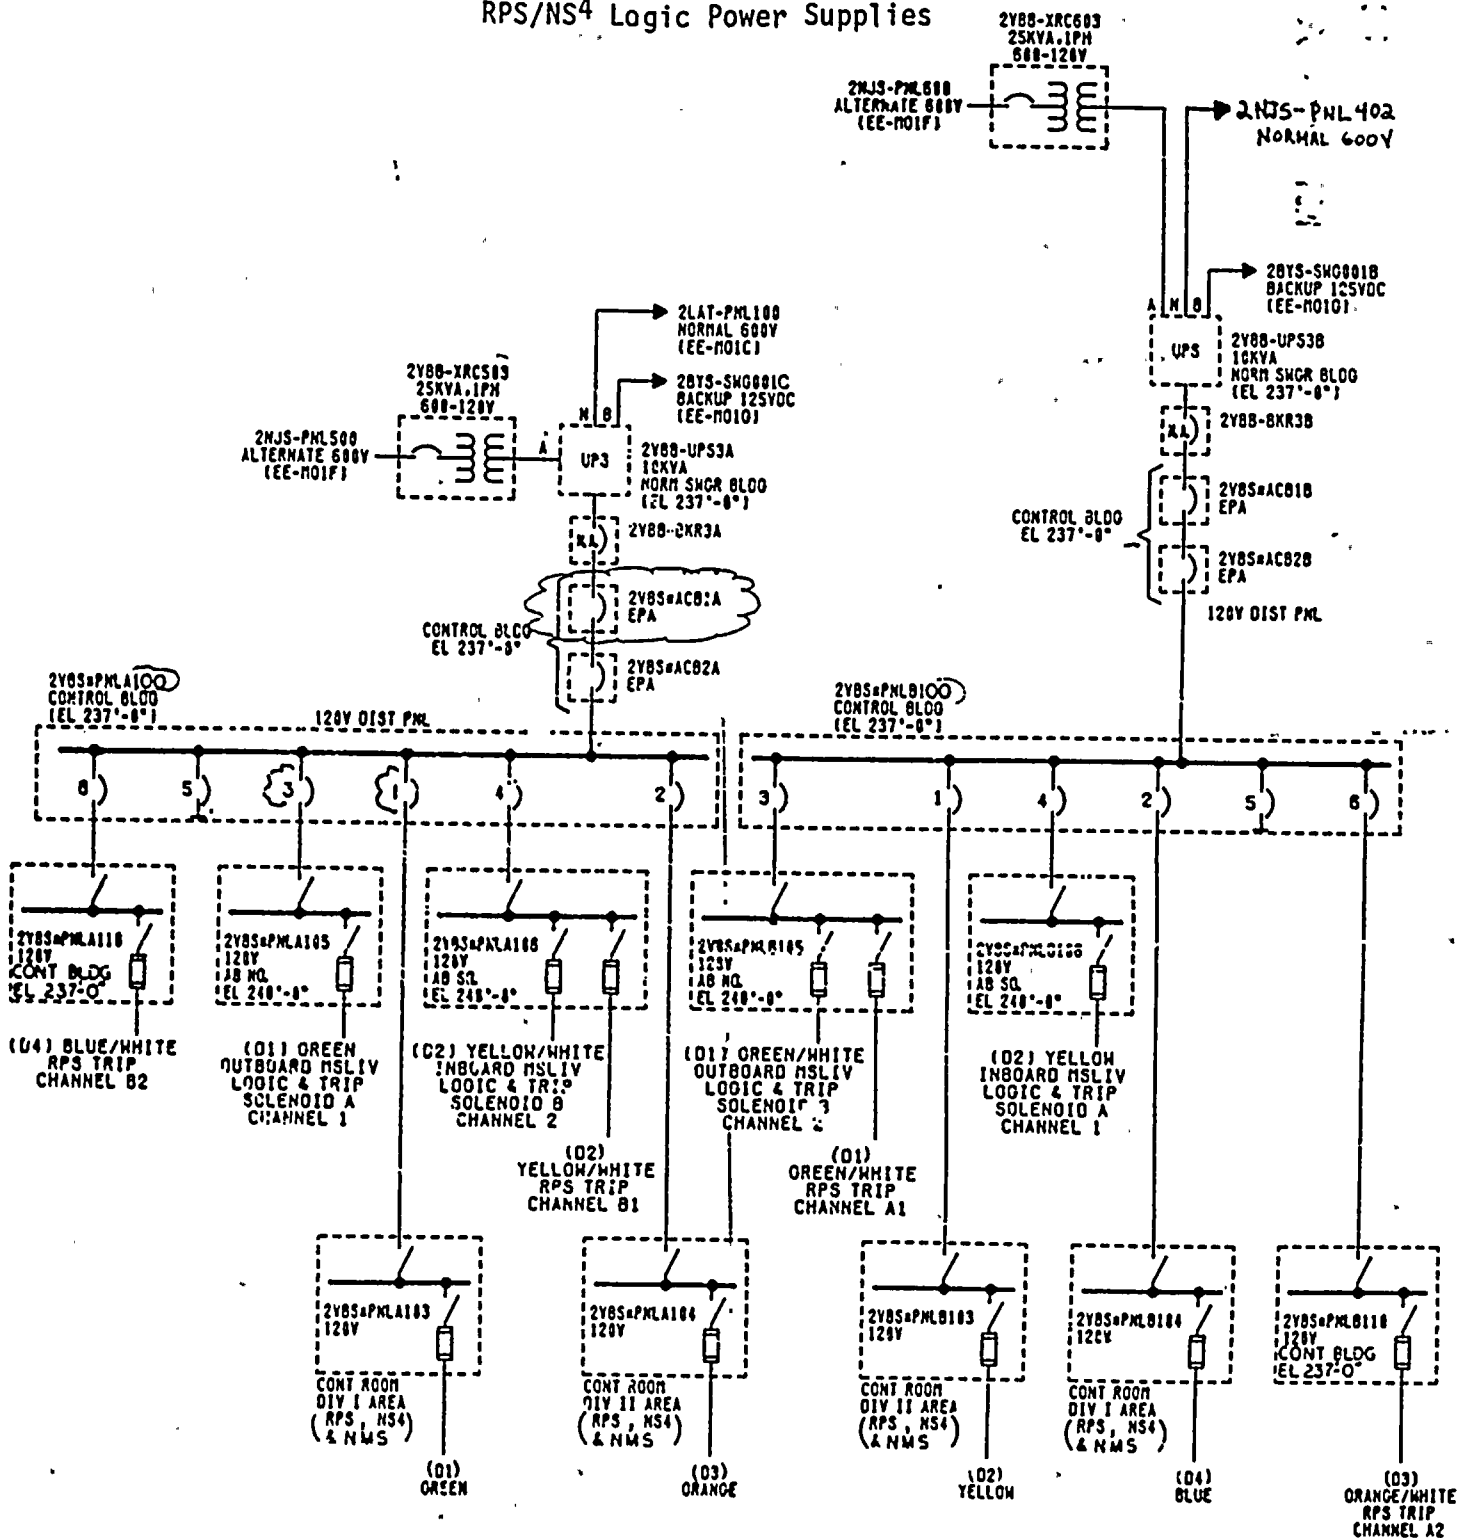
RPS/NS4 Logic Power Supplies

The root cause of the event was design deficiency. Testing of these EPAs is a major operational event due to the loss of power to a single division of the RPS/NS<sup>4</sup> logic. A loss of power to a single division of the RPS/NS<sup>4</sup> logic results in a half scram and in numerous Engineered Safety Features (ESF) actuations such as primary containment isolation, secondary containment isolation and auto initiation of GTS. Because the EPAs cannot be tested without interrupting power, the operators took several hours assessing plant impact, reviewing prints, and taking preventative measures in order to prepare the plant for the EPA surveillance. This places an unnecessary burden upon Operations personnel when the EPA design could be improved to enable testing without power interruptions. Therefore, the EPA design should be modified to avoid unnecessary ESF actuations in the future.

The inadvertent failure of the EPA output breaker resetting mechanism or an unanticipated trip of an EPA has the potential to create a serious transient during power operation. The loss of power to Division 1 RPS/NS<sup>4</sup> logic has the following plant impact:

1. The plant impact statements in both the six month and eighteen month EPA surveillance procedures were revised to aid the SSS and control room operators in adequately assessing the plant impact for performance of these procedures.
2. The cause for the EPA output breaker resetting mechanism failure is unknown, and the investigation will continue. If the cause of the equipment failure results in additional corrective actions, a supplemental report will be issued.
3. A Training Modification Request (TMR) has been initiated to train Operations personnel on the unique design feature of the SDC isolation circuit to assist in preventing recurrence of this event.
4. The EPAs will be modified to allow testing without power interruptions. This modification will be completed during the 1988 midcycle outage.
