SUBJECT: LER 87-069-00: on 871023, numerous ESF actuation occurred due to loss of power to Non-Class 1E uninterruptible power supply. Caused by design deficiency, personnel error & equipment failure. Sys isolation signals reset. W/871120 ltr.

FACILITY NAME (1) Nine Mile Point Unit 2	DOCKET NUMBER (2) 0 5 0 0 0 410	PAGE (3) 1 OF 07
--	---	----------------------------

TITLE (4) **Loss of Power to a Non-Class 1E Uninterruptible Power Supply Results in ESF Actuations due to Design Deficiency and Personnel Error**

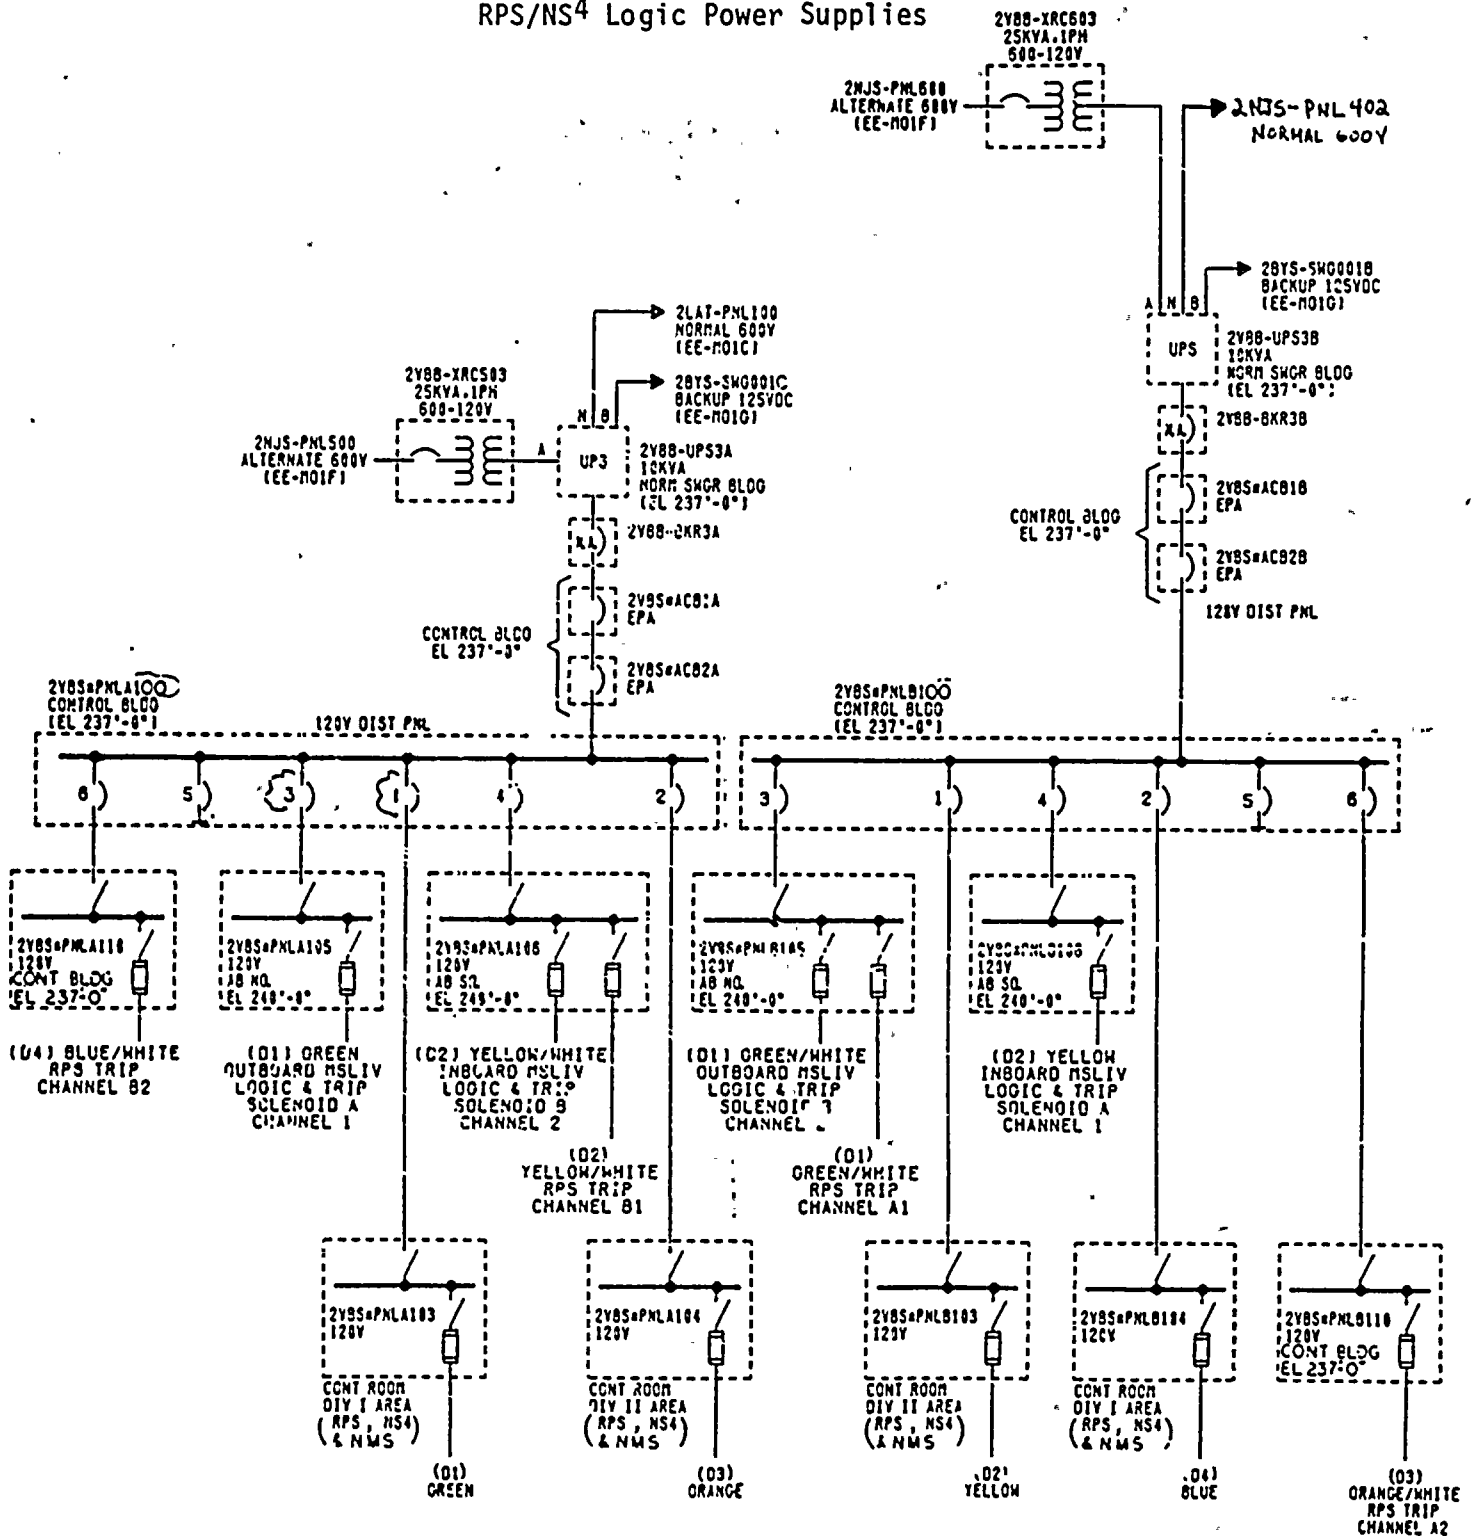
RPS/NS4 Logic Power Supplies

At 1144 hours a "system trouble" alarm was received in the control room for UPS3B. (Refer to Attachment 1 for power supply configuration.) Scram recovery activities were in progress. Consequently, a Niagara Mohawk Licensed Operator was dispatched three hours later to investigate the cause for the alarm at UPS3B. The operator found that the UPS was being fed through its normal supply, but a "sync loss" alarm was in at the local control panel. This alarm normally indicates that the alternate supply is not present. (It was later determined that the alternate supply was not available due to a blown fuse.) He proceeded to push one of the two pushbuttons on the control panel, thinking they were lamp test buttons. These buttons are actually Forward and Reverse Transfer pushbutton switches. By pushing the Reserve Transfer button, the operator unknowingly transferred UPS3B to an inoperable alternate power supply which caused the downstream Electrical Protection Assemblies (EPAs) to trip on undervoltage. The tripping of the EPAs resulted in a loss of power to the Division 2 Reactor Protection System (RPS)/Nuclear Steam Supply Shutoff System (NS⁴) logic and subsequent ESF actuations as follows:

The intermediate cause was determined to be a blown fuse in the alternate supply which caused the input breaker to trip. Because the normal supply will not synchronize unless the alternate supply is available, the "sync loss" alarm was generated. The most probable cause for blowing the fuse was the voltage transient experienced when in-house loads were fast-transferred from the normal station transformer to the reserve transformers upon tripping the turbine at 1142 hours that day. During this fast-transfer, the UPS was operating from its normal power supply so no output interruption occurred.

A root cause is design deficiency. This type of equipment failure (i.e. blown fuse) has occurred on other occasions, primarily whenever power supplies upstream of the UPS's are transferred. Although the UPS power is not interrupted by the blown fuse, it results in an inoperable alternate power source and creates the potential for operator errors when operating this equipment. Thus, a design change can prevent repeated-UPS equipment failures and personnel errors. It should be noted that the UPS can operate indefinitely without the alternate source. Therefore, the alternate source is not required to be operable. Its primary purpose is for maintenance.

1. The blown fuse in the alternate supply was replaced and the input breaker reset to restore the inoperable alternate supply that same day.
2. Operator aids (signs) were placed on the UPS control panels (3A and 3B), advising personnel that the pushbuttons are actually transfer switches and not lamp test buttons.
3. The individual who caused the power supply transfer was counseled and participated in preparing the operator aids that were placed on the control panels.
4. A memo was issued to all Operations personnel addressing this event and other events involving personnel error as well as corrective actions to prevent recurrence of these events.

7. The UPS fuse sensing circuits will be modified to minimize the potential of blowing fuses when voltage transients are experienced during transfers. This modification will be implemented in accordance with station modification priorities.
