REGULATORY INFORMATION DISTRIBUTION SYSTEM (RIDS)

SUBJECT: LER 87-076-00:on 871212,potential radioactive release
 ..resulting from design deficiency in floor drain sys.

LICENSEE EVENT REPORT (LER)

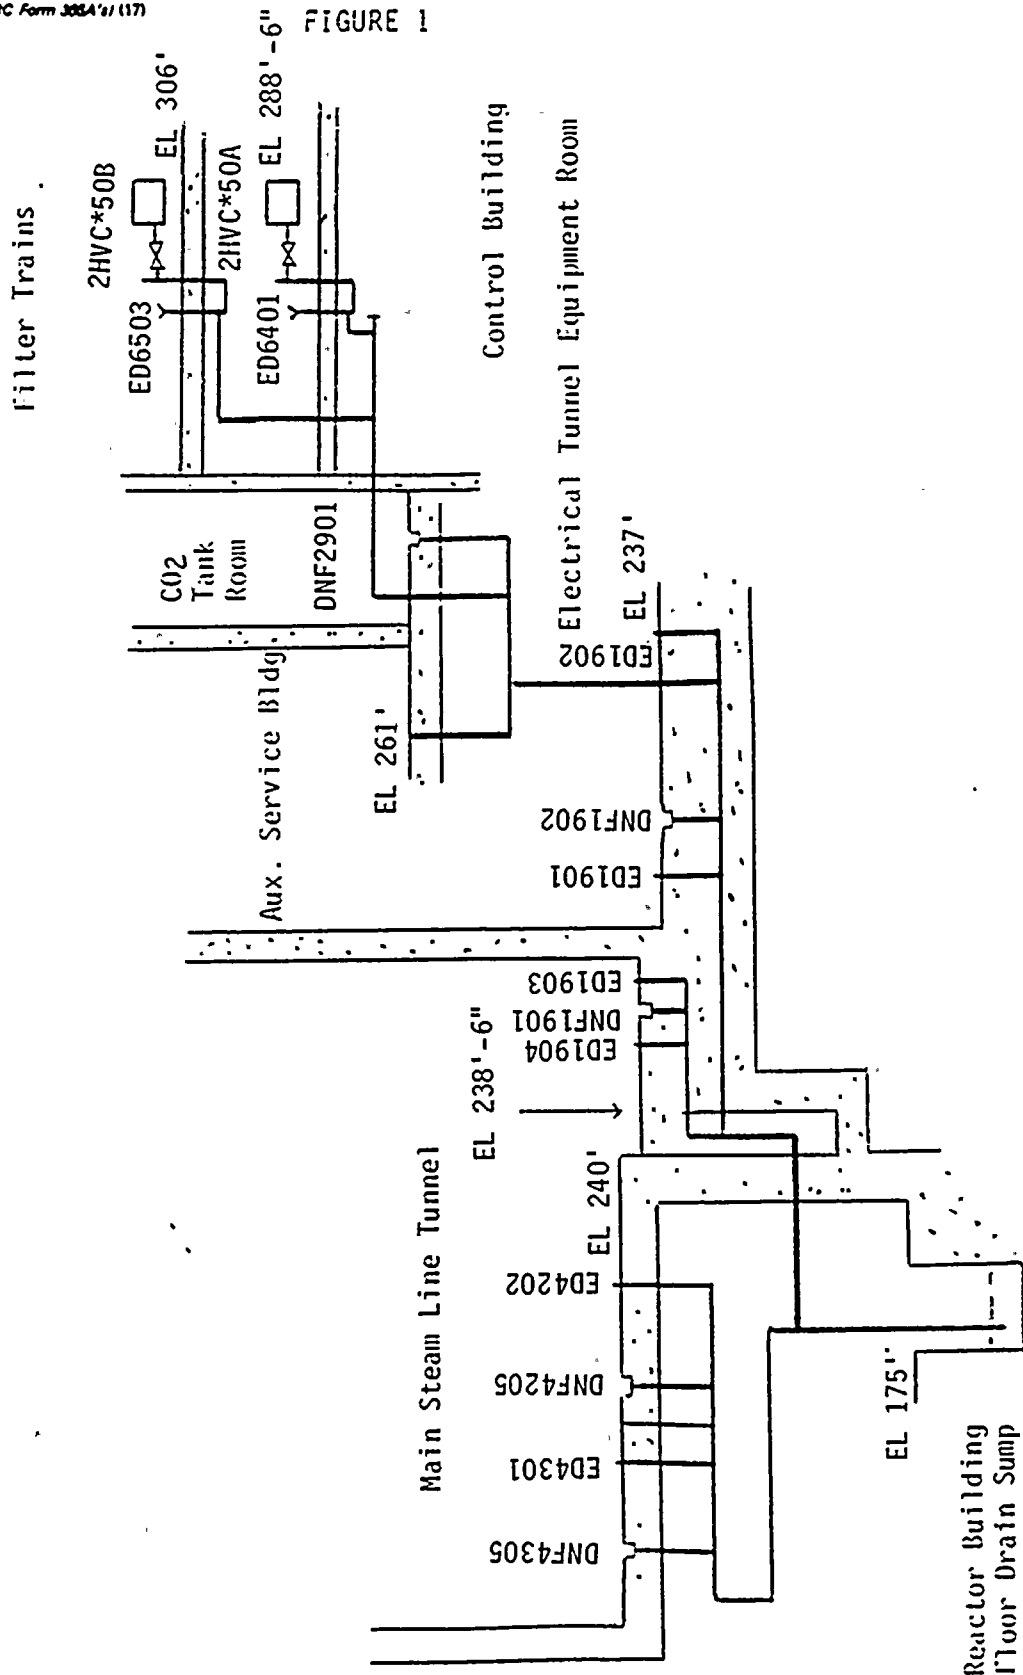
FIGURE 1

On December 12, 1987 during a 10CFR21 (F87-014) review, it was discovered that the drain lines from the control room charcoal filter train cubicles, the main steam tunnel, and the auxiliary service building joined together in the auxiliary service building and continued into the reactor building and terminated in the reactor building floor drain sump (Figure 1). Specifically, there was an air communication path between the control room pressure boundary, the main steam tunnel, and secondary containment through the equipment and floor drain piping. This particular design posed a threat to plant personnel and equipment safety in the event of a high energy line break or a feedwater line break accident in the Main Steam tunnel. At the time of discovery the reactor was in cold shutdown with the reactor mode switch in the "Shutdown" position.

The root cause of this event was a design deficiency. This deficient design allowed the intercommunicating drain lines to be installed without the consideration of a design basis accident occurring such as a high energy line break or a feedwater line break accident in the steam tunnel.

1. Modification No. PN2Y87MX244 - This modification isolated the control building filter drain line from all areas of the plant, thereby protecting the control room pressure boundary from any backflow of air through these lines. Modification completed 12/18/87.
2. Modification No PN2Y87MX247 - This modification eliminated all the drain lines from the CO₂ tank room and the electrical tunnel HVAC room that connected with the main steam tunnel, by cutting and capping these lines. Modification completed 12/18/87.
3. Modification No. PN2Y87MX258 - This modification provided manual shutoff valves in the main header so that the drain from the steam tunnel could be isolated, if required. In addition, this modification also reduced the diameter of a portion of vertical drain line in order to cut down the flow into the Reactor Building. Modification completed 12/20/87.

1. Modification No. PN2Y87MX261 - This modification provided a loop seal on the 6 inch drain header in each Reactor Building auxiliary bay such that all floor and equipment drains in Elevation 240' would be isolated from the lower elevations of the auxiliary bays and secondary containment. Modification completed 12/19/87.
2. Modification No. PN2Y87MX263 - This modification installed loop seals in the filter drains of the Standby Gas Treatment System. Modification completed 12/19/87.
