NINE MILE POINT UNIT 1
REPORT FOR THE
FEEDWATER SYSTEM TRANSIENT
OF DECEMBER 19, 1987

MARCH 1988

REPORT ON THE NMPI FEEDWATER TRANSIENT
EVENT OF DECEMBER 19, 1987

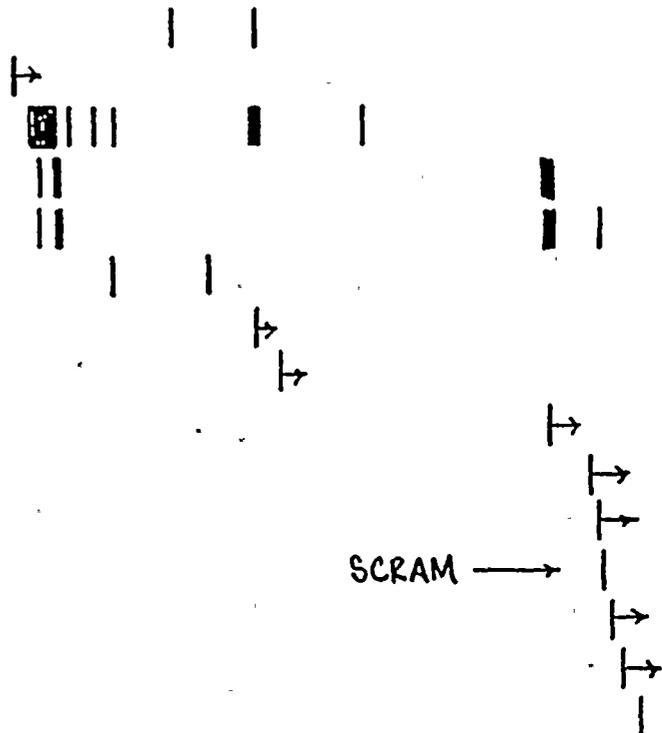
Regardless of the type of 13 FCV failure or of the power level at the time of failure, the effect of the failure was to increase the vibration of the Feedwater System, and this vibration was picked up by various sensors. Figures 1-3 present data for the various alarms that were recorded for the 1978 and 1987 events (no similar data is available for the 1975 event). Figure 1 shows the 20 alarms and 8 trips from 14 sensors in the Feedwater System that have been attributed to vibrations induced by the fractured stem of FCV 13A on December 19, 1987, as well as two fire alarms set off by dust from insulation vibrated loose from its piping. These alarms occurred within about a 3 1/2 minute interval (as described in Section III). Figure 2 shows the seven alarms from 3 sensors from vibrations in the five minute period preceding the manual scram from full power on January 20, 1978 when the plug from FCV 13A unscrewed from its stem.

13 FCVs are controlled by a single signal to seek the same stem position. With FCV 13A plug unscrewed the control signal calls for a wider open position for both valves, but the actual plug position is such that FCV 13B is open wider, thus passing significantly more flow than FCV 13A. With a fractured stem, on the other hand, both plugs (in the open position) are open to the same extent. It is reasonable, therefore, that the effect of a stem fracture is greater than that for an unscrewed plug.

This reasoning is reinforced by examination of Figure 3, which presents the alarms generated on January 22 and 23, 1978 when the reactor was being brought up to power following the scram of January 20. The fault was with FCV 13B in this case, and the problem was subsequently discovered to be a fractured stem. As long as the reactor was operating at a power level sufficiently low that the two motor driven pumps could provide feedwater, there was no problem. When FWP 13 was put in service, and the total feedwater flow increased above about 2 million pounds per hour, the Feedwater System experienced severe vibration problems. In both of these events there were trips of fifth stage feedwater heaters, as there were in the December 1987 event, indicating severe vibration of the piping downstream of the 13 FCVs. Although there was vibration, there was no recorded damage to the piping supports because the flow rate was low and resonance of the system was prevented.

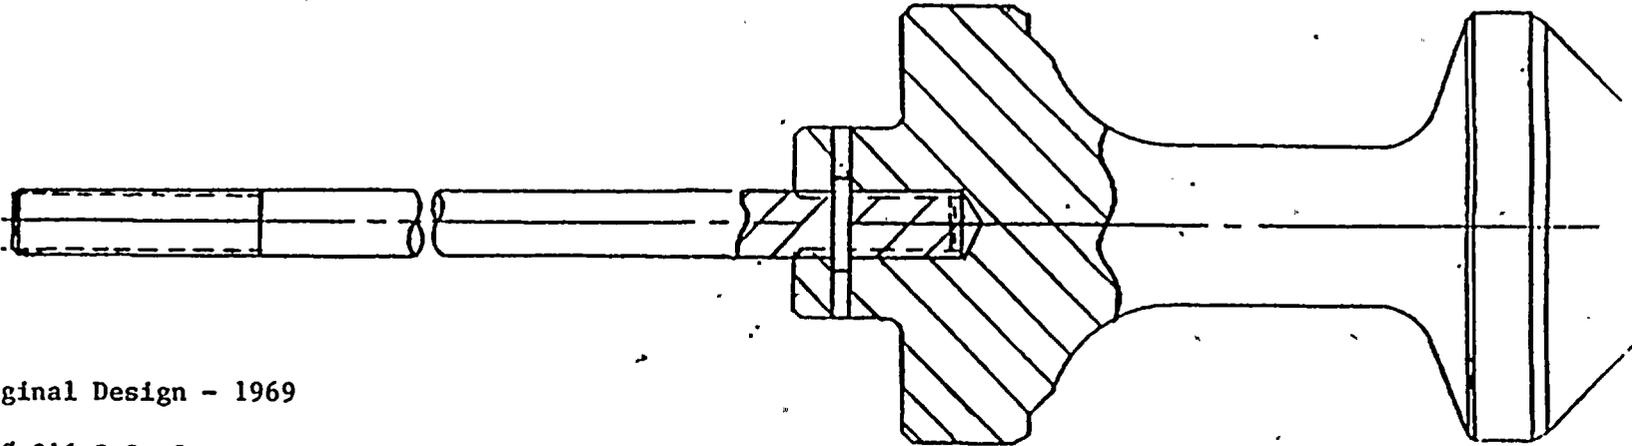
Original Design - 1969

Following the January 1978 event in which the FCV 13A plug unscrewed from the stem and the FCV 13B stem fractured, the vendor proposed a modification to the then existing stem/plug design. That design, shown in Figure 4, featured a 1 inch diameter shaft, screwed into the plug, and pinned with a 1/4 inch diameter pin; twice the plug became unscrewed and once the shaft broke in service. The modification as shown in Figure 5, employed a seal weld where the 1 inch diameter stem screwed into the plug. A letter from the vendor stated, "Also, the valve plugs will be welded to the stems to strengthen the

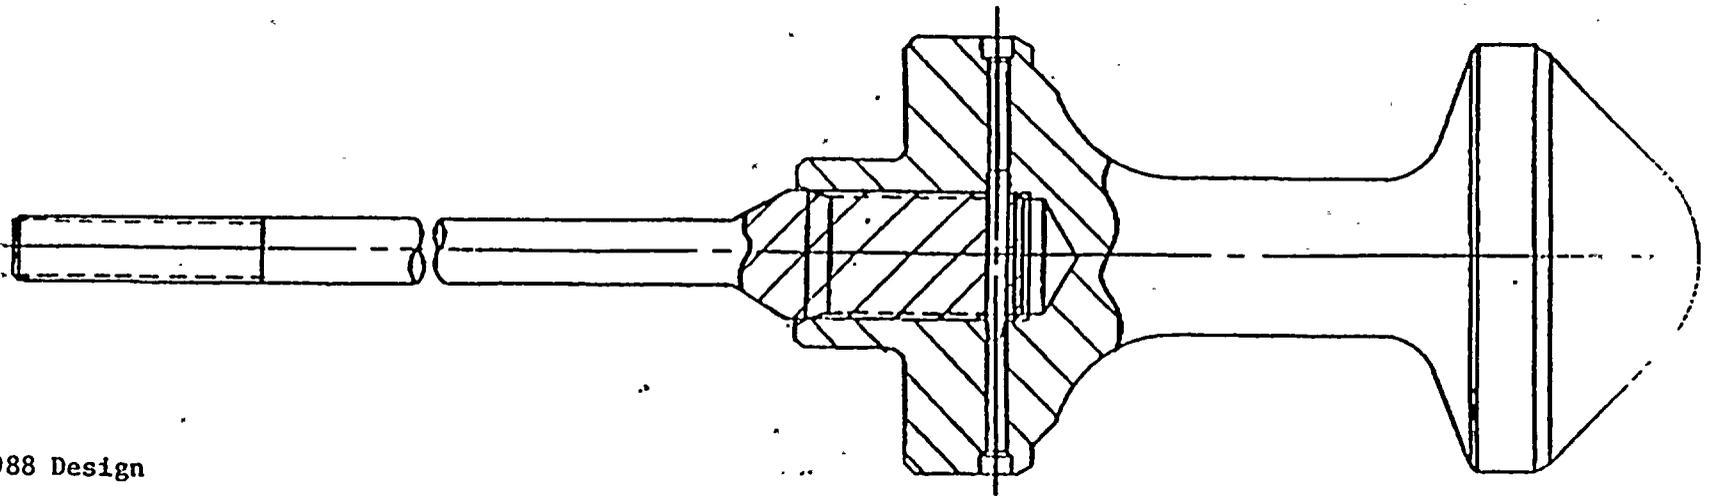
1988 Design

The smooth transition from the 1 inch to the 2 inch diameter on the shaft decreases the stress concentration factor, and as stated in Appendix D, "the redesign is better than the original and should be acceptable for short term [i.e., a two year refueling cycle] operation."

A modification has been made to the stem plug connection to preclude such failure of the FCVs for a normal 2 year refueling cycle.
