METALLURGICAL INVESTIGATIONS OF TWO
TWO FAILED COMPONENTS

PART ONE: PLUG AND VALVE STEM,
PART NO. FW-13A-FCV

PART TWO: STAINLESS STEEL WELD METAL
FROM FEEDWATER PIPE

NIAGARA MOHAWK POWER
CORPORATION

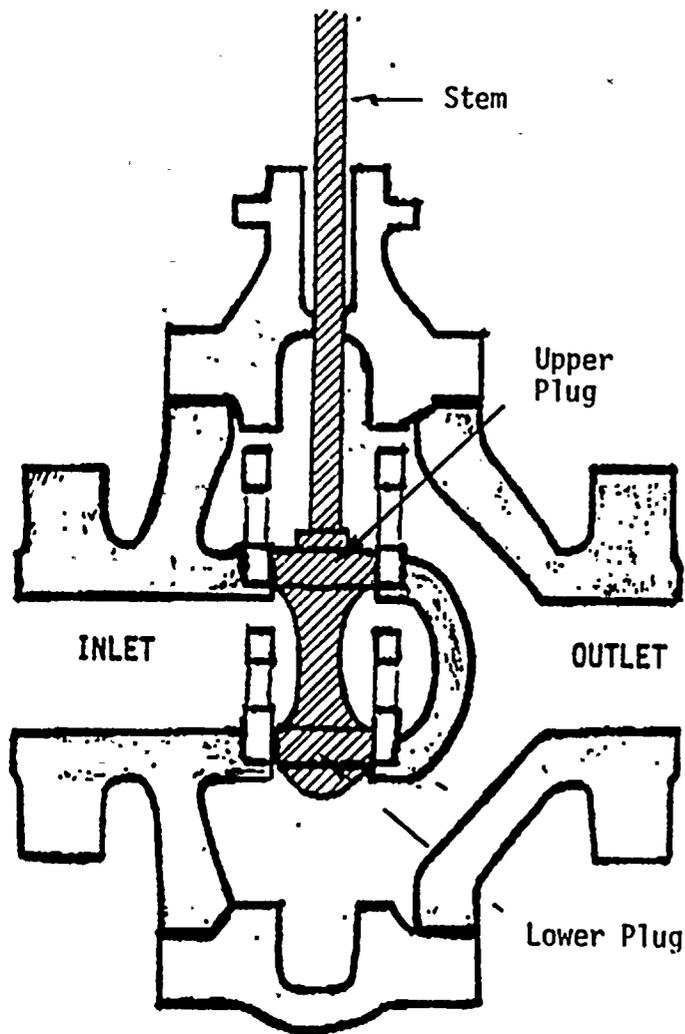
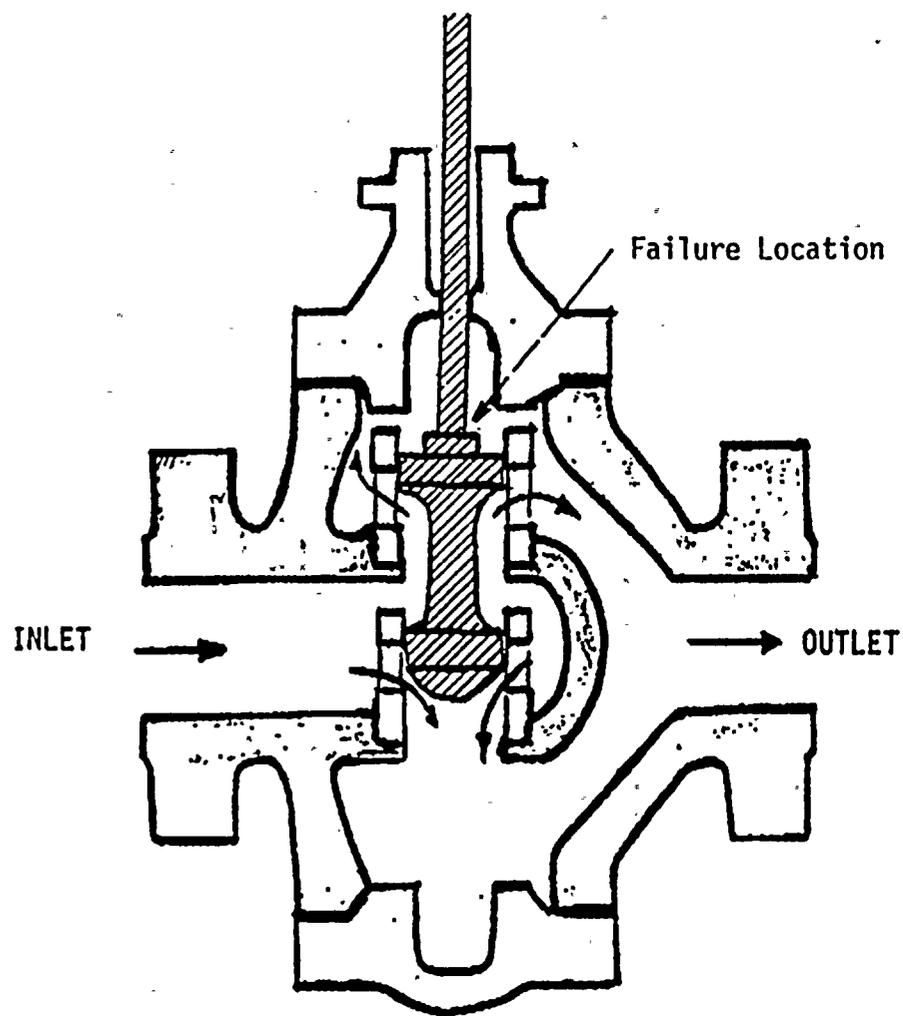
FIGURE 1. SKETCH OF THE FLOW-CONTROL VALVE SHOWING THE STEM/PLUG COMPONENT, PART NO. FW-13A-FCV
(Cross-hatched area) Drawing supplied by NMPC

Figure 1b. The failure was a transverse fracture of the 1-inch-diameter stem through the fillet weld.

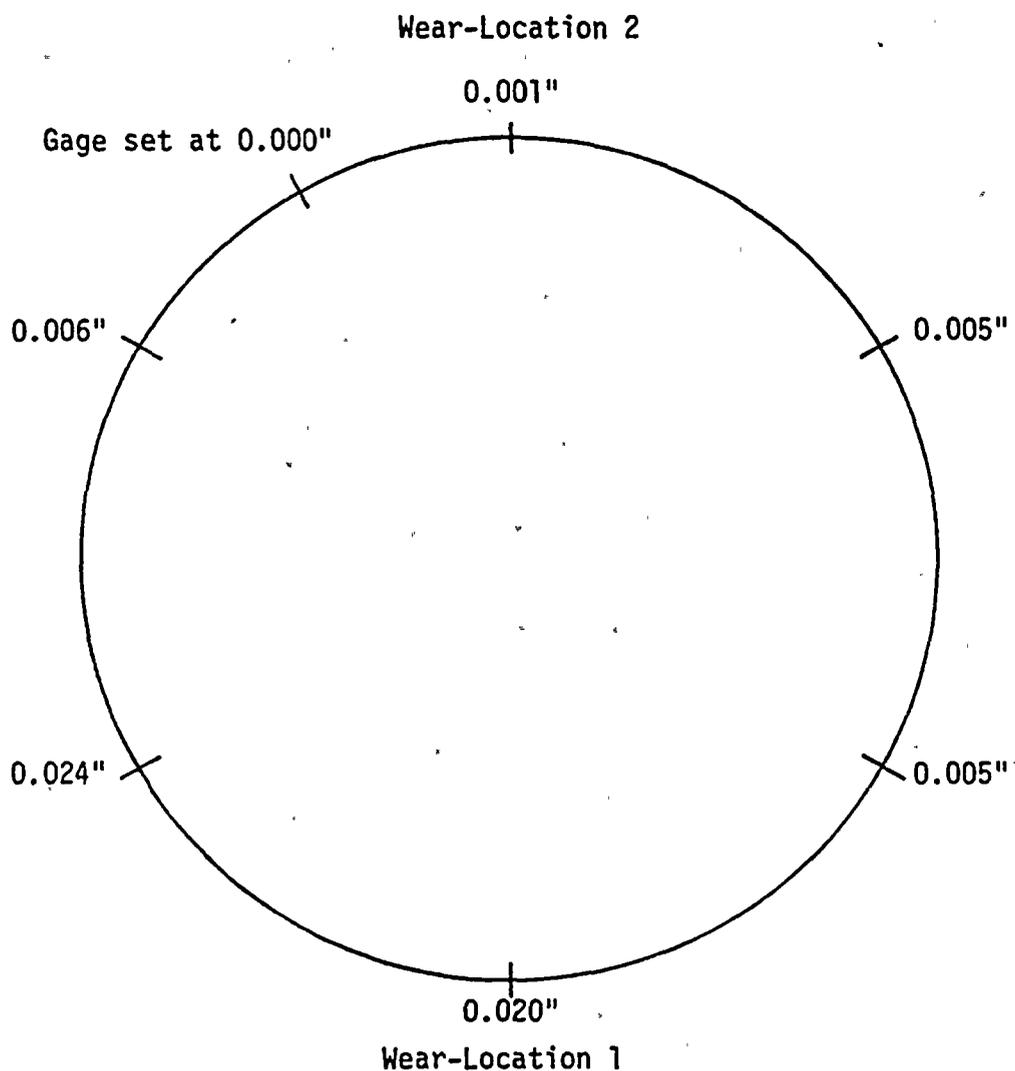
Measurements of the depths of wear on the lower plug were made using a dial-displacement gage while the plug was rotated 360 degrees in a lathe. The gage was adjusted to zero at a location on the cylindrical surface midway between two wear areas. The results of the depth measurements are recorded in Figure 3. Two adjacent wear areas were worn to depths of 0.020 and 0.024 inch, respectively. The depths of the remaining wear areas were 0.006 inch or less. The primary fatigue-crack-origin region was found to be aligned with, and on the same side of the valve stem, as was the area, Wear-Location 1 in Figure 3, that was worn to a depth of 0.020 inch. The secondary fatigue-crack origin was on the same side and aligned with the wear area identified in Figure 3 as Wear-Location 2.

FIGURE 3. SKETCH SHOWING THE DEPTH OF WEAR AT THE 60-DEGREE WEAR LOCATIONS ON THE LOWER PLUG

The primary fatigue-crack origin was approximately in alignment with, and on the same side of the stem, as was the side of the lower plug at Wear-Location 1 in the sketch. Similarly, the secondary fatigue-crack origin was in alignment with Wear-Location 2 in the sketch.

Recommendations to prevent such failures in the future are: (1) to increase the diameter of the stem and to use a streamline, elliptical, or parabolic form of fillet at the welded joint, and (2) to consider a change of design and/or material for the plug to provide better wear resistance of the lower end of the plug.

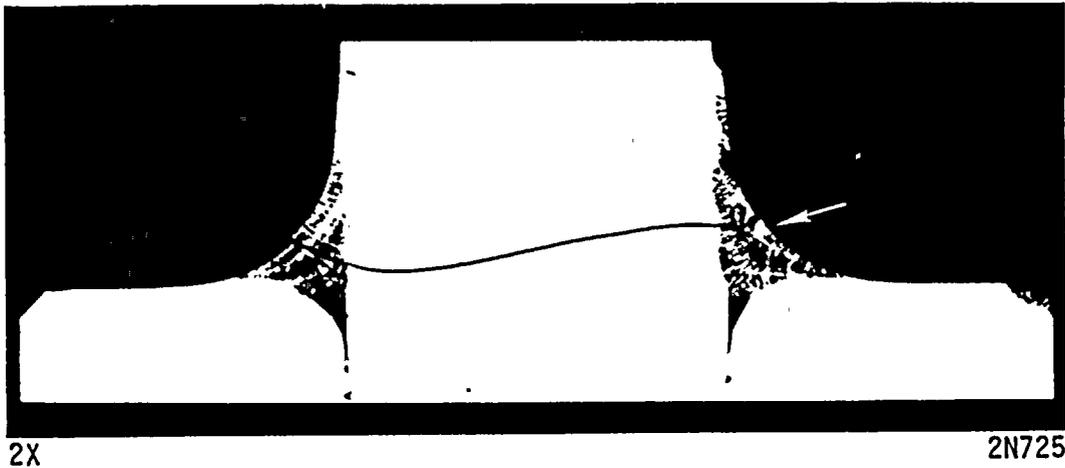
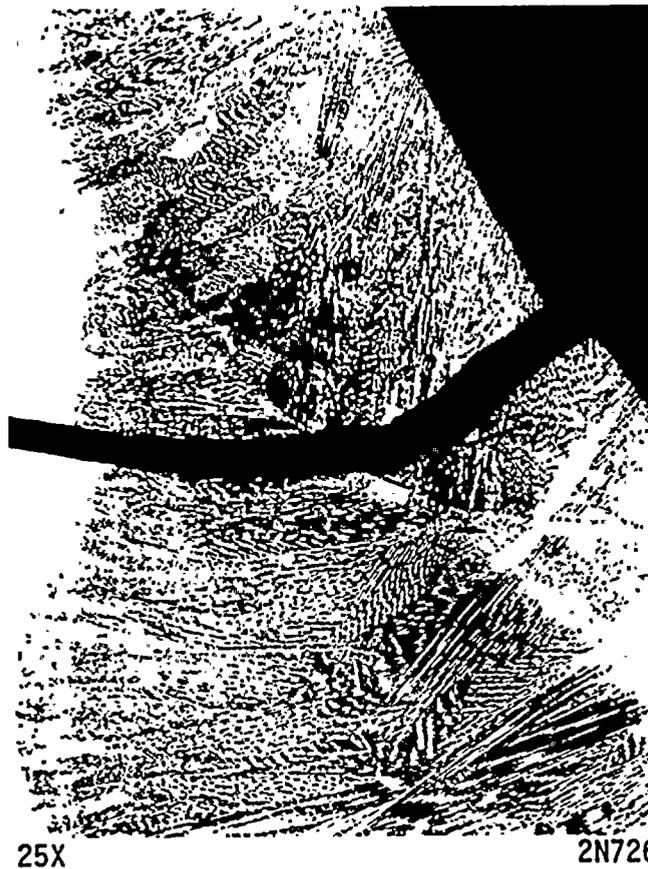
The fracture was observed in the metallographic sections to be transgranular through the weld metal and across the stem. The microstructure of the weld metal was typical of the microstructure of Type 316 stainless steel weld metal in the as-welded condition. The microstructure of the stem was typical of the microstructure of wrought and annealed Type 316 stainless steel. No evidence of sensitization in the microstructure of the weld-heat-affected zone of the stem was observed. A photomicrograph of one of the seven serial sections is shown in Figure 8a. The primary fatigue crack was located on the side of the stem identified by the arrow in Figure 8a; a portion of the fillet weld and crack is shown in Figure 8b at a higher magnification.

The results of the fractographic examinations indicated that the mode of crack propagation was primarily fatigue. The mode of crack initiation, although not observed on the fracture surface since a specific site of crack initiation was not identified, apparently was fatigue also. The macroscopic features of the primary fatigue-thumbnail pattern and the microscopic fatigue striations, which were observed, indicated that the general vicinity of the initiation site was subsurface near the root of the weld. The nature of a crack initiator at that location would most likely be that of a weld flaw, such as a hot crack or weld-metal pore. Flaws of that nature are frequently stress-raisers

FIGURE 8. A METALLOGRAPHIC CROSS SECTION THROUGH THE PRIMARY FATIGUE-CRACK-ORIGIN REGION

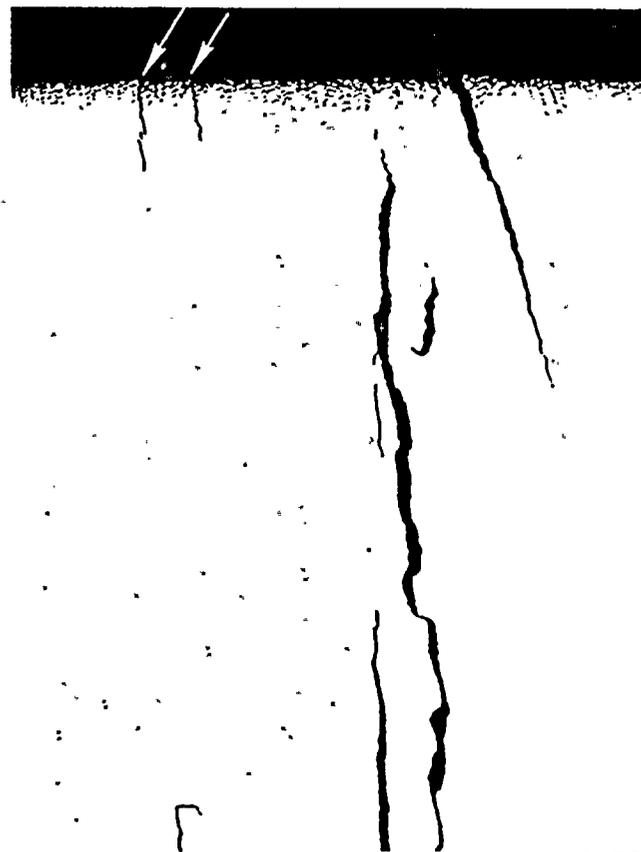
FIGURE 11. METALLOGRAPHIC CROSS SECTION OF THE BOAT SAMPLE SHOWING THE NATURE OF THE INTERGRANULAR FRACTURE THROUGH WELD METAL

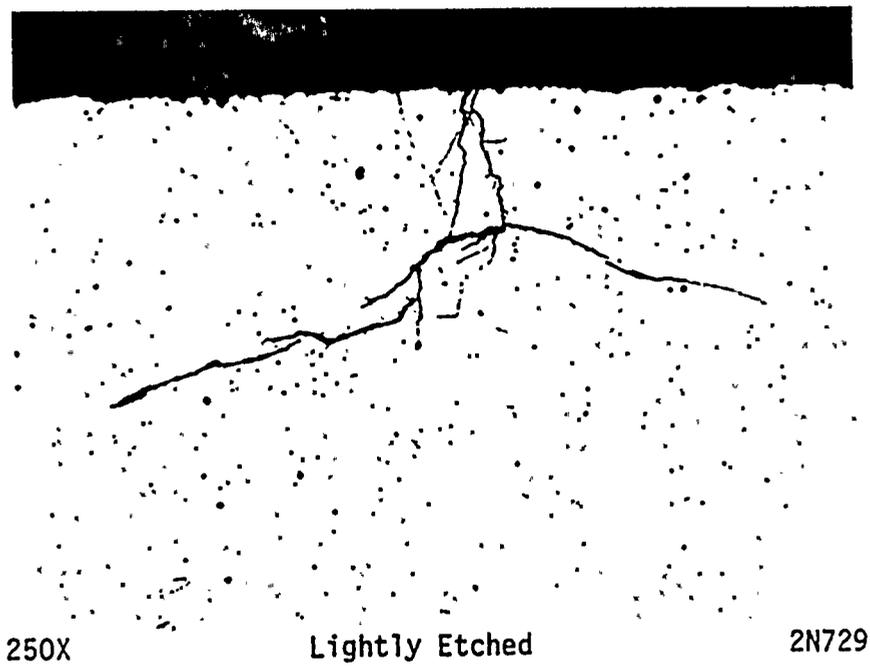
FIGURE 12. ONE OF THE SMALL TRANSGRANULAR STRESS-CORROSION CRACKS OBSERVED IN THE OUTSIDE SURFACE OF THE WELD METAL

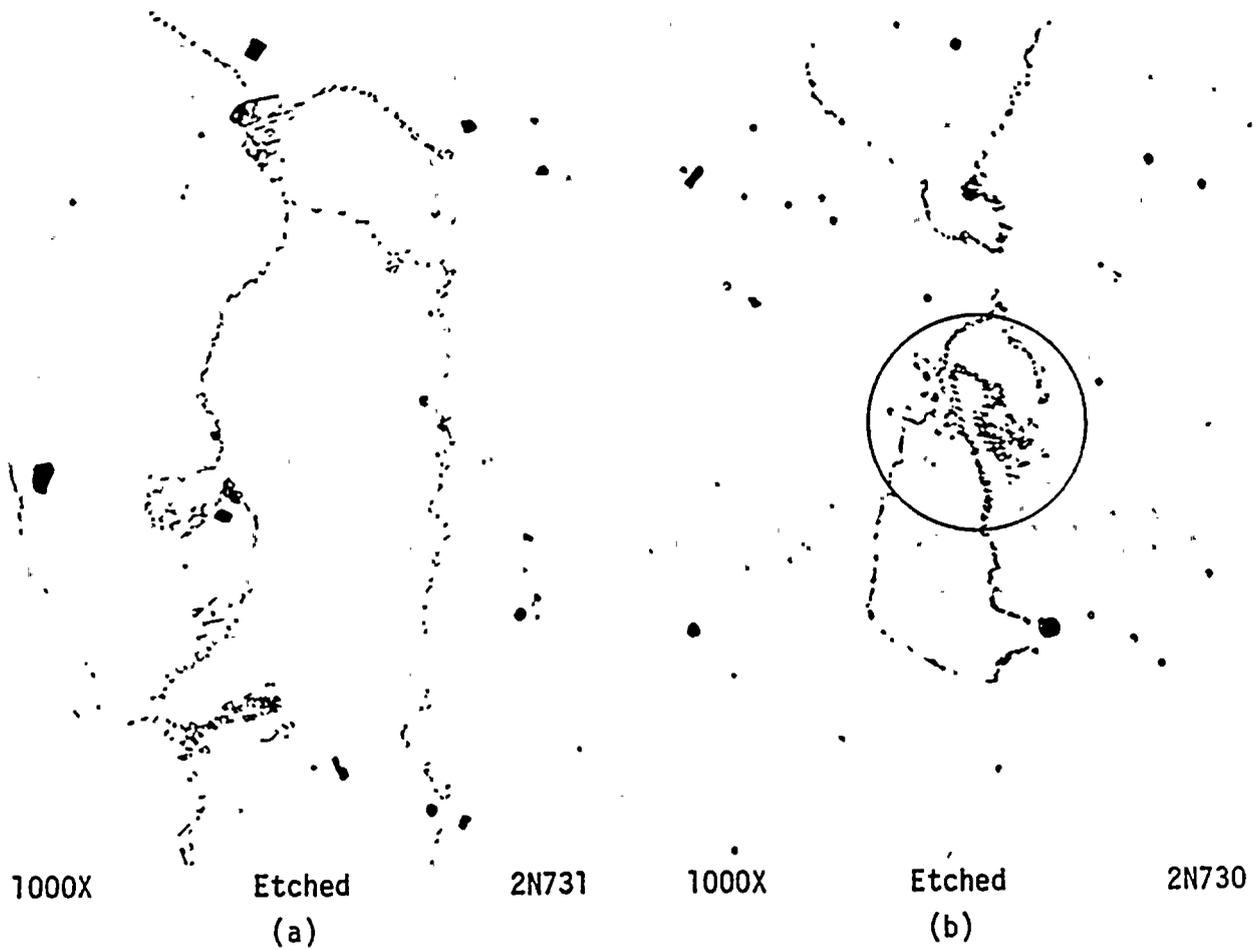
FIGURE 13. EXAMPLES OF THE INTERGRANULAR CARBIDE PHASE OBSERVED IN THE WELD-METAL GRAIN BOUNDARIES

Figures 13a and 13b show examples of the intergranular phase in two areas of the weld metal where the phase was displayed most prominently. The phase was evident in virtually all of the weld-metal grain boundaries observed in the metallographic specimen. Occasionally, the phase exhibited a lamellar morphology, as shown in Figure 13b.

The most significant results of the laboratory examinations were (1) the presence of discolorations and corrosion on the fracture surface which was more evident toward the inside surface than toward the outside surface of the pipe, (2) a fracture mode identified as intergranular, and (3) the presence of an intergranular carbide phase. The distribution over the fracture surface of corrosion and discolorations indicated that the failure most likely started on the inside surface of the circumferential pipe weld. The surface of the earlier stages of crack propagation were apparently exposed to the corrosive environment for longer periods of time. The presence of intergranular carbides in the weld metal constituted a sensitized condition of the weld metal. Stainless steels derive their resistance to corrosion principally from the presence of chromium. The formation of intergranular iron-chromium

In order to eliminate sensitization and the subsequent potential IGSCC in austenitic stainless steel weld metal, it is recommended that a stabilized stainless steel welding electrode, such as E347, be used, and that prolonged heating or slow cooling of the weld metal through the temperature range of 1000 to 1550 F be avoided.

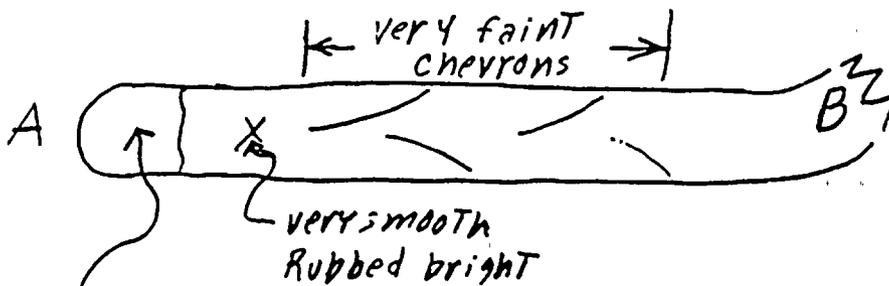
Figure 3A

Hackley, seemingly porous. No hinge seen. No impact seen.
