SUBJECT: Special rept: on 880120, scram experienced due to actual low Level 3 water level condition.

RE: Docket No. 50-410  
SPECIAL REPORT

In accordance with Nine Mile Point Unit 2 (NMP2) Technical Specification 3.5.1(f), we hereby submit the following Special Report concerning an Emergency Core Cooling System injection.

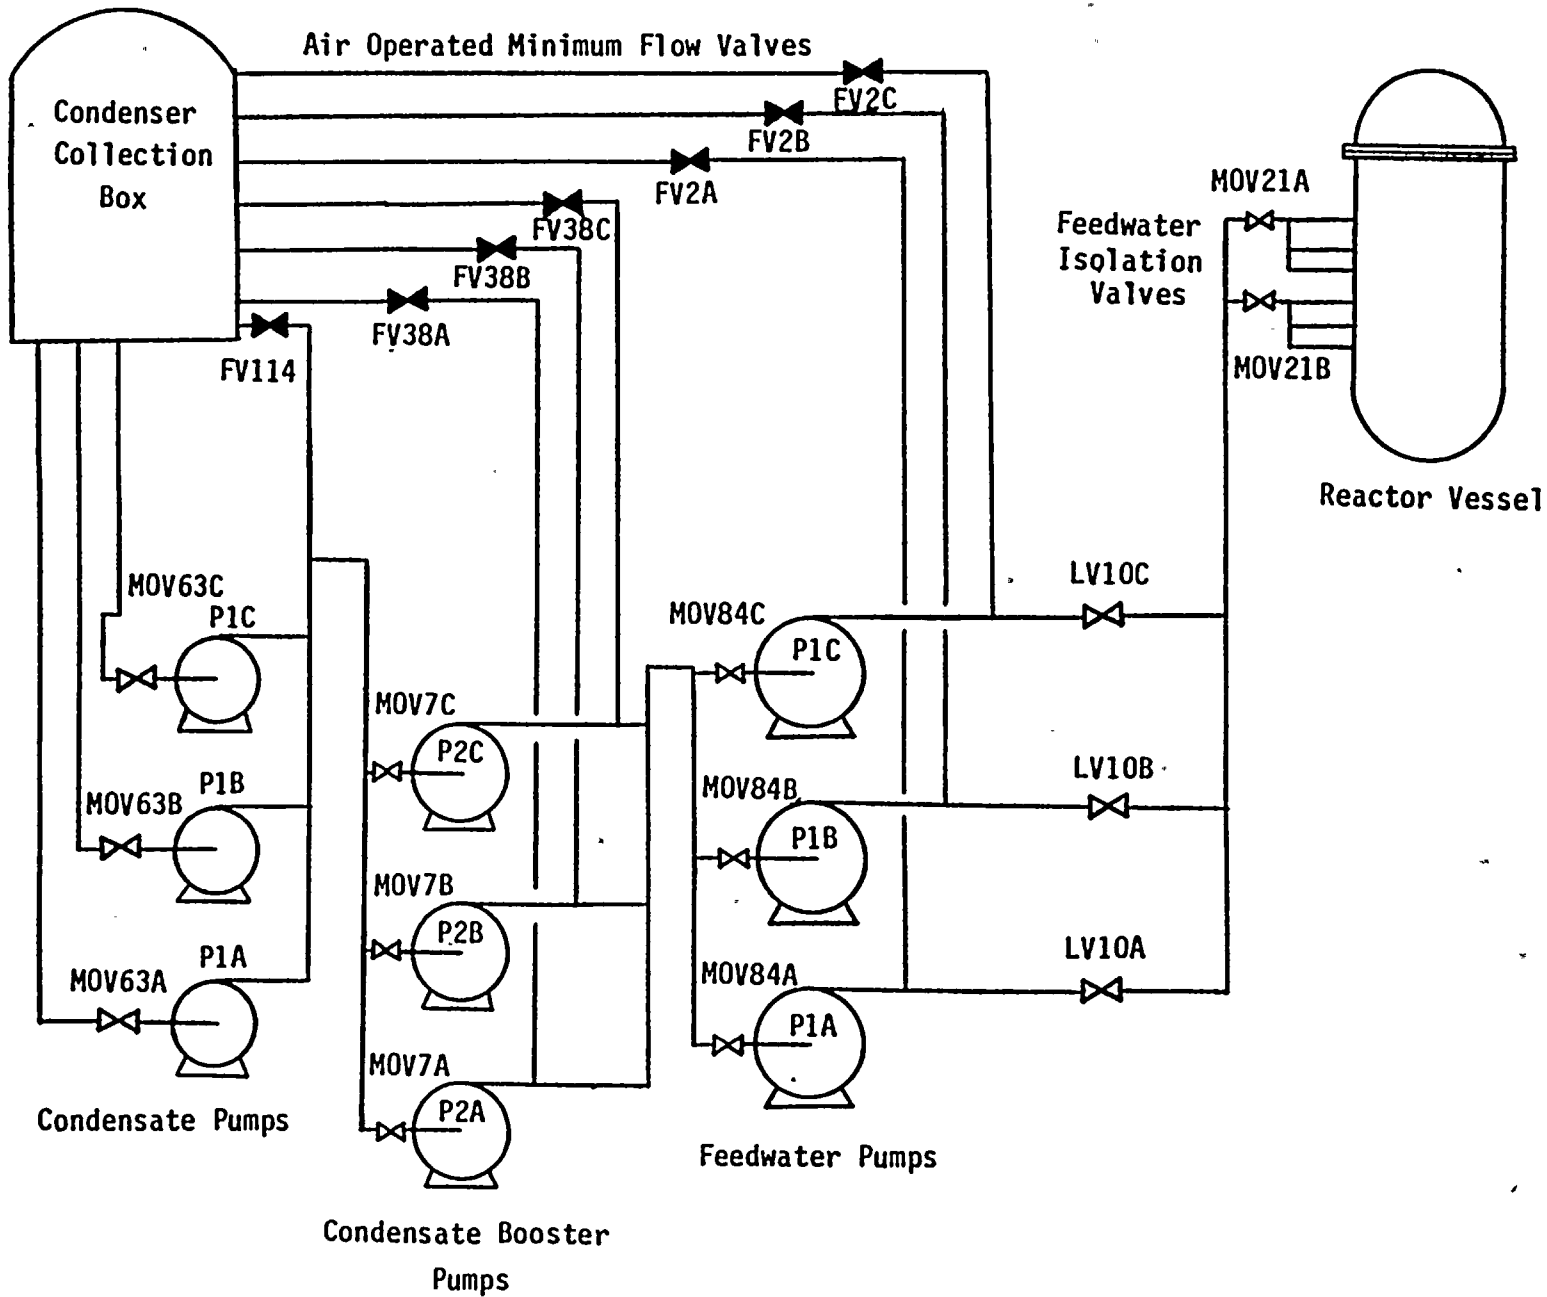
FIGURE 1

A Niagara Mohawk operator, while placing a markup (tag out), valved Instrument Air System (IAS) prefilter 2A out of service without ensuring that the redundant prefilter 2B was in service. Instrument air pressure throughout the plant began to decay due to this valving error. The licensed operators first noticed the "CRD Scram Valve Pilot Air Header Pressure Low" annunciator and immediately began to investigate. As air pressure decayed, the air operated minimum flow valves for the condensate, condensate booster, and feedwater pumps failed open (Figure 1). These minimum flow valves failed open since they are air-operated valves and are designed to fail open on loss of instrument air. As a result, feedwater flow recirculated back to the condenser subsequently reducing feedwater flow to the vessel.

A root cause analysis for this event has been completed per Site Supervisory Procedure S-SUP-1, "Root Cause Evaluation Program". The root cause has been determined to be personnel error. The operator visually verified that the isolation valves for prefilter 2B were open by observing the length of the valve stems. However, he should have physically verified the valves' position open. These valves were in fact closed. Thus, when the operator isolated prefilter 2A for maintenance, the instrument air compressors were isolated from the rest of the system.
