SUBJECT: LER 87-028-01: on 871219, manual reactor scram initiated due to feedwater piping vibration.

| TITLE (4) Manual Reactor Scram Initiated Due To Feedwater Piping Vibration | | | | | | | | | | | | | | | | | | | | | | | | | | |

RE: Docket No. 50-220
LER 87-28, Supplement 1

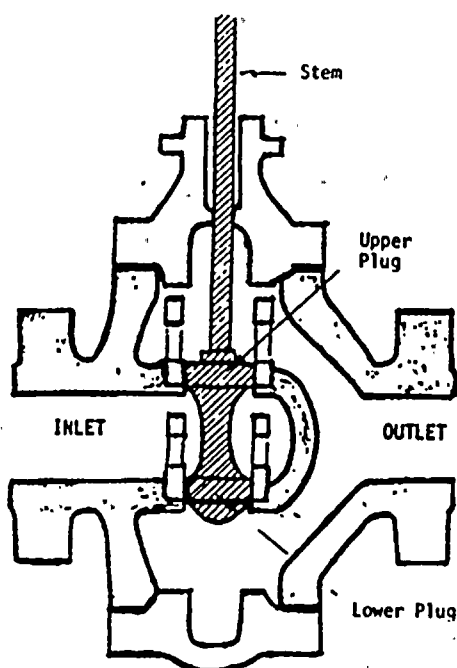
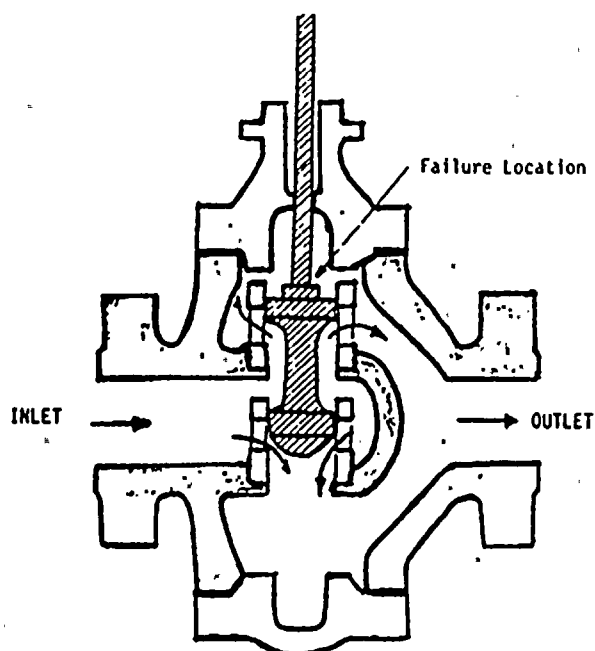
ATTACHMENT 1

Disassembly and inspection of the internals of FCV 13A (Attachment 1) revealed that the valve plug had separated from the valve stem. This was a result of a fracture through the weld between the stem and the plug which seals the threaded connection between the 1-inch diameter shaft and the valve plug (Attachment 2). In addition, there were marks on both the valve plug and on the valve seat cages, indicating that the plug had been hammering against the webbing between the ports in the cages. The plug in those areas had been worn such that indentations several mils deep had been made in the plug circumference. The failed valve plug and stem were sent offsite for metallographic analysis to help determine the cause and mechanism of failure.

SKETCH OF THE FLOW-CONTROL VALVE SHOWING THE STEM/PLUG COMPONENT.
(Cross-hatched area)

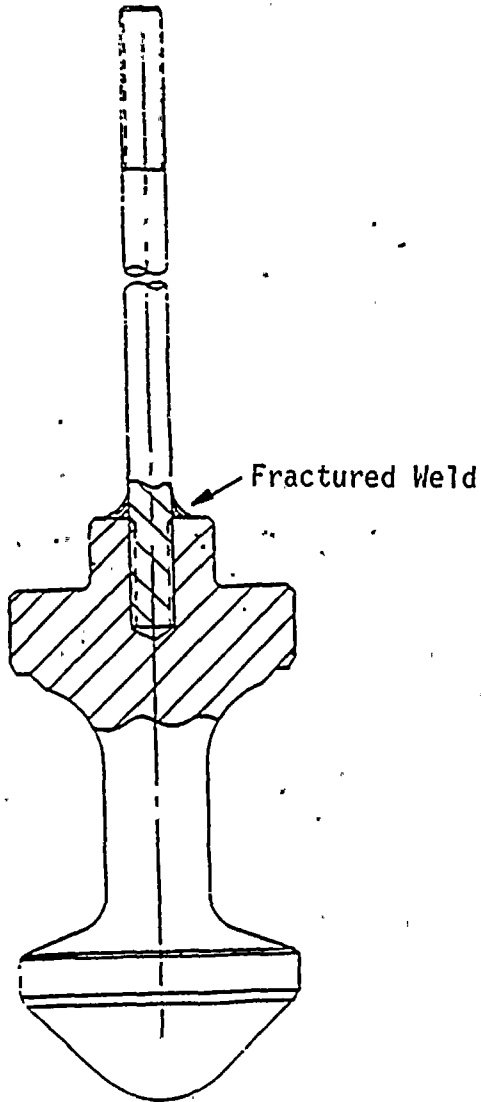
Modified Design in 1978

The root cause of this event was determined to be flow-induced vibration of the plug in FCV 13A. This vibration induced a fatigue fracture in the valve stem, allowing the plug to oscillate open-close and establish damaging vibrations in the feedwater piping. Increased stress concentration at a small-radius fillet weld (connecting the stem to the plug) is believed to be a contributing factor.

Metallurgical analysis of the FCV 13A valve plug and stem indicated that the weld failure was a reverse bending fatigue fracture. The bending stresses were believed to have developed in service as a result of wear on the lower plug. Flow-induced vibration over a long period of time wore the contact surface between the plug and the cage and, through increased amplitude of vibration caused by this wear, caused the stem to fail in fatigue.

1" Ø 316 S.S. Stem

9/16" Radius Weld - Machine

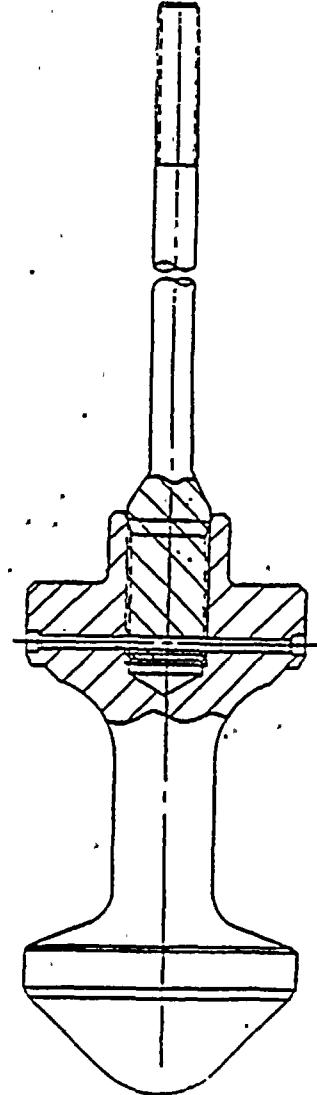
1988 Design

1" Ø 17-4 PH Stem with 2" Ø

Conn. At Plug - 3/8" Ø Pin

A redesigned valve plug/stem assembly has been installed in FCV 13A and 13B (Attachment 2). The attachment point has been strengthened by increasing the diameter of the stem where it attaches to the plug and adding a conical section to reduce the stress intensification at the attachment point. A 3/8-inch diameter pin is used to secure the valve plug to the stem.
