LICENSEE EVENT REPORT (LER)

FACILITY NAME (1)										DOCKET NUMBER (2)										PAGE 31	
Nine Mile Point Unit 1										0 5 0 0 0 2 2 0										1 OF 016	
TITLE (4)																					
Failure To Hydrostatically Test A Portion Of The ASME Class 1 Pressure Boundary Due To Procedural Error																					
EVENT DATE (5)			LER NUMBER (6)				REPORT DATE (7)			OTHER FACILITIES INVOLVED (8)											
MONTH	DAY	YEAR	YEAR	SEQUENTIAL NUMBER	REVISION NUMBER	MONTH	DAY	YEAR	FACILITY NAMES			DOCKET NUMBER(S)									
0 6	1 8	8 8	8 8	0 1 2	0 0	0 5	1 8	8 8				0 5 0 0 0									
OPERATING MODE (9)		THIS REPORT IS SUBMITTED PURSUANT TO THE REQUIREMENTS OF 10 CFR 81 (Check one or more of the following) (11)																			
N		20.402(b)				20.406(e)				50.73(e)(2)(iv)				73.71(b)							
POWER LEVEL (10)		20.406(e)(1)(i)				50.36(e)(1)				50.73(e)(2)(v)				73.71(e)							
0 0 0		20.406(e)(1)(ii)				X 50.36(e)(2)				50.73(e)(2)(vi)				OTHER (Specify in Abstract below and in Text, NRC Form 368A)

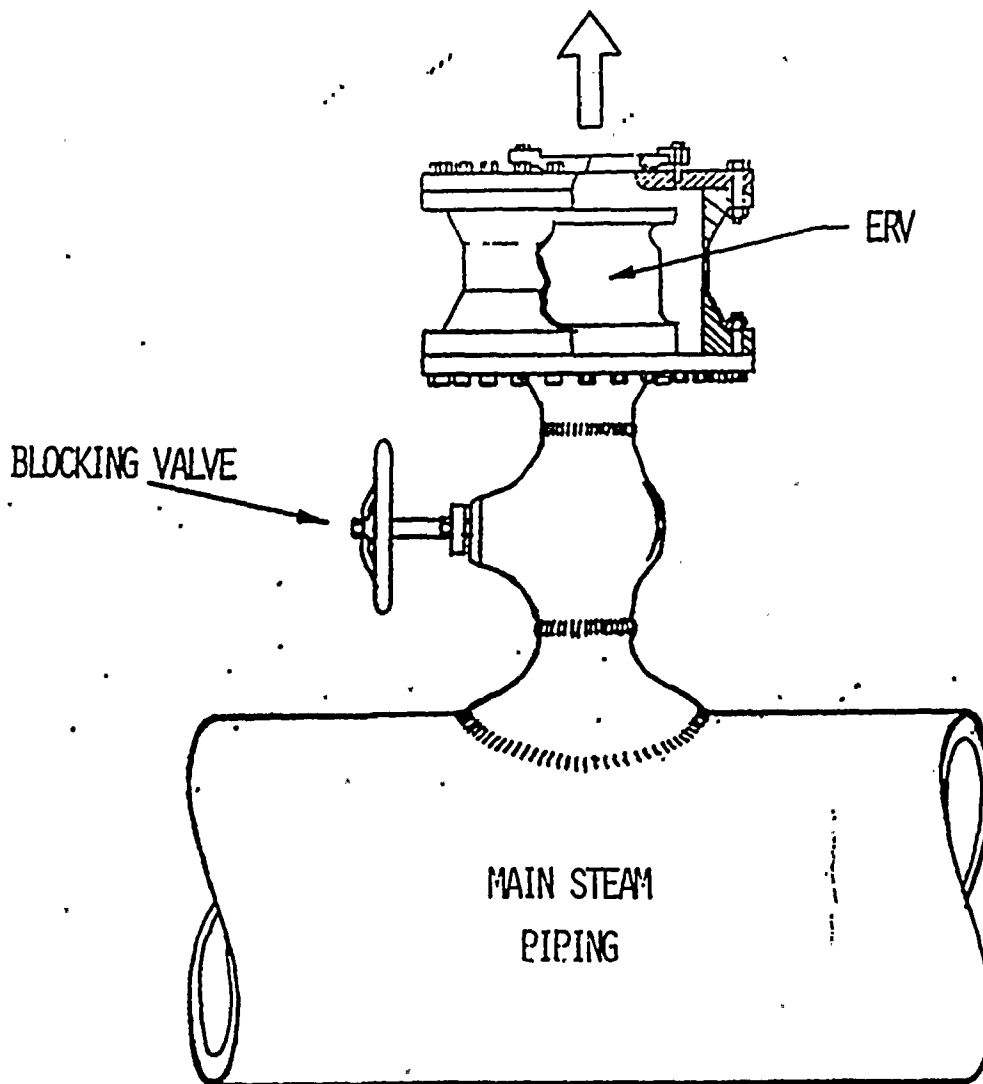
FIGURE A

There are six EMRV's located on the two main steam lines (three on each line) within the primary containment. The EMRV's bolt to flanges which are welded to the manual blocking valves located upstream. The manual blocking valves are connected to the main steam lines via welded attachments. Figure A (page 6 of 6) illustrates the typical configuration for the EMRV's and manual blocking valves.

The root cause of this event was personnel error as a result of an error in procedure N1-ISI-HYD-01, Revision 0, used for the hydrostatic test. The procedural error was in the omission of the portion of main steam system from the manual blocking valves up to and including the EMRV's during the conduct of the ASME Class 1 hydrostatic test. Several factors which contributed to the procedural error are:

Initial corrective action involved generating Occurrence Report No. 88-368 to document the event. The portion of the main steam system which was excluded from the ASME Class 1 hydrostatic testing in 1986 will be tested prior to start up during the current refueling outage. A special hydrostatic test procedure has been generated (N1-ISI-HYD-402) which will test the portion of the system from the manual blocking valves to the flanged connection at the EMRV's. The EMRV's will be removed for this test and the flanges will be blanked off. The EMRV's will be tested separately using a higher quality test medium to avoid the potential for foreign material to accumulate on the seating surfaces. Testing in this manner will fulfill the requirements of ASME Section XI paragraph IWB-5210.
