SUBJECT: LER 88-039-01:on 880806,reactor scram due to loss of
 electrohydraulic control sys pressure.

LICENSEE EVENT REPORT (LER)

FACILITY NAME (1)		DOCKET NUMBER (2)		PAGE (3)	
Nine Mile Point Unit 2		0 5 0 0 0 410		1 OF 04	
TITLE (4) Reactor Scram due to Loss of Electrohydraulic Control System Pressure Caused by Excessive Vibration

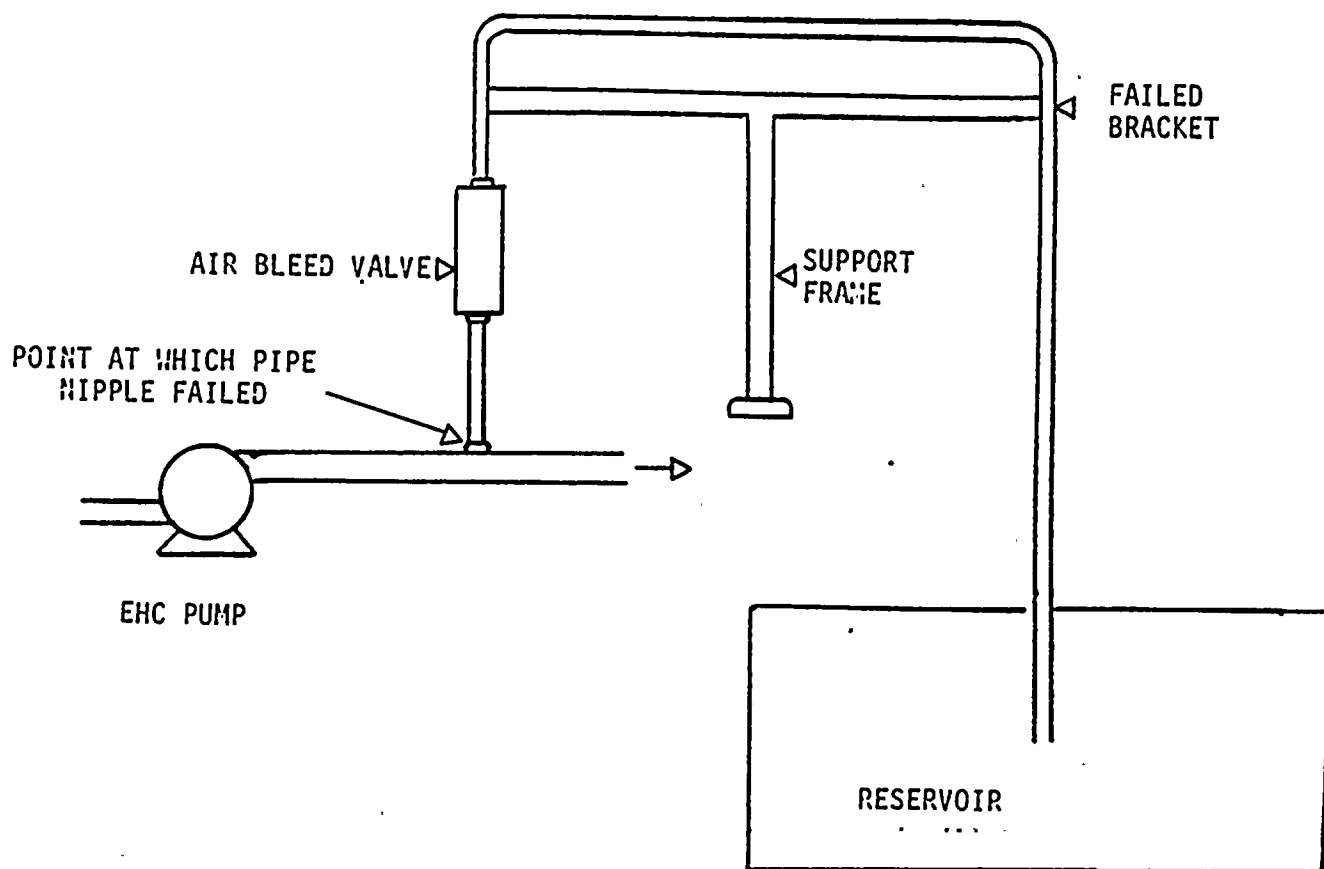
EHC HYDRAULIC POWER UNIT (SIMPLIFIED)

The reactor scram was the result of a turbine EHC fluid leak due to a pipe nipple failure. The failure occurred on the threaded portion of the 2 inch long 1/4 inch pipe nipple connecting the EHC pump "B" discharge header to the air bleed valve (see Diagram 1).

The immediate cause of the pipe nipple failure has been attributed to excessive vibration. Vibration caused the clamp used to secure the piping downstream of the air bleed valve to the piping support frame to fail. System vibration then caused the unsupported pipe to bend at the air bleed valve pipe/pump discharge piping tee connection causing fatigue stress. The pipe failure occurred at this "bending point". The cause of the excessive vibration is currently under investigation. The clamp on the piping associated with the EHC "A" pump was found intact and secure.

2. Work request (WR 136781) was issued to replace the failed section of piping. The failed nipple ("B" pump) and its "A" pump counterpart (WR 136792) were removed for inspection and new pipe nipples installed. The Niagara Mohawk Quality Control Department is presently performing an analysis on the failed pipe nipple.
