SUBJECT: LER 88-045-00: on 880915, design rated reactor core flow exceeded due to personnel error.

FACILITY NAME (1) Nine Mile Point Unit 2 DOCKET NUMBER (2) 0 5 0 0 0 0 470 1 OF 07

TITLE (4) Design Rated Reactor Core Flow Exceeded due to Personnel Error Results in Plant Operation in an Unanalyzed Condition

EVENT DATE (5) 09 15 88 LER NUMBER (6) 045 REPORT DATE (7) 10 17 88 OTHER FACILITIES INVOLVED (8) N/A

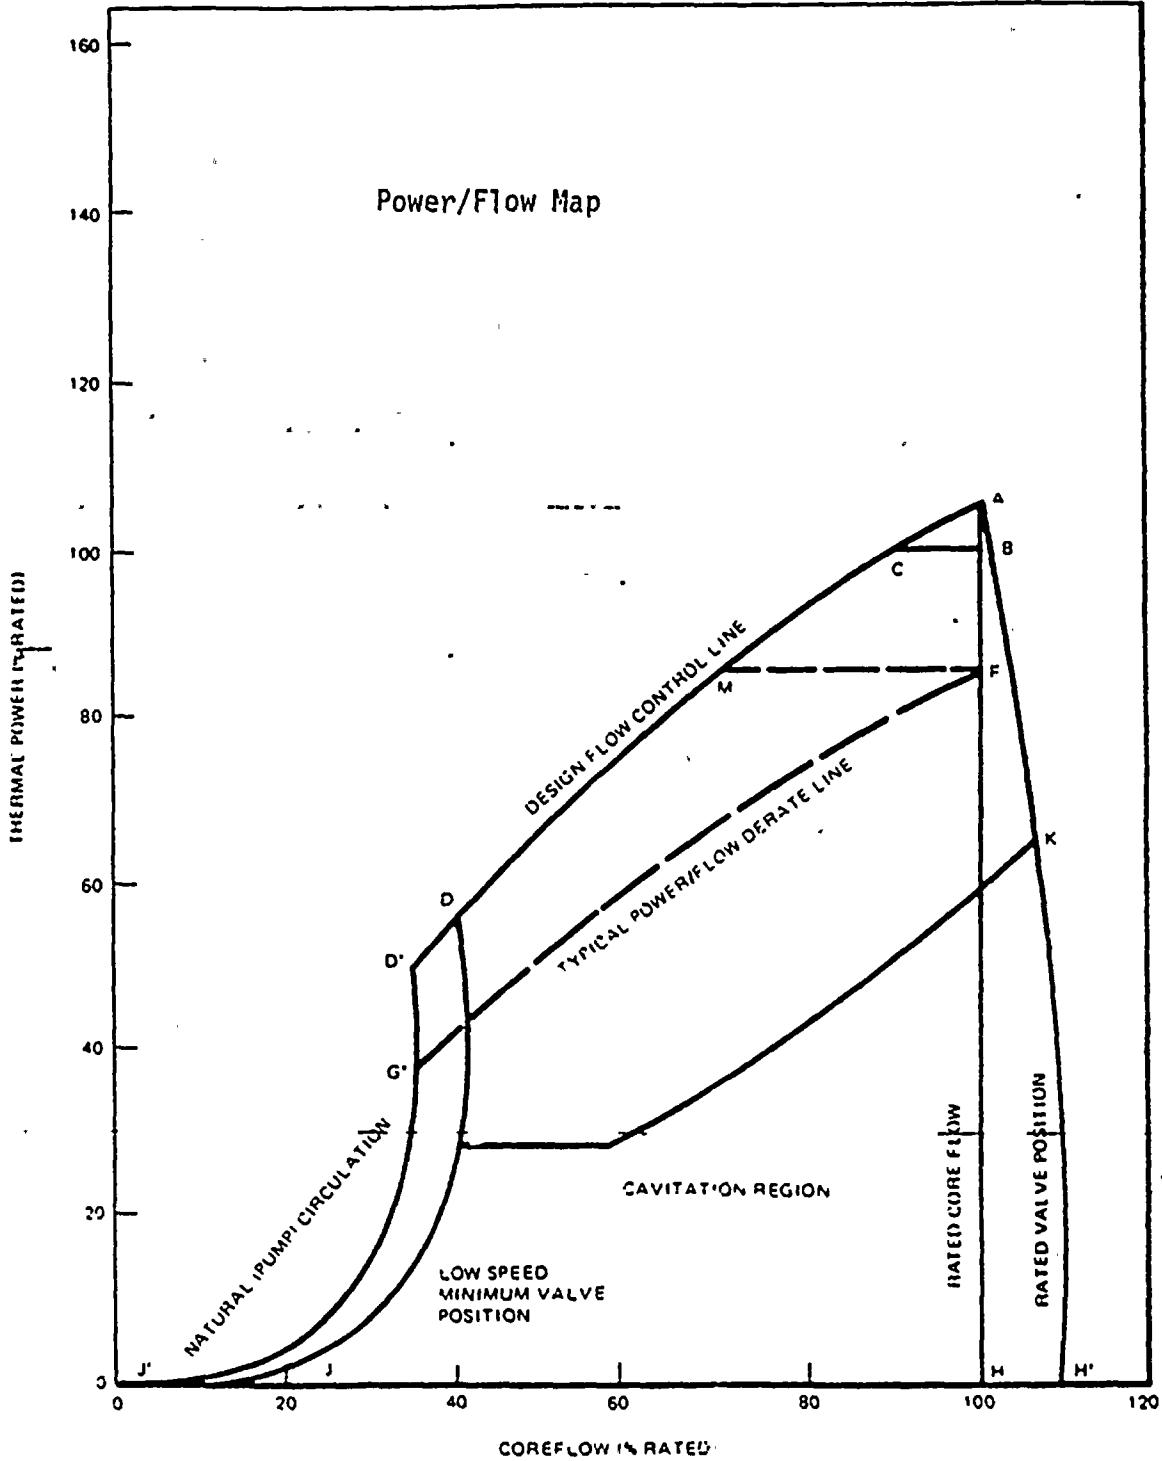
NMP2 Final Safety Analysis Report (FSAR), Chapter 15, "Accident Analyses", Figure 15.0.2, Power/Flow map represents the acceptable operational constraints for abnormal operational transient evaluations (Attachment 1). The power/flow map places a limit on reactor core flow of 100% of rated for accident analyses.

The error introduced into the reactor core flow measurement due to the improperly calibrated flow instrumentation has been determined to be approximately 4.5%. When indicated reactor core flow exceeded 95.5% of rated, actual core flow exceeded 100% of rated. Therefore, each time core flow exceeded 95.5% of rated, NMP2 was placed in a condition not specifically addressed in the NMP2 Final Safety Analysis Report.
