SUBJECT: LER 88-066-00:on 881201,alternate rod insertion actuation
 during surveillance test due to design deficiency.

FACILITY NAME (1) Nine Mile Point Unit 2										DOCKET NUMBER (2) 0 5 0 0 0 410				PAGE (3) 1 OF 05	
---	--	--	--	--	--	--	--	--	--	--	--	--	--	-------------------------	--

TITLE (4) Alternate Rod Insertion Actuation During Surveillance Test due to Design Deficiency															
--	--	--	--	--	--	--	--	--	--	--	--	--	--	--	--

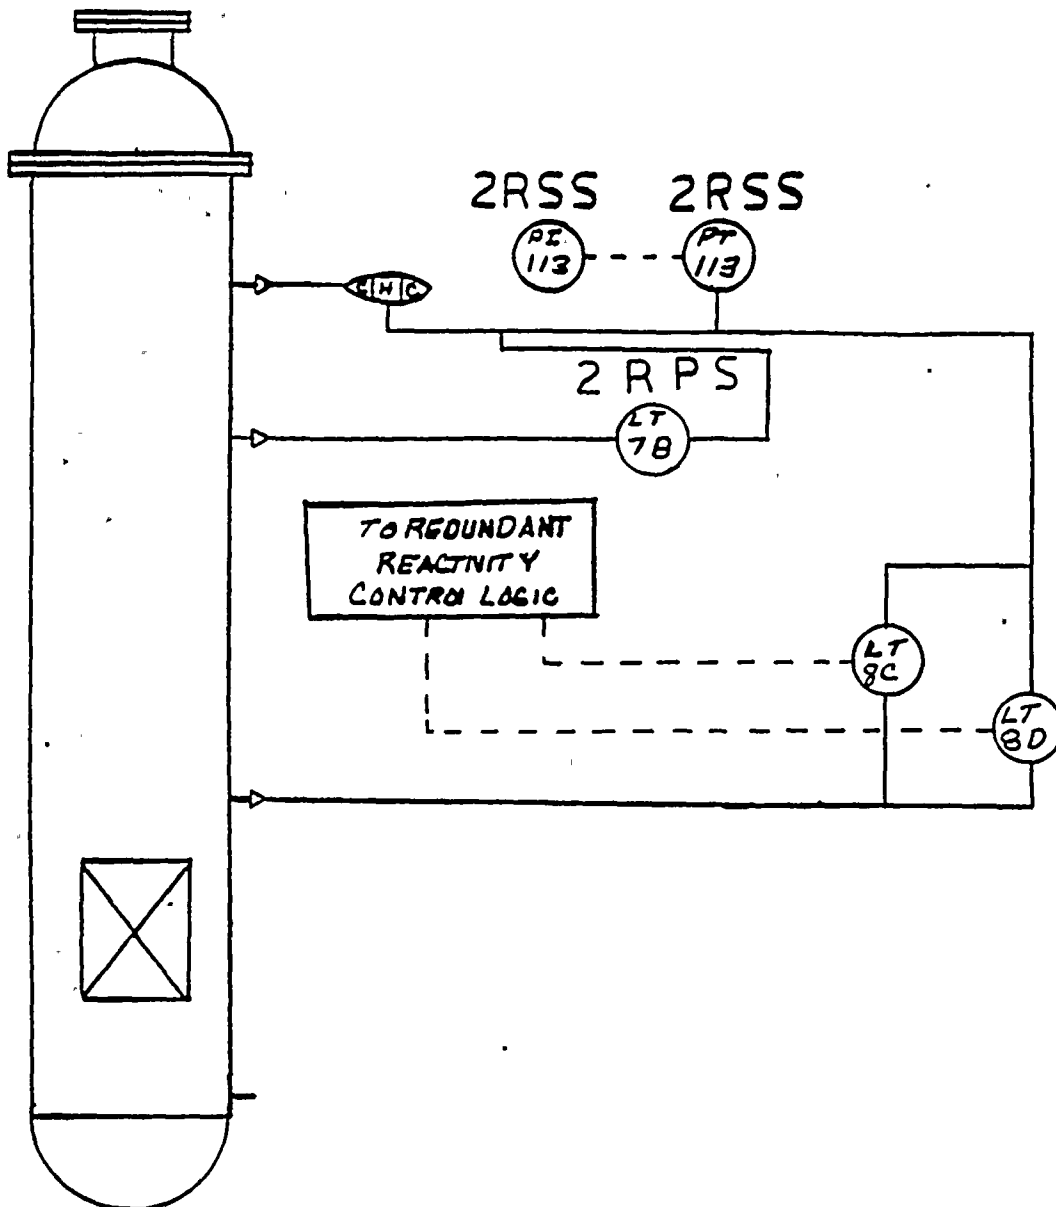
FIGURE - 1

When the I&C technician returned the pressure transmitter to service, a pressure transient was transmitted throughout the common leg in which the level transmitters are mounted. (See Figure 1) This pressure transient caused a spurious Reactor Protection System (RPS) half scram on low level transmitter 2ICS*LT7B and A Division II RRCS initiation signal.

The root cause of this event is design deficiency. The present design of level transmitter 2RSS*PT113 reference leg is such that, both channels of Division II are connected together. Therefore, when the pressure transient occurred at 2RSS*PT113, both channels of Division II were affected. A trip of both channels of a division satisfied the logic for initiation of the RRCS.

Corrective action will be to evaluate the priority of Modification No. PN2Y85MX089 for redesign of the level transmitters configuration, where both channels of a single division would not be affected by a pressure transient on the common sensing line. This modification would reduce the chances of a recurrence of an event of this type.

1. Revise Operating Procedure N2-OP-101C "Plant Shutdown" to remove the RRCS from service while the plant is shutdown. This will eliminate the possibility of a spurious perturbation in a common sensing line that could cause an ARI initiation resulting in a control rod insertion.
