U.S. NUCLEAR REGULATORY COMMISSION
REGION I

Report No: 50-220/89-80
Docket No. 50-220
License No. DPR-63
Licensee: Niagara Mohawk Power Corporation
300 Erie Boulevard West
Syracuse, New York 13202

Facility Name: Nine Mile Point Unit 1

Inspection conducted on August 22-28, 1989 (Inspection Report 89-80)

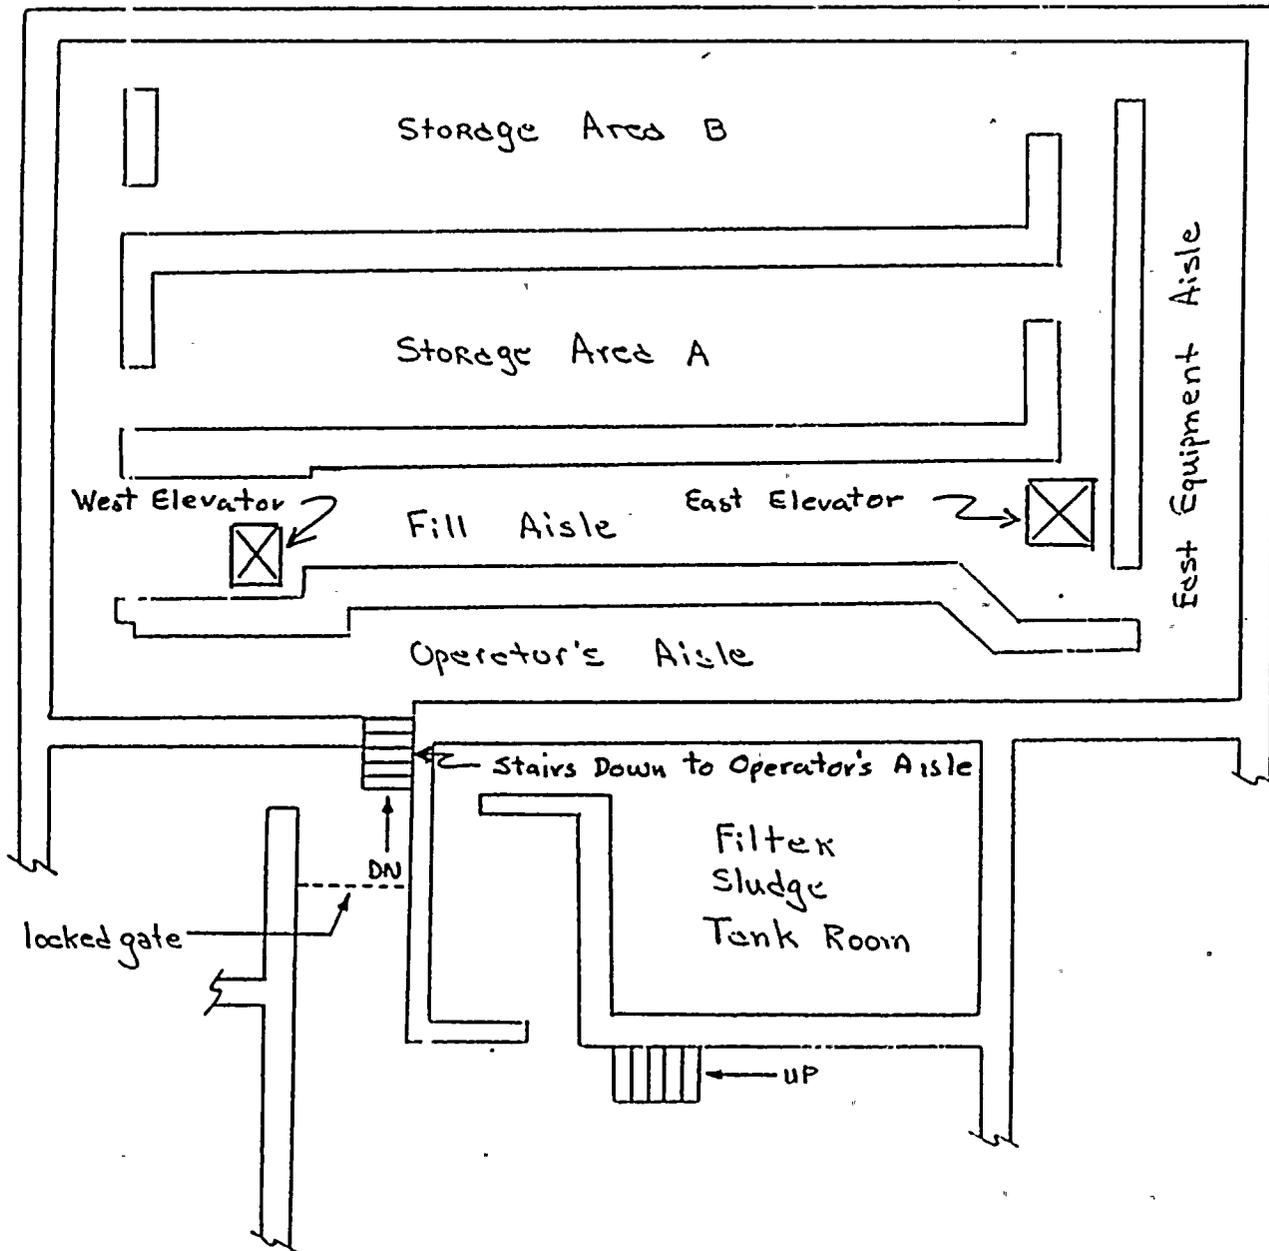
Figure 1

The 225' elevation of the Radwaste Processing Building is a sub-basement of approximately 2400 square feet, subdivided by 30" thick shield walls into five working areas: the operator's aisle, the fill aisle, storage areas A and B, and the east equipment aisle (see Figure 1). The room is the lowest point in the radwaste building and contains two floor drain sumps. The #11 sump is located in the east equipment aisle and the #12 sump is located at the west end of the operator's aisle. The sumps were used for the collection of waste from routine washdowns/decontaminations of the processing line. In addition, the sumps received additional inputs from other sources within the radwaste building. Both the floor and the lower portions of the walls were painted with a protective coating to facilitate decontamination of the room. The room was designed to receive processed wastes in the form of dewatered resins and sludges, transfer the waste material into 55-gallon drums, provide temporary storage capability, and to make final transfer to a loading dock for shipment in shielded casks.

Floor Plan
225' Elevation Sub-basement
Radwaste Building
