SUBJECT: LER 90-016-00: on 901202, ESF actuation, automatic initiation of HPCS sys logic & automatic start of Div III standby EDG. Cuased by spurious reactor vessel level instrument signal & personnel error. Operations verified proper operation of DG.

RE: Docket No. 50-410
LER 90-16

TITLE (4) **Engineered Safety Feature Actuation - High Pressure Core Spray and Division III Standby Emergency Diesel Generator Initiation Due to Personnel Error**

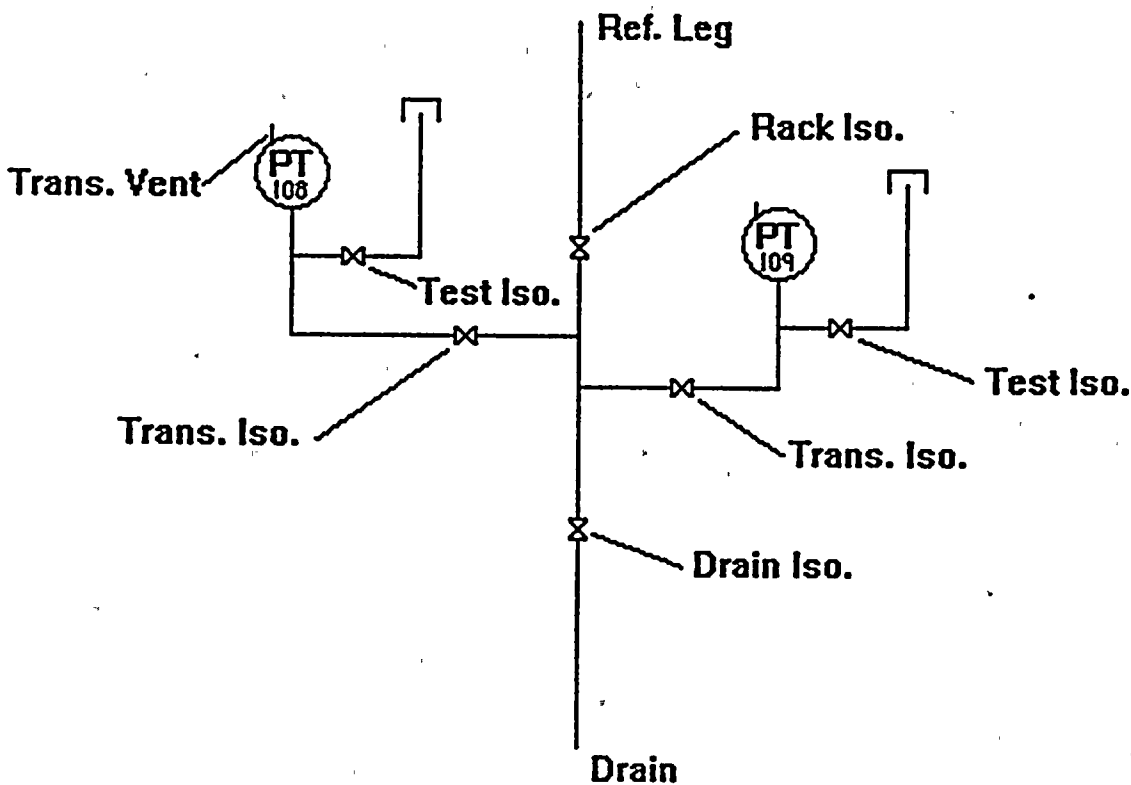
INSTRUMENT RACK 26

On December 1, 1990, at 1850 hours, Instrument and Control (I&C) technicians began work on replacing the instrument sensing line isolation valve for Reactor Vessel Pressure Transmitter 2ISC*PT108 (note attached diagram) per Work Request (WR) #180770. Work was started with the instrument rack isolation valve and the drain isolation valve marked-up (closed and open respectively). The transmitter isolation valve was replaced using Maintenance Instruction Procedure S-MI-5.3-001 Attachment A, "Use of Procedures". The markup on the rack drain valve and isolation valve was then cleared (valves closed and opened respectively) causing air to be trapped in the instrument tubing between pressure transmitters 2ISC*PT108 and 2ISC*PT109.

1. Bleed air from the instrument tubing associated with pressure transmitter 2ISC*PT108 (note attached drawing) by cracking the test isolation valve and opening the transmitter vent valve.
2. Bleed air from the instrument tubing associated with pressure transmitter 2ISC*PT109 by cracking the test isolation valve and opening the transmitter vent valve.
3. Bleed air from the reference leg by cracking the drain isolation valve.

At approximately 0122 hours, an ESF actuation occurred. The actuation was the result of a pressure surge on the reference leg of 2ISC*PT108. Pressure transmitter 2ISC*PT108 shares common reference leg tubing with two Reactor Vessel Water Level Transmitters, 2ISC*LT10A and 2ISC*LT10C. While venting to the drain, a pressure surge on the common reference leg induced a spurious low-low reactor water level (108.8") signal to be generated by the level transmitters. The transmitters' outputs satisfied the logic for the Engineered Safety Feature actuation -

A root cause for this event has been performed per Nuclear Division Procedure NDP-16.01, "Root Cause Evaluation" and the Root Cause Evaluation Workbook. The immediate cause of the event was a spurious signal initiated by a pressure surge on the reference leg of reactor vessel level transmitters 2ISC*LT10A and 2ISC*LT10C.

The root cause for this event was determined to be personnel error due to poor work practices. While preparing the work package associated with the replacement of the instrument isolation valve, the planner failed to consider that restoring the pressure transmitter to service could have an affect on the Reactor Vessel Water Level Instrumentation. Had he done so, the planner would have evaluated the work to be "Level 1" work which would have required a specific maintenance procedure to be written. The procedure would have then received a technical and safety review, and would have included the requirement to backfill the pressure transmitter prior to valving it into service.

- 1) Conducting an Accountability Meeting with the personnel involved to review the circumstances of the ESF actuation.
- 2) Instructing the Planning Department on the correct use of Maintenance Instruction Procedure S-MI-5.3-001, "Use of Procedures". Specifically, the purpose of this guidance was to reinforce the importance of considering the full scope of the job when developing a work package.
- 3) Developing a Lessons Learned Transmittal to inform the Planning, Operations, and I&C Departments of the circumstances surrounding this event and the corrective actions taken to prevent recurrence.
