U. S. NUCLEAR REGULATORY COMMISSION
REGION I

Report No. 50-410/92-81

Facility Name: Nine Mile Point Nuclear Power Station, Unit 2

Conducted: March 24-28, 1992

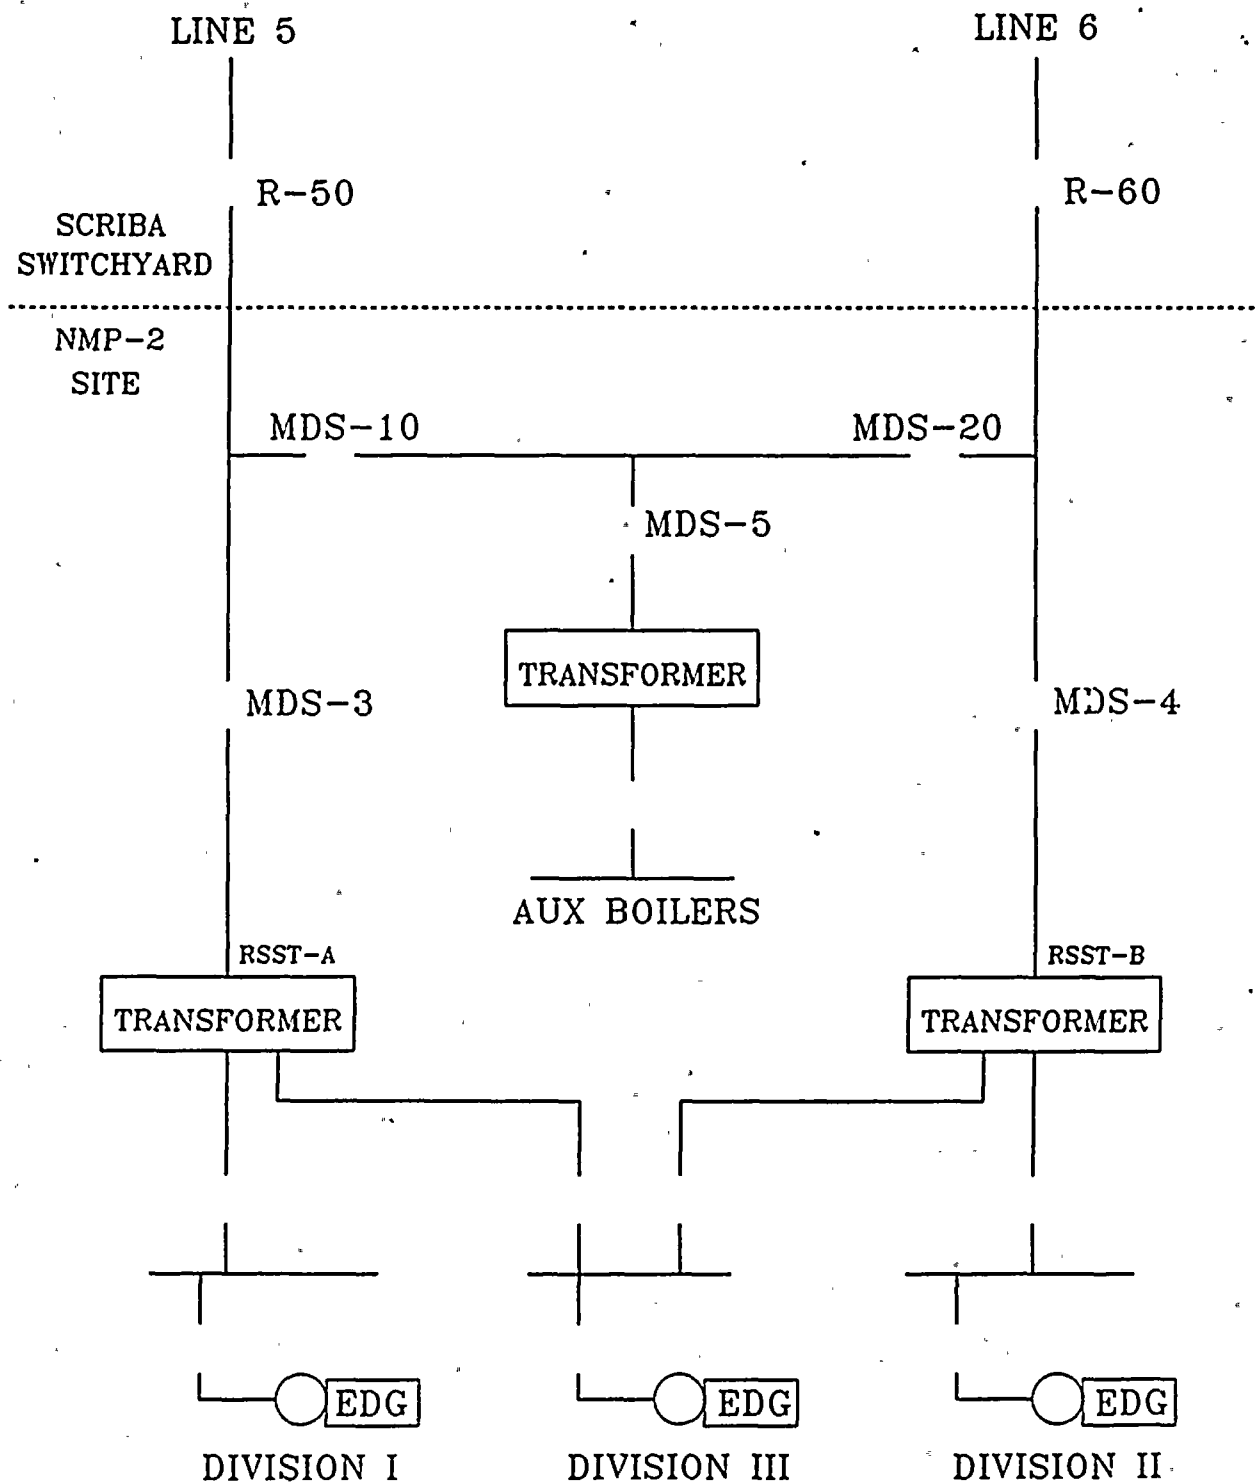
FIGURE 1

The auxiliary boiler relay trip (type 86) had also tripped the next breaker up the circuit (see Figure 1), R-50. The relay logic included two sets of contacts which effectively mimicked the power circuit up to MDS-5. Since R-50 and MDS-10 were closed, a current path existed which picked up another relay (type 94), which tripped R-50. At the time of the event, MDS-20 was open so no current path existed to actuate the type 94 relay for the line 6 breaker, R-60.

The trip of R-50 deenergized all equipment being supplied from line 5. This equipment included UPS-1A, two of the three air compressors, the Division I bus and the Division III bus. After about 10 seconds, the Division III EDG successfully completed an automatic start and restored power to the Division III bus. After about 20 seconds, control
