Braidwood Station, Unit 1
Renewed Facility Operating License No. NPF-72
NRC Docket No. STN 50-456

Subject: Braidwood Station, Unit 1 Steam Generator Tube Inspection Report for
Refueling Outage 19

**BRAIDWOOD STATION UNIT 1
STEAM GENERATOR EDDY CURRENT INSPECTION REPORT**

REFUELING OUTAGE 19 (A1R19)

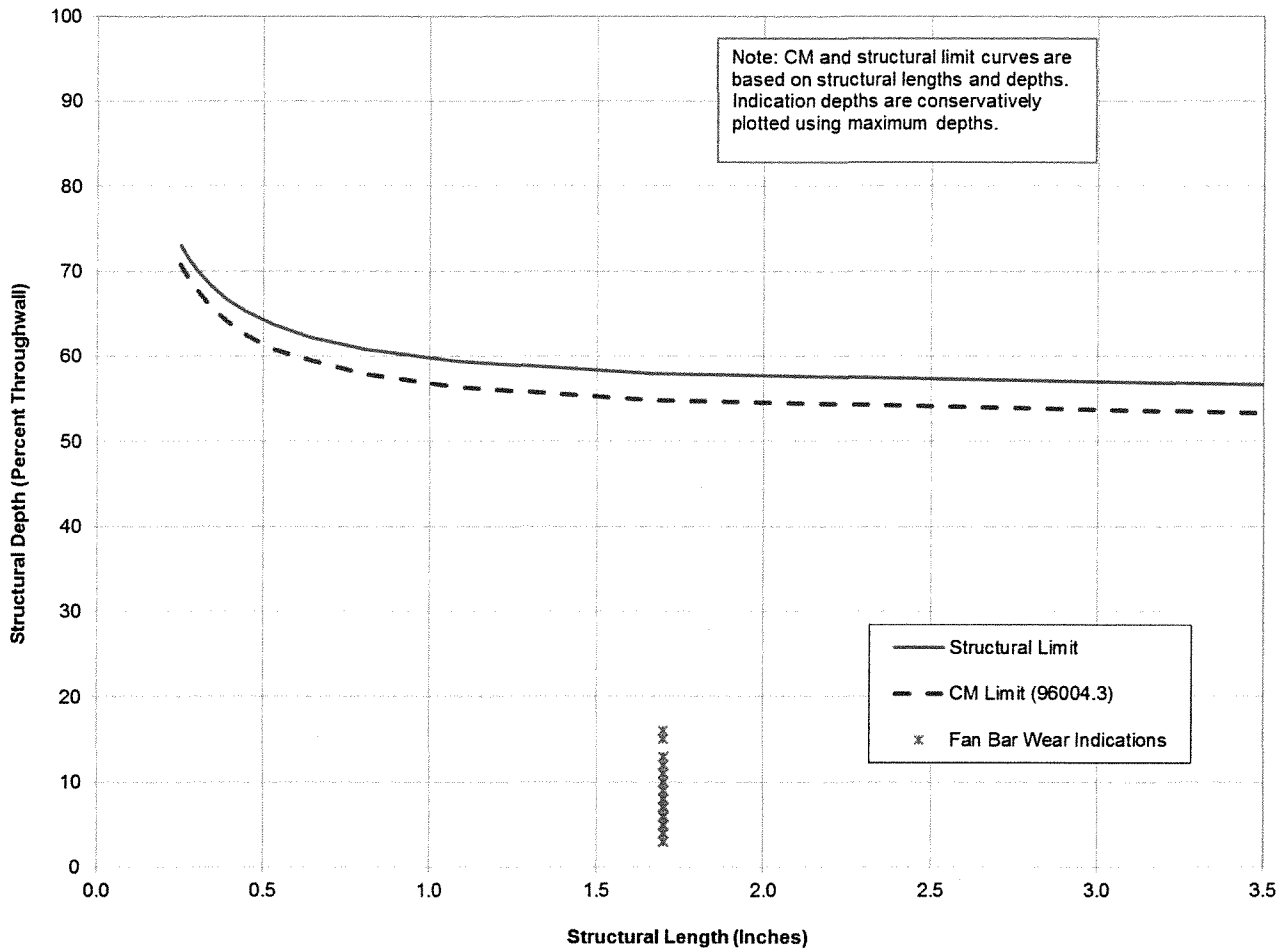
Condition Monitoring Results for Fan Bar Wear

Fan Bar Wear- The largest Fan Bar wear indication found during the A1R19 inspection was 16% TW as measured by the EPRI Appendix H qualified technique 96004.3, Rev. 13. This is well below the Fan Bar wear structural limit and CM limit curves. No tubes were required to be plugged.

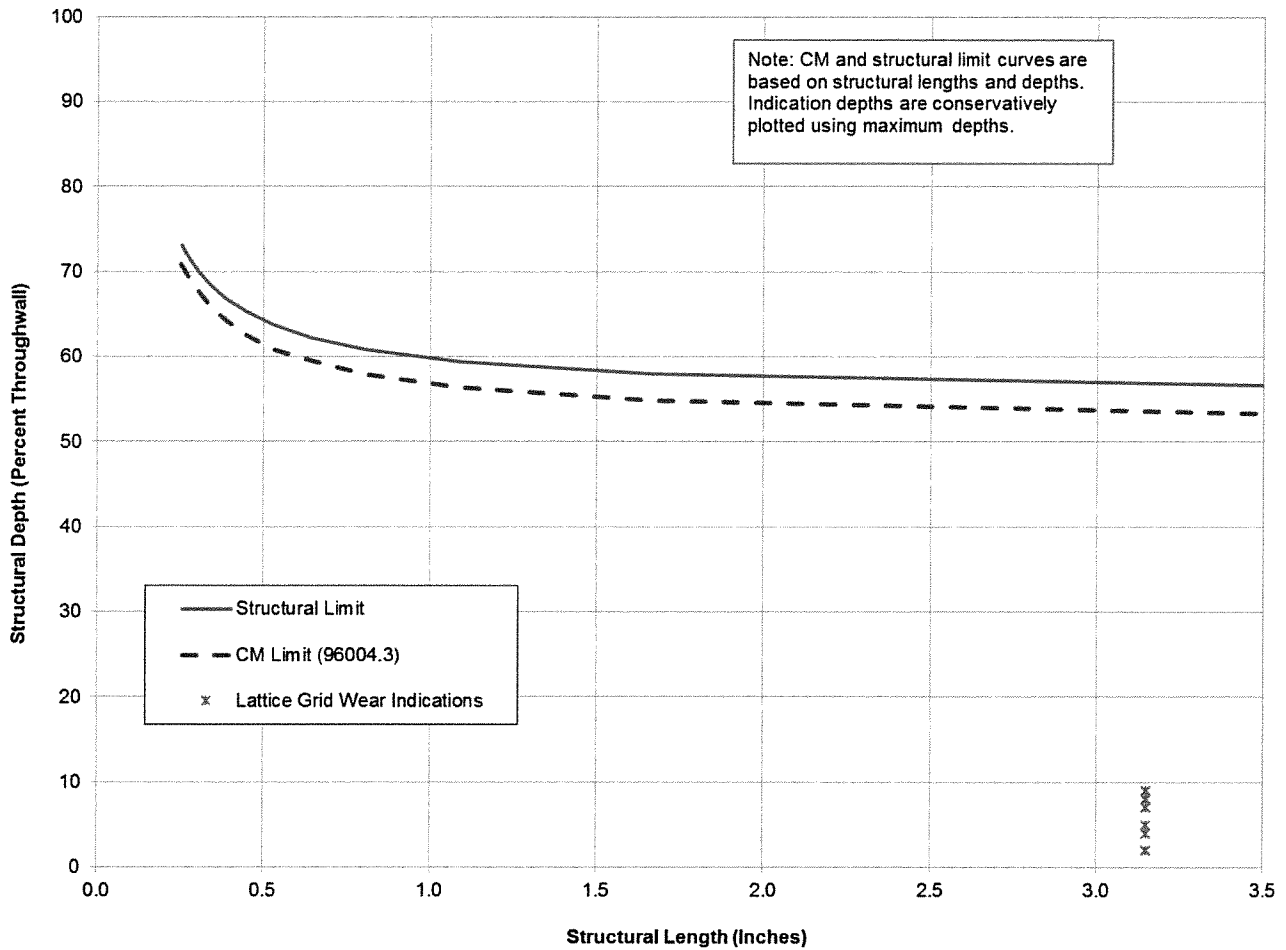
Condition Monitoring Results for Lattice Grid Wear

Lattice Grid Wear- The largest Lattice Grid wear indication found during the A1R19 inspection was 9% TW, as measured by the EPRI Appendix H qualified technique 96004.3, Rev. 13. This is well below the Lattice Grid wear structural limit and CM limit curves. No tubes were required to be plugged.

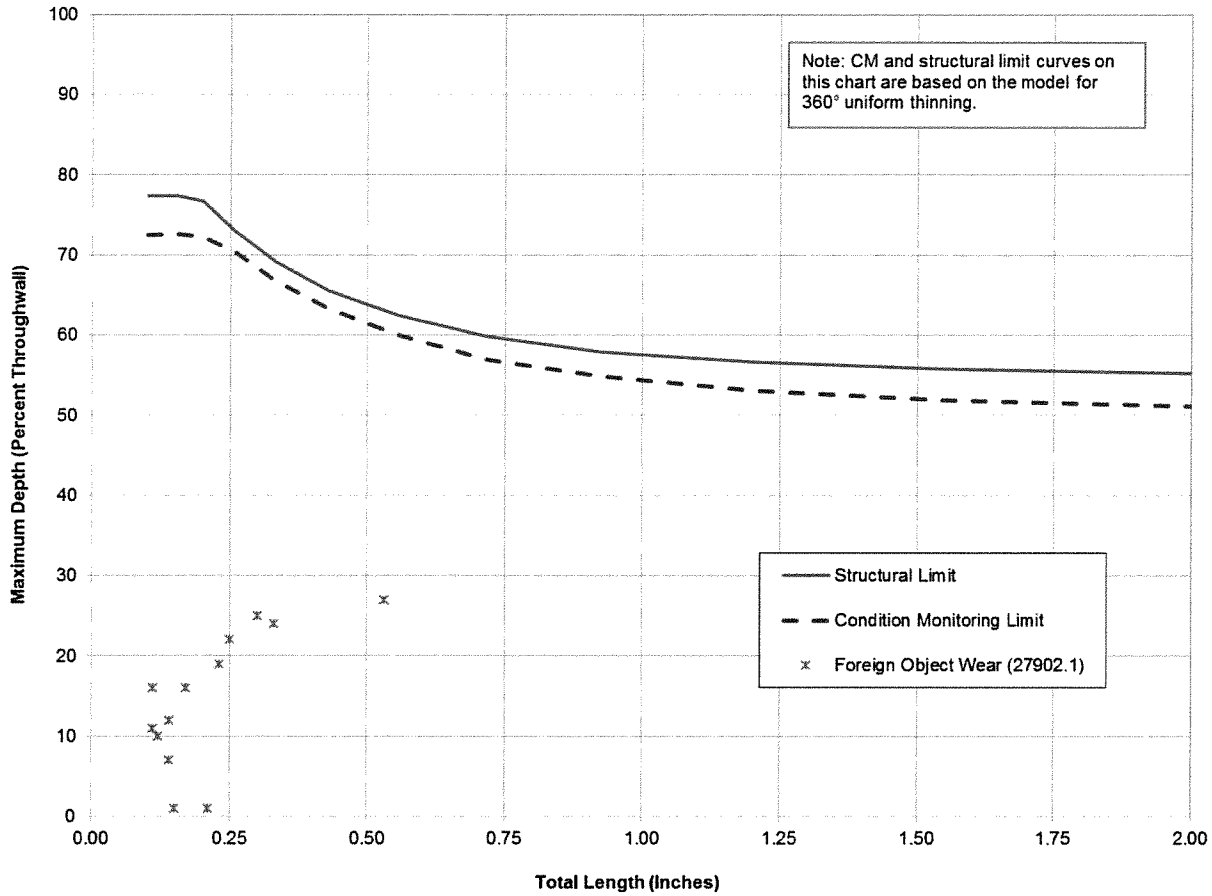
Condition Monitoring Results for Foreign Object Wear

Foreign Object Wear - The largest foreign object wear indication found during the A1R19 inspection was 27% TW with axial length of 0.62 inches as measured by the EPRI Appendix H qualified technique 27902.1, Rev 2. This is well below the Foreign Object wear structural limit and CM limit curves. No tubes were required to be plugged due to FO wear. The four tubes were plugged preventively due to the priority "1" object not being retrieved.
