U.S. NUCLEAR REGULATORY COMMISSION
REGION I

Report No. 85-21

Facility Name: Nine Mile Point, Unit 2

Meeting Summary: Management Conference on June 17, 1985
(Report No. 50-410/85-21)

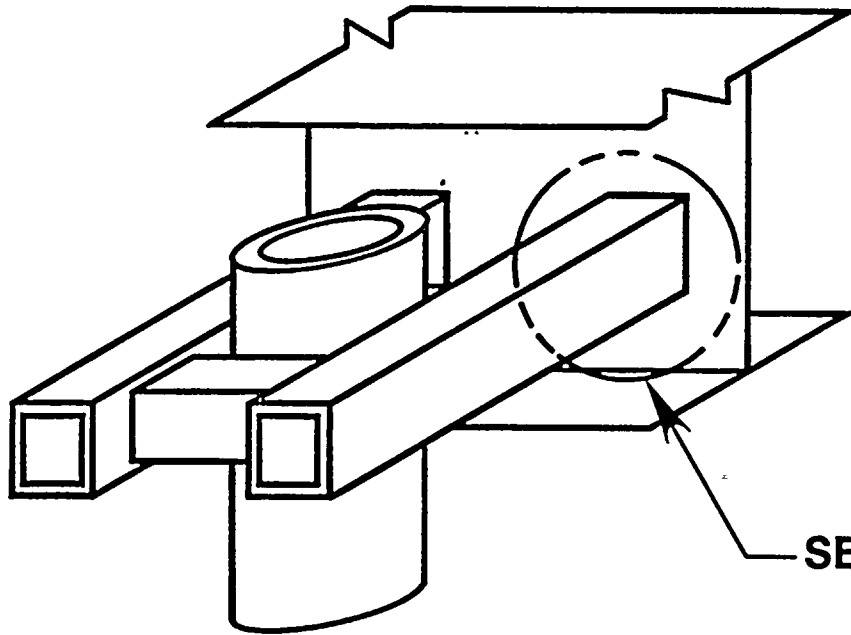
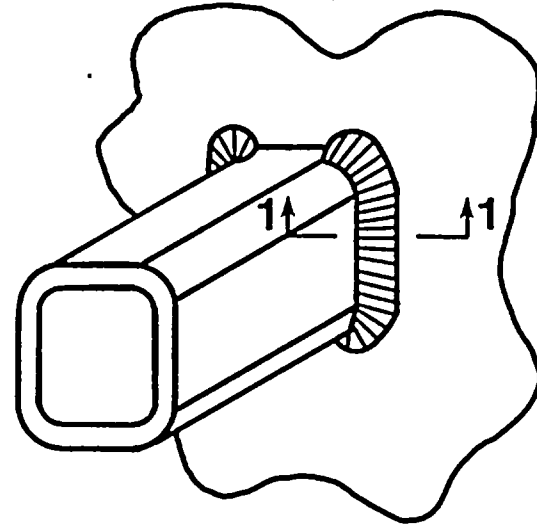
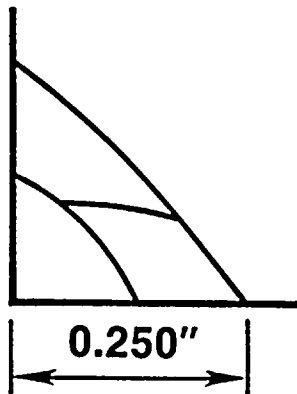
DETAIL A

WELD SIZE SPECIFIED ON DRAWING	_____	0.25"
ACTUAL WELD SIZE	_____	0.19"
WELD SIZE NEEDED	_____	0.08"
SAFETY FACTOR = 0.19 / 0.08 = 2.4

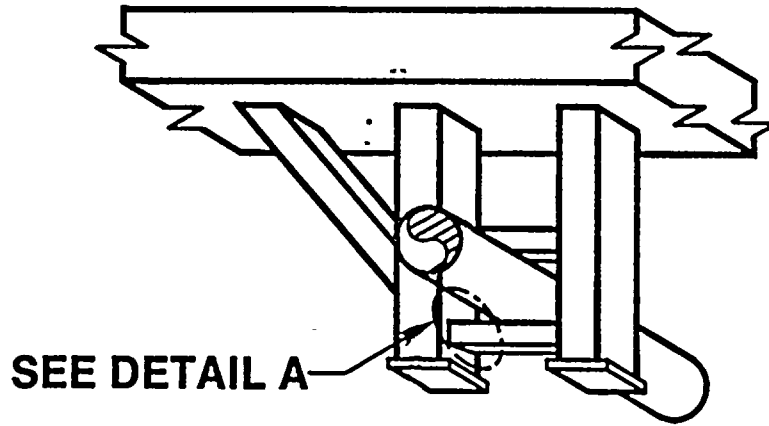
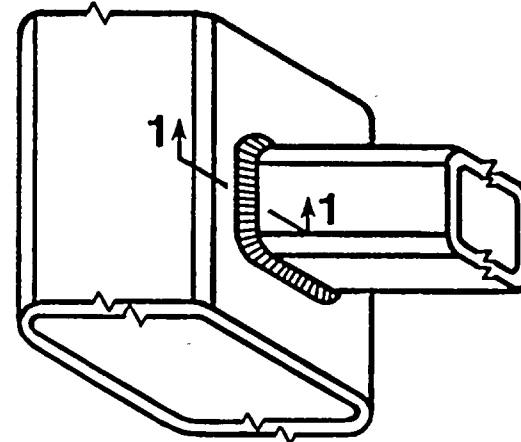
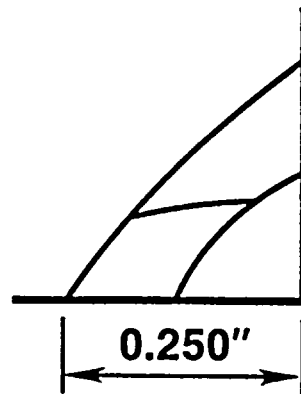
DETAIL A

WELD SIZE SPECIFIED ON DRAWING	_____	0.25"
ACTUAL WELD SIZE	_____	0.19"
WELD SIZE NEEDED	_____	0.07"
SAFETY FACTOR = 0.19 / 0.07 = 2.7
