REGULATORY INFORMATION DISTRIBUTION SYSTEM (RIDS)

SUBJECT: LER 91-009-01: on 910503, ESF actuation occurred due to spurious high radiation level signal. Caused by inadequate welder training program content. Procedure change evaluation initiated. W/910801 ltr.

RE: Docket No. 50-410
LER 91-09, Supplement 1

TITLE (4)
Engineered Safety Feature Actuation due to a Spurious High Radiation Level Signal

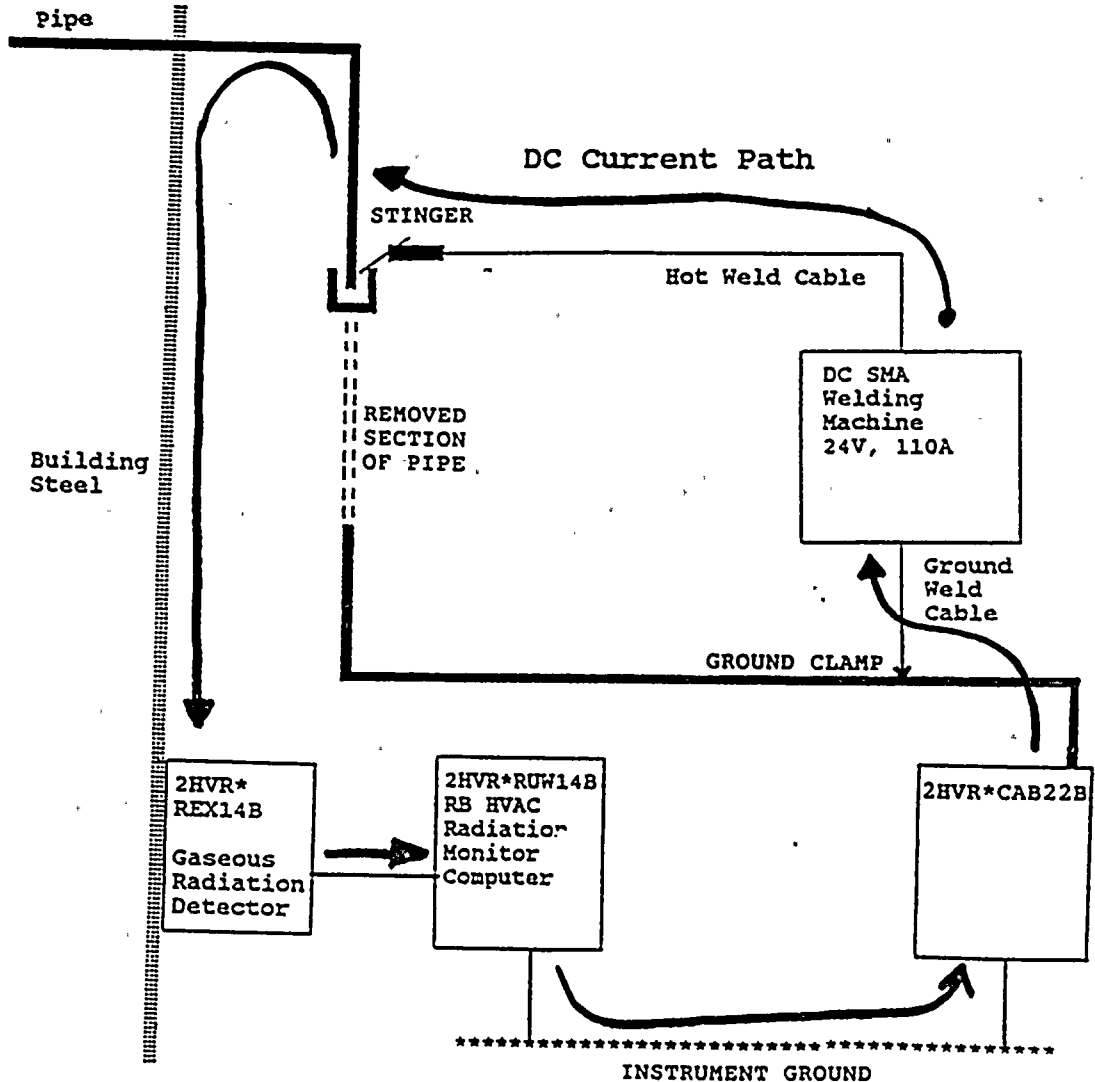
The intermediate cause of this event has been determined to be improper setup of welding equipment. First, the hot and ground leads were run side-by-side and routed near 2HVR*CAB14B instrument cables. A magnetic field built up around the parallel welding leads and induced a voltage in the instrument cabling. Secondly, the welder grounded the welding equipment to the pipe to be welded, but did not consider the ground path after the pipe was cut. The ground was physically close to the pipe being welded, but electrically, it presented a high impedance path from the hot lead to the ground lead (see attached diagram). The result of either or both of these routing problems caused the electrical noise induced spiking and trip of 2HVR*CAB14B. The electrical noise was localized and did not affect identical radiation monitoring equipment six feet away from 2HVR*CAB14B.

The electrical routing between the welding hot cable (Stinger) and the welding ground lead (ground) influences the exposed detector cable signals by providing a path to ground.

2. The current welding instructions provide specific guidance and Engineering evaluation for high frequency AC TIG welding to ensure instrumentation is not impacted. No such controls exist for DC welding. Therefore, until the procedure in action 6 is written, a memo has been written to the Maintenance Managers from Nine Mile Point Units 1 and 2 emphasizing caution when performing any welding near instrumentation. This memo directs that welding cables are routed away from instrumentation cables.
