U. S. NUCLEAR REGULATORY COMMISSION  
REGION I

REPORT NOS. 50-220/92-19  
50-410/92-21

FACILITY NAME: Nine Mile Point Nuclear Station Units 1&2

INSPECTION DATES: July 6-10, and August 24-28, 1992

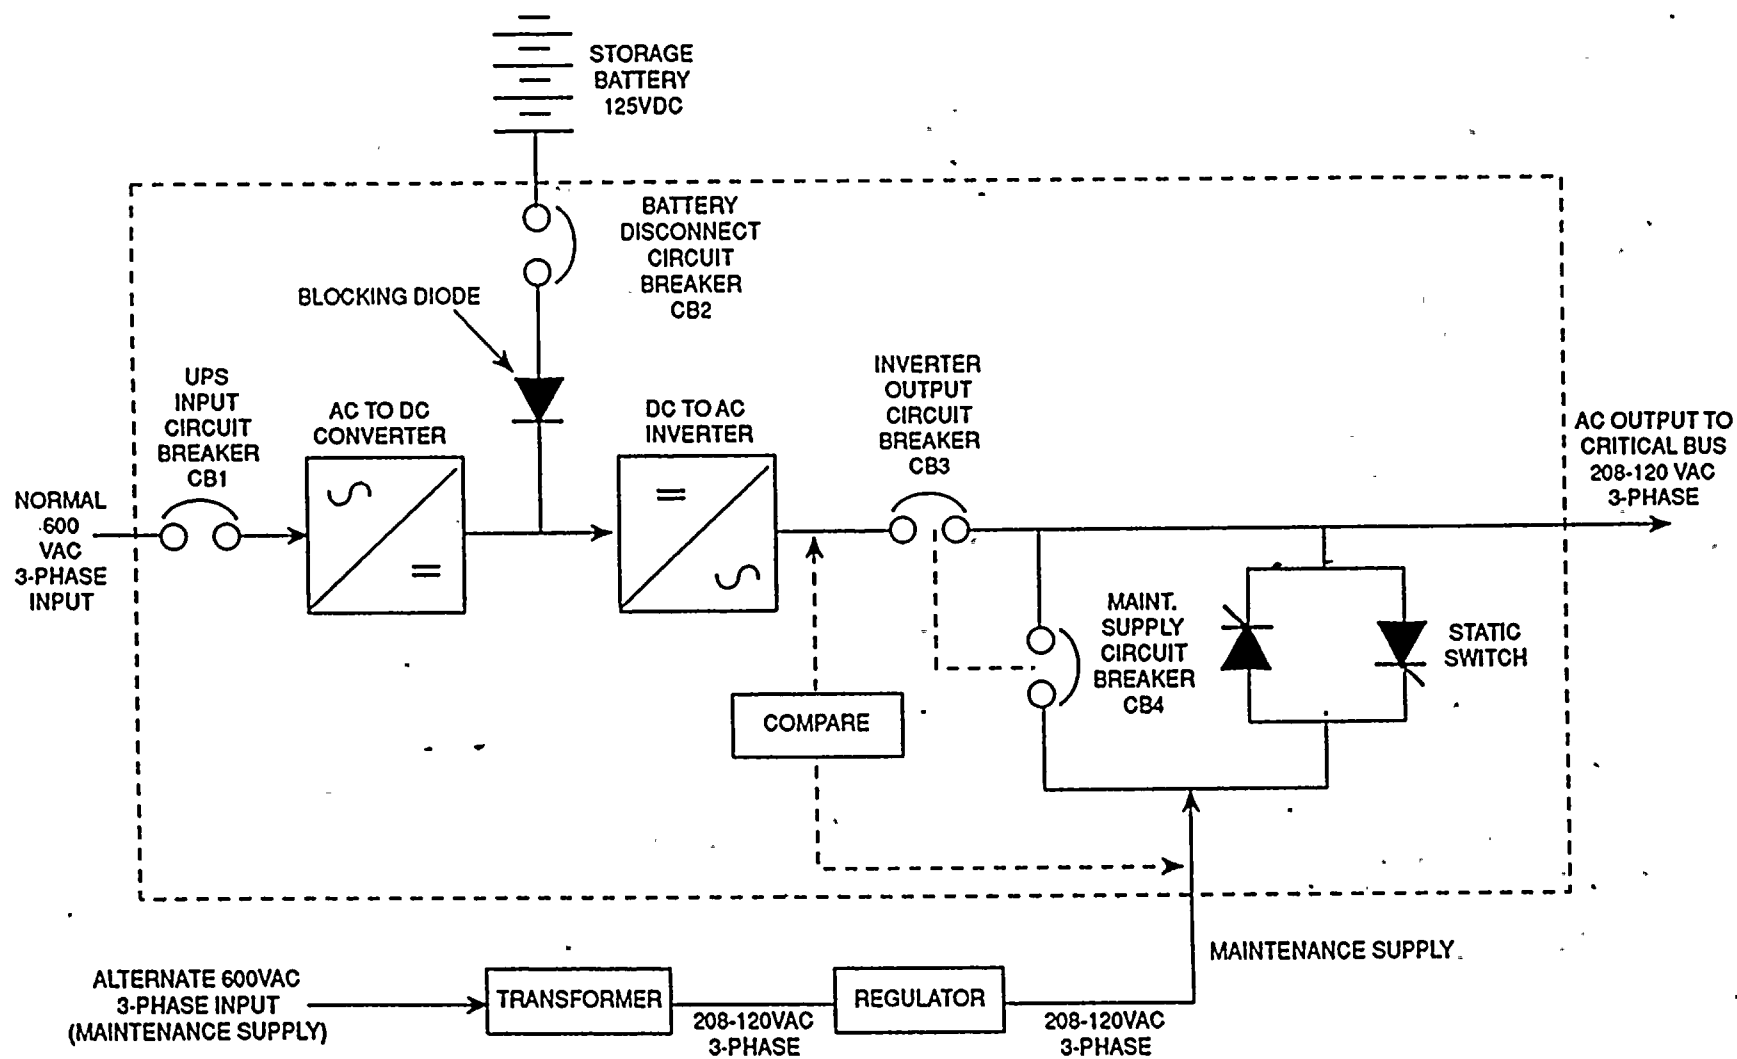
FIGURE 1.0 Simplified electrical single line diagram for a UPS unit

Uninterruptible Power Supplies (UPS) are designed to provide continuous power to important electrical loads should the UPS lose their normal ac power. UPS are designed to preclude the three most common power disturbances which affect the reliable operation of electrical equipment loads: (1) power line noise, (2) power fluctuation, and (3) sudden loss of power. See Section 4.3 of NUREG-1455 for a complete description of the UPS design. A typical electrical simplified single line diagram of a UPS unit is shown in Figure 1.0.

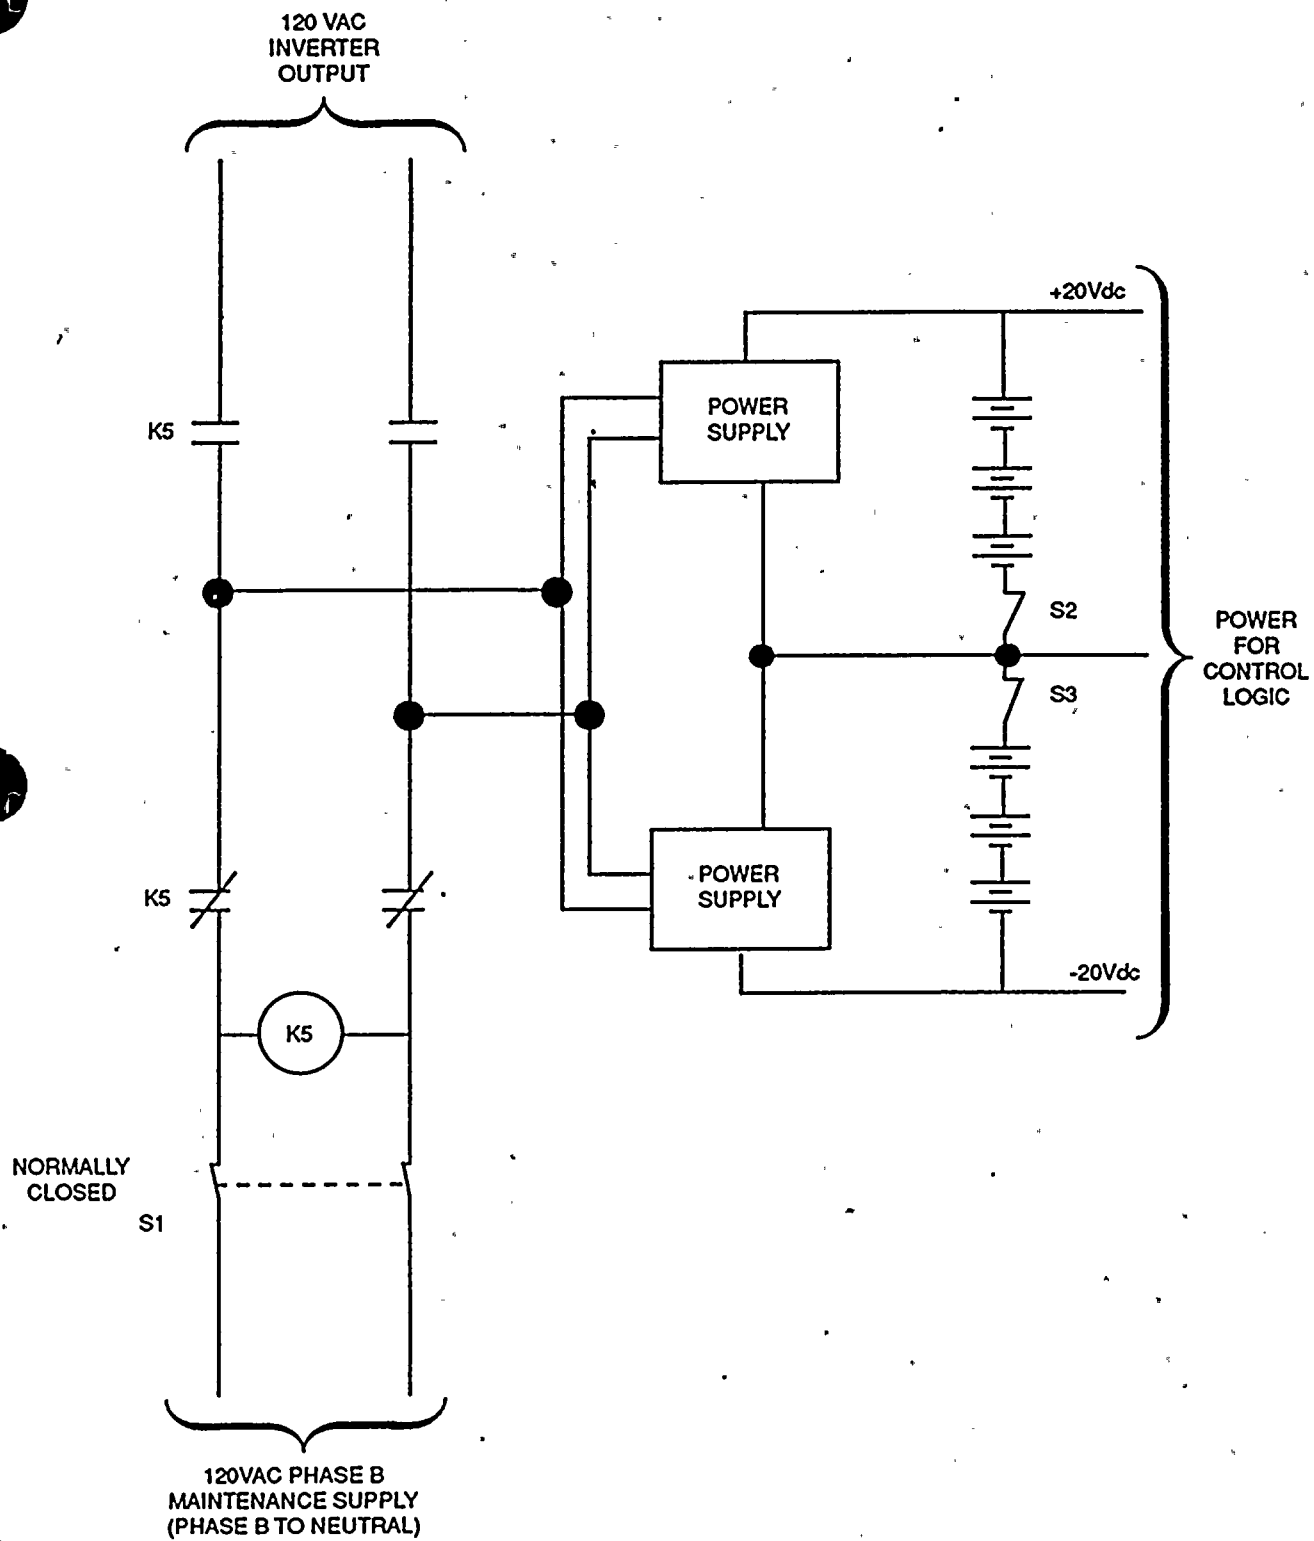
FIGURE 2.0 Simplified diagram for UPS control logic power supply (shown at time of event)

The IIT team, in Section 4.3.4 of their report, identified a concern with the UPS logic power supply. If the maintenance voltage supply degrades, this will result in a loss of the UPS. This concern, a common mode failure of all five UPS units, was confirmed on August 13, 1992, at the Nine Mile Point 2 event.

The Restart Readiness Assessment Team (RRAT) in September 1991, reviewed the licensee's corrective action. The licensee had switched the power supply for the UPS control logic from the maintenance power supply to the more reliable UPS inverter output. In addition, the licensee had replaced all the associated control logic supply batteries for each unit prior to restart.

During this inspection, the inspector noted that the licensee has made additional design changes in the UPS logic power control panel to make these units more reliable and maintainable. A simple design change, SC2-0309-91, implemented by the licensee, has modified the UPS-1A, 1B and 1G UPS units. This modification replaced the existing power supply panel (A27 Pan) internal to the UPS units with an upgraded version. The old power supply panel had two internal power supplies (the maintenance and inverter power supplies). In the old design, a relay (K5) was used to switch the power from one source to another upon failure of the preferred source for the control logic, as shown in Figure 2.0.
