**INVESTIGATION OF SHUTDOWN OF UPS SYSTEMS
(2VBB - 1A, 1B, 1C, 1D, 1G) AT NIAGARA MOHAWK POWER CORP --
NINE MILE POINT 2 NUCLEAR POWER PLANT**

I. EXECUTIVE SUMMARY

**ROOT CAUSE REPORT FOR THE
EXIDE UPS 1A, B, C, D, G
TRIP EVENT OF AUGUST 13, 1991**

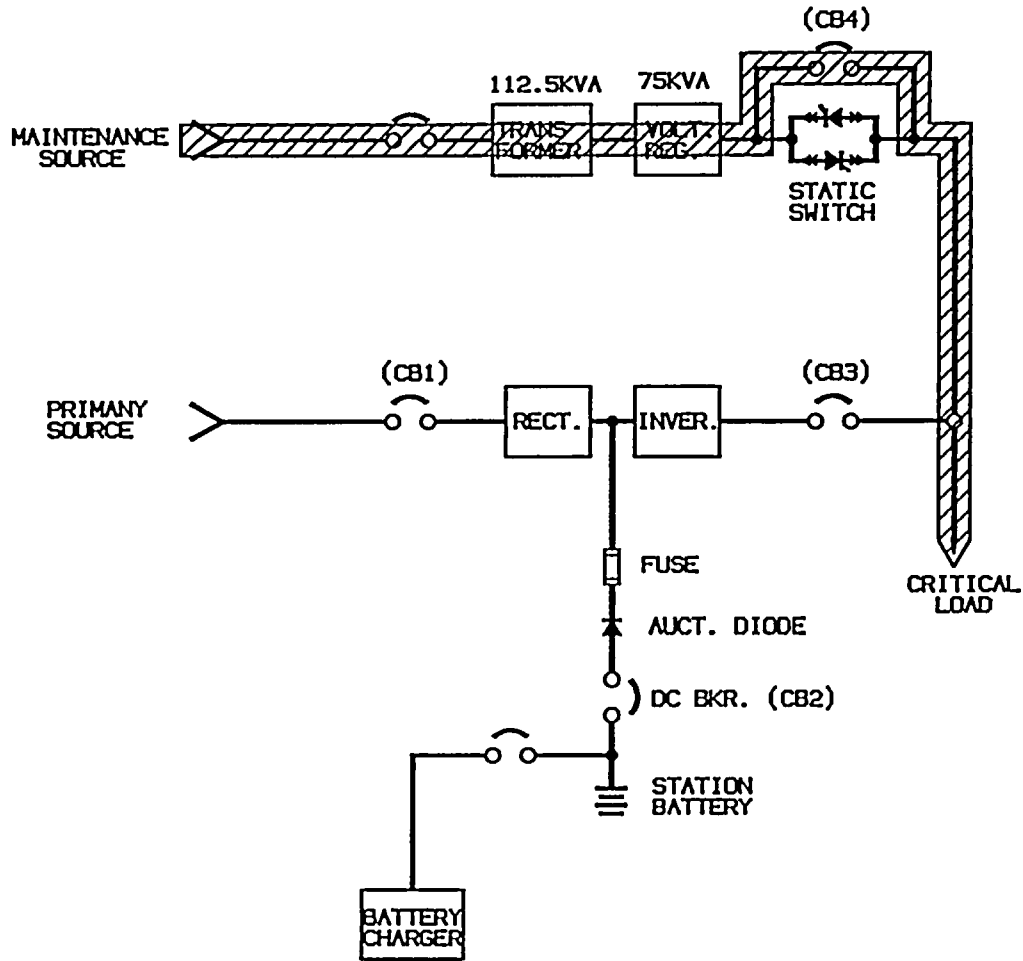
C) UPS Trip, Inverter Failure, or Simultaneous Failure of Rectifier and Station Battery Supply

- 1) Inverter stops.
- 2) Static switch and bypass breaker (CB4) transfer the critical load to maintenance source uninterrupted. But Maintenance Source must be:
 - available
 - within $\pm 10\%$ of the inverter output voltage
 - in sync with inverter output voltage
 - within ± 0.5 Hz of the inverter output frequency
- 4) If maintenance source does not meet transfer conditions, then critical load supply is lost.

Conclusion #1: Condition C4 existed during the event.

The maintenance source was not acceptable during the 12 cycles of phase B power failure and an UPS trip occurred during this time, resulting in critical load loss.

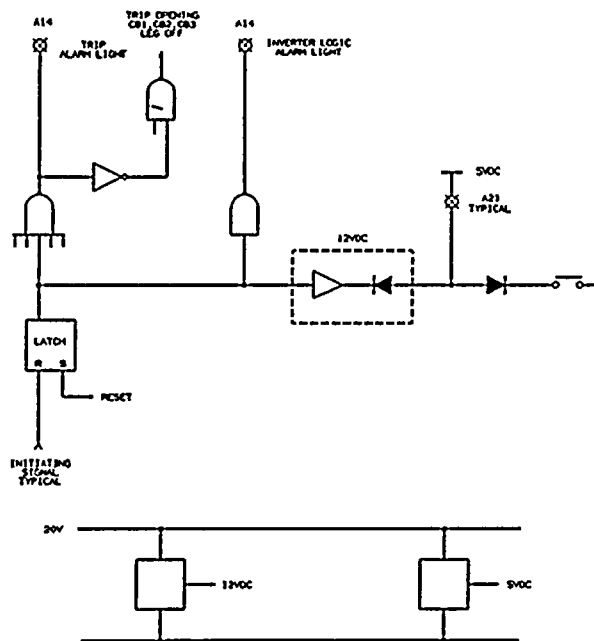
Figure 2: Typical UPS Trip and Alarm Circuit

The cause of an UPS trip is indicated by lamp indications on the UPS Control Panel (A14) and the UPS Card Cage Panel (A13) accompanied by an audible alarm (horn). The horn can be silenced by pushing the button #23 on the control panel. Cause for trip (shut down) of the UPS is indicated by lamps #26 through #35 on the Card Cage panel followed by the inverter logic light #34 on the control panel. The resulting trip of the UPS is indicated by Lamp #24 on the control panel. All trip-related alarms are stored. There is an alarm unstore (reset) button #19 on the printed circuit card A13A21 on the Card Cage panel. The unstore button will extinguish all lamps on the Control panel and Card Cage panel simultaneously.

- 2) Reportedly, none of the trip initiation lamps #26 through #35 on the A13A21 circuit card were lit. But without trip initiation lamp indication, the cause for a UPS trip is not readily evident. The cause for the trip has to be reasoned out.

Logic Power Supply Failure Alarm suspect because of its direct connection to the maintenance source which could explain a simultaneous failure in all 5 UPS systems.

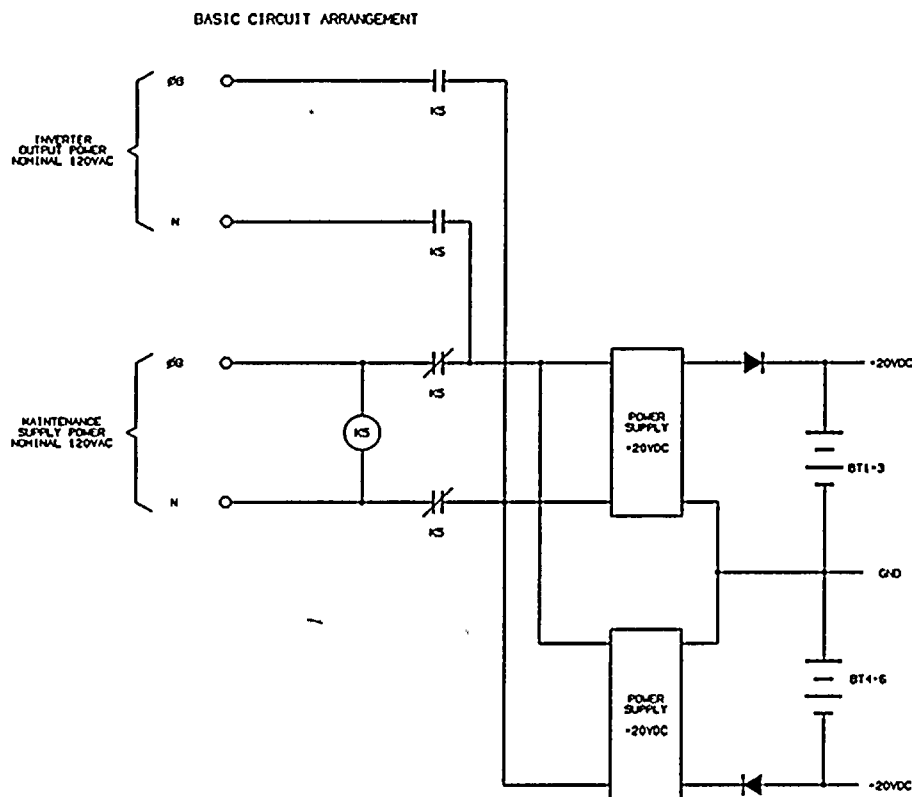
Normally the maintenance source supplies power through the N.O. Contacts of the energized relay K5. If maintenance power fails, K5 drops out and switches to inverter power. In case of power supply fail, the control batteries supply logic power and issue a control battery discharge alarm (lamp #20 on A13A21 annunciation #2 printed circuit board). This alarm is issued if the +/- 20 VDC should fall below 18 VDC. It does not initiate a trip.

Should the \pm 20 VDC logic power supply drop below 16.5 VDC, then a logic power supply failed alarm and UPS trip is issued.

During the shutdown event, the maintenance power to the logic power supplies (phase B to neutral) has to drop from 120 VAC to about 50 VAC in response to the high voltage drop from 200 kV to 80 kV. This voltage may or may not cause K5 to drop out, depending on their individual dropout voltages. If K5 does not drop out, the power supplies may lose regulation and decrease their output DC voltage substantially. The control battery is incorporated as part of the logic power supply design to keep the logic supply voltage above 16.6 VDC during such incidents to avoid a shutdown of the UPS.

The need for battery power was for only 200 milliseconds, hardly a noticeable discharge for properly maintained and fully charged control batteries. After 200 milliseconds, the maintenance power was restored and all conditions should have returned to normal. But due to the batteries deficient state, the batteries were unable to supply control power for the 200 milliseconds required. This was the single contributor to the incident.

These batteries were found to have degraded over time and measured only 0.6 VDC instead of the expected 18.0 VDC. The logic power control batteries had been in service over six (6) years. This is two (2) years over the recommended service life. Exide Electronics had recommended that these batteries be changed, at a minimum, every four (4) years.

1. Niagara Mohawk is aware that the current UPS systems represent technology that is over ten (10) years old. Exide Electronics current UPS systems represent three (3) technological advances and represent state of the art power protection. It is our recommendation that Niagara considers replacement of the present systems with our present designs.
2. If Niagara Mohawk chooses to have Exide Electronics maintain the UPS systems at Nine Mile Point, we recommend our Powercare Preferred Service Package that covers all facets of maintenance, 7 x 24 emergency service, Preventive Maintenance Inspections, modifications and parts.
3. If Niagara Mohawk chooses to continue maintaining this equipment, the following recommendations are applicable:
 - A. Inspect logic power control battery condition at least once every year. (See B. page 11)

- B. Perform annual preventive maintenance on UPS modules per manufacturers recommendations or have manufacturer perform an annual site acceptance test.

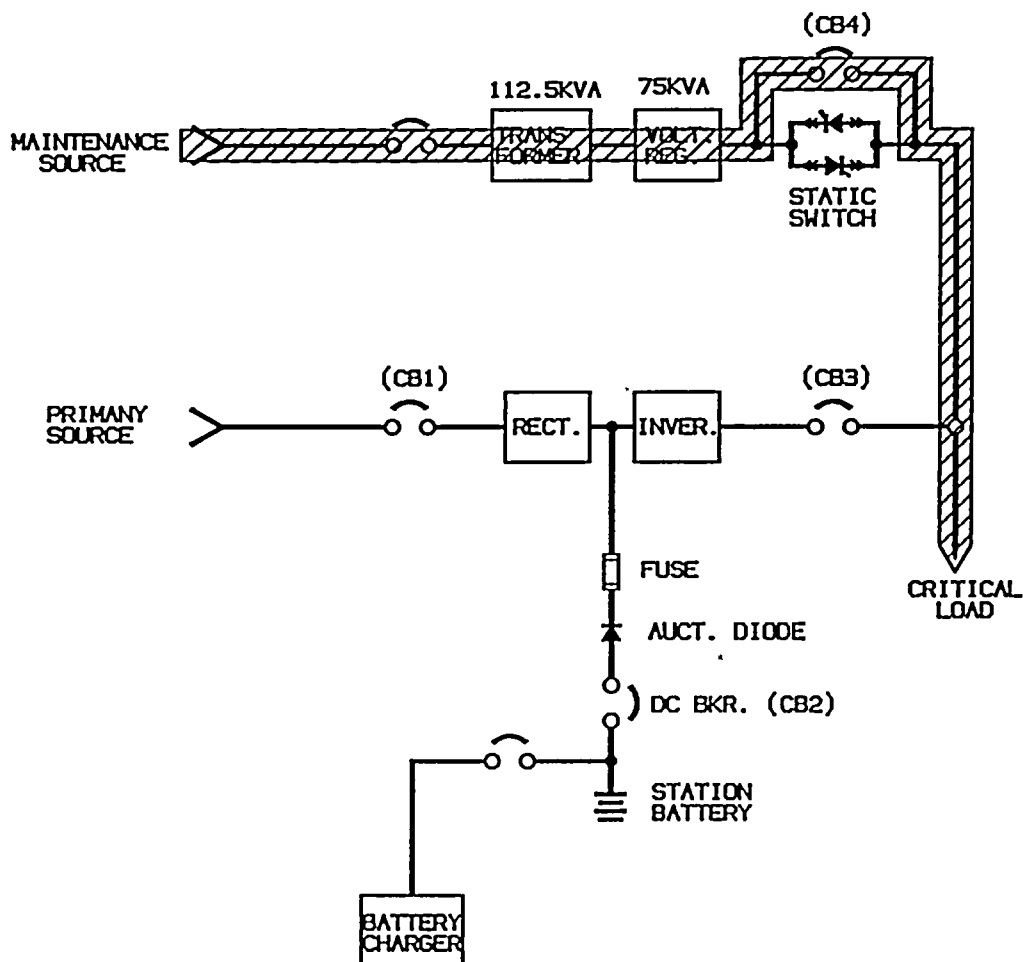
C) UPS Trip, Inverter Failure, or Simultaneous Failure of Rectifier and Station Battery Supply

- 1) Inverter stops.
- 2) Static switch and bypass breaker (CB4) transfer the critical load to maintenance source uninterrupted. But Maintenance Source must be:
 - available
 - within $\pm 10\%$ of the inverter output voltage
 - in sync with inverter output voltage
 - within ± 0.5 Hz of the inverter output frequency
- 4) If maintenance source does not meet transfer conditions, then critical load supply is lost.

Conclusion #1: Condition C4 existed during the event.

The maintenance source was not acceptable during the 12 cycles of phase B power failure and an UPS trip occurred during this time, resulting in critical load loss.

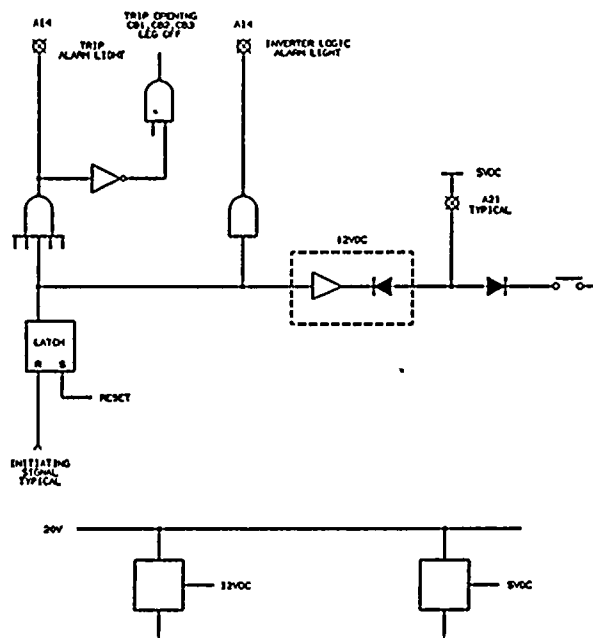
Figure 2: Typical UPS Trip and Alarm Circuit

The cause of an UPS trip is indicated by lamp indications on the UPS Control Panel (A14) and the UPS Card Cage Panel (A13) accompanied by an audible alarm (horn). The horn can be silenced by pushing the button #23 on the control panel. Cause for trip (shut down) of the UPS is indicated by lamps #26 through #35 on the Card Cage panel followed by the inverter logic light #34 on the control panel. The resulting trip of the UPS is indicated by Lamp #24 on the control panel. All trip-related alarms are stored. There is an alarm unstore (reset) button #19 on the printed circuit card A13A21 on the Card Cage panel. The unstore button will extinguish all lamps on the Control panel and Card Cage panel simultaneously.

- 2) Reportedly, none of the trip initiation lamps #26 through #35 on the A13A21 circuit card were lit. But without trip initiation lamp indication, the cause for a UPS trip is not readily evident. The cause for the trip has to be reasoned out.

Logic Power Supply Failure Alarm suspect because of its direct connection to the maintenance source which could explain a simultaneous failure in all 5 UPS systems.

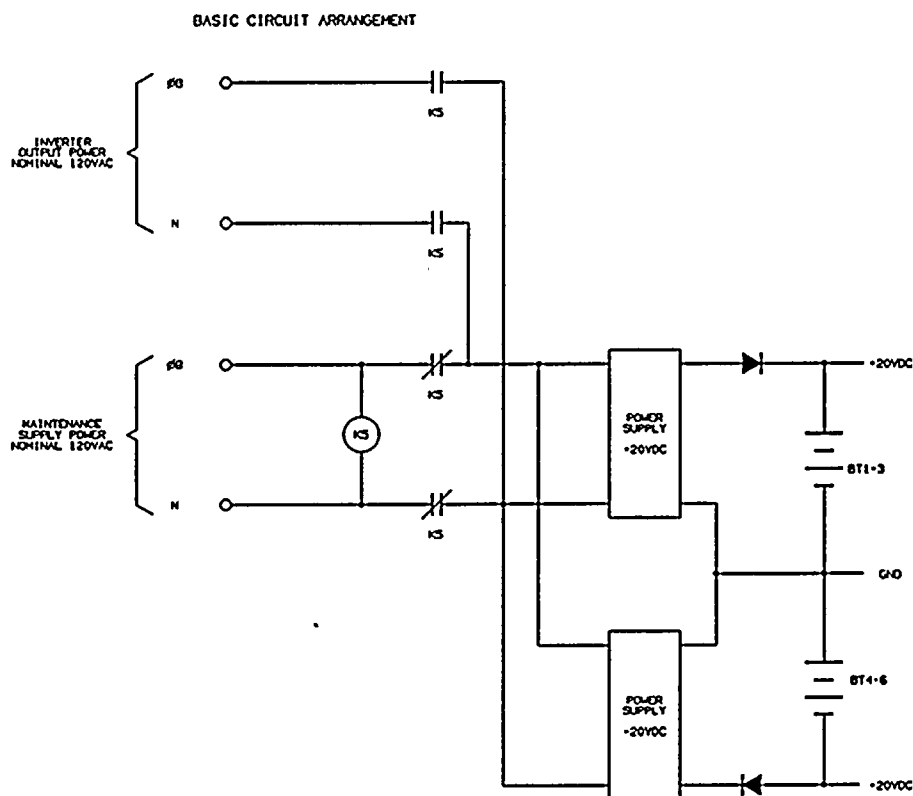
Normally the maintenance source supplies power through the N.O. Contacts of the energized relay K5. If maintenance power fails, K5 drops out and switches to inverter power. In case of power supply fail, the control batteries supply logic power and issue a control battery discharge alarm (lamp #20 on A13A21 annunciation #2 printed circuit board). This alarm is issued if the +/- 20 VDC should fall below 18 VDC. It does not initiate a trip.

Should the \pm 20 VDC logic power supply drop below 16.5 VDC, then a logic power supply failed alarm and UPS trip is issued.

During the shutdown event, the maintenance power to the logic power supplies (phase B to neutral) has to drop from 120 VAC to about 50 VAC in response to the high voltage drop from 200 kV to 80 kV. This voltage may or may not cause K5 to drop out, depending on their individual dropout voltages. If K5 does not drop out, the power supplies may lose regulation and decrease their output DC voltage substantially. The control battery is incorporated as part of the logic power supply design to keep the logic supply voltage above 16.6 VDC during such incidents to avoid a shutdown of the UPS.

The need for battery power was for only 200 milliseconds, hardly a noticeable discharge for properly maintained and fully charged control batteries. After 200 milliseconds, the maintenance power was restored and all conditions should have returned to normal. But due to the batteries deficient state, the batteries were unable to supply control power for the 200 milliseconds required. This was the single contributor to the incident.

- B. Perform annual preventive maintenance on UPS modules per manufacturers recommendations or have manufacturer perform an annual site acceptance test.

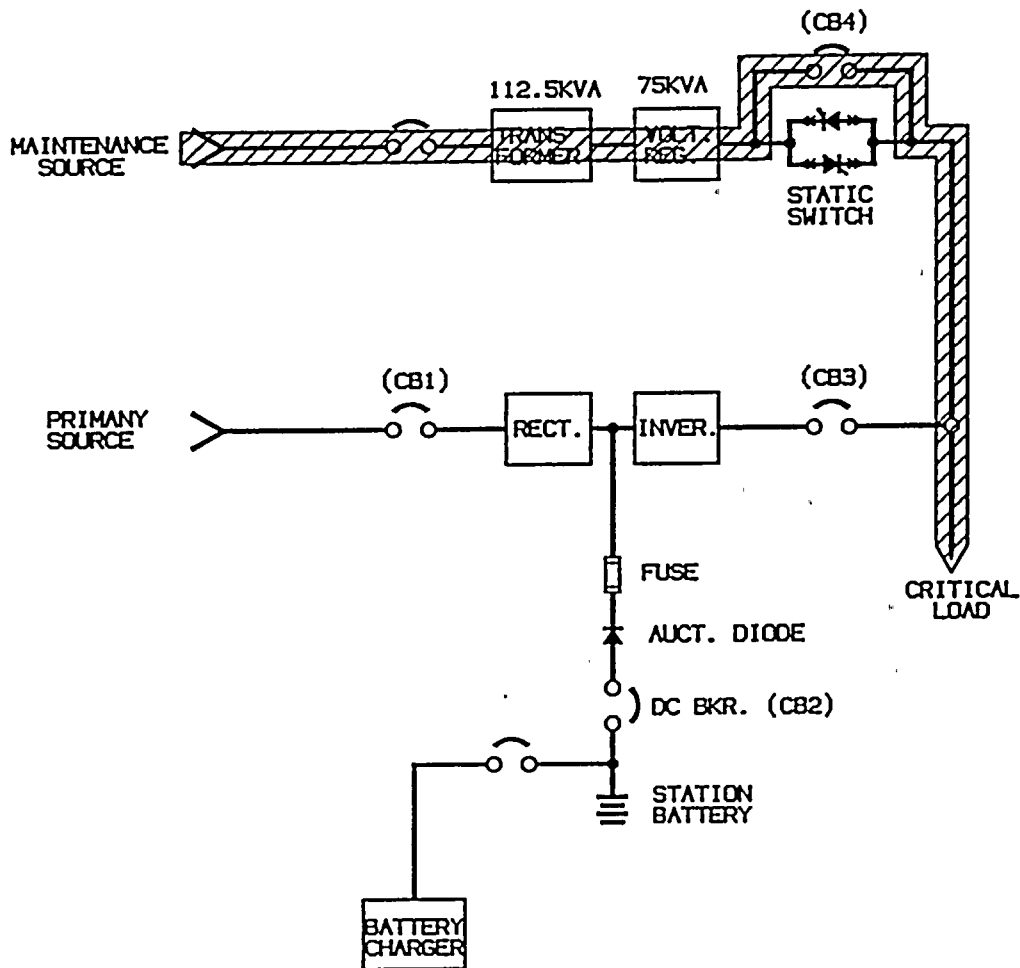
C) UPS Trip, Inverter Failure, or Simultaneous Failure of Rectifier and Station Battery Supply

- 1) Inverter stops.
- 2) Static switch and bypass breaker (CB4) transfer the critical load to maintenance source uninterrupted. But Maintenance Source must be:
 - available
 - within $\pm 10\%$ of the inverter output voltage
 - in sync with inverter output voltage
 - within ± 0.5 Hz of the inverter output frequency
- 4) If maintenance source does not meet transfer conditions, then critical load supply is lost.

The maintenance source was not acceptable during the 12 cycles of phase B power failure and an UPS trip occurred during this time, resulting in critical load loss.

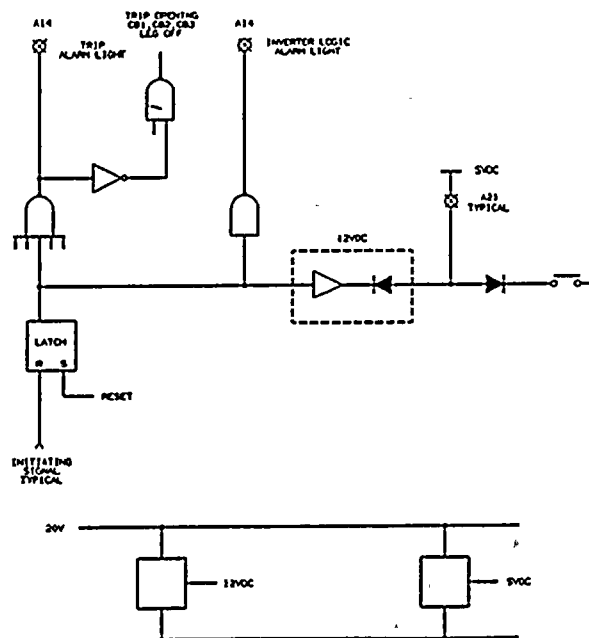
Figure 2: Typical Fast UPS Trip and Alarm Circuit

The cause of an UPS trip is indicated by lamp indications on the UPS Control Panel (A14) and the UPS Card Cage Panel (A13) accompanied by an audible alarm (horn). The horn can be silenced by pushing the button #23 on the control panel. Cause for trip (shut down) of the UPS is indicated by lamps #26 through #35 on the Card Cage panel followed by the inverter logic light #34 on the control panel. The resulting trip of the UPS is indicated by Lamp #24 on the control panel. All trip-related alarms are stored. There is an alarm unstore (reset) button #19 on the printed circuit card A13A21 on the Card Cage panel. The unstore button will extinguish all lamps on the Control panel and Card Cage panel simultaneously.

Logic Power Supply Failure Alarm suspect because of its direct connection to the maintenance source which could explain a simultaneous failure in all 5 UPS systems.

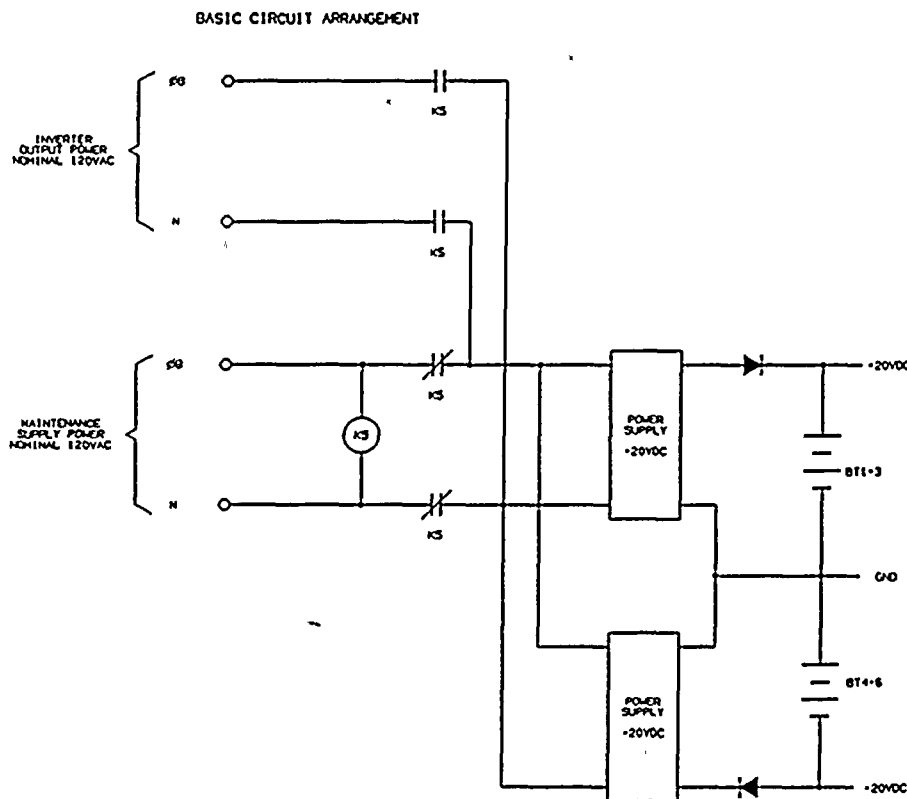
Normally the maintenance source supplies power through the N.O. Contacts of the energized relay K5. If maintenance power fails, K5 drops out and switches to inverter power. In case of power supply fail, the control batteries supply logic power and issue a control battery discharge alarm (lamp #20 on A13A21 annunciation #2 printed circuit board). This alarm is issued if the +/- 20 VDC should fall below 18 VDC. It does not initiate a trip.

Relay K5 drops out between 78 VAC max and 25 VAC min variation between relays. The power supplies lose regulation if the AC supply drops below 96 VAC, and trip between 86 VAC mx and 78 VAC min.

By design, should the logic supply voltage drop below 16.5 VDC, the logic power supply alarm is generated and the UPS trip signal is issued. This is, in fact, what the test results proved.

- B. Perform annual preventive maintenance on UPS modules per manufacturers recommendations or have manufacturer perform an annual site acceptance test.
