SUBJECT: SUMMARY OF JUNE 10, 1993, MEETING TO DISCUSS THE INSPECTION AND

POSSIBLE REPAIR OF A FLAW IN HIGH PRESSURE CORE SPRAY NOZZLE

WELD KC-32 AT NINE MILE POINT NUCLEAR STATION, UNIT 2

HIGH PRESSURE CORE SPRAY SAFE END TO SAFE END EXTENSION WELD 2-RPV-KC32

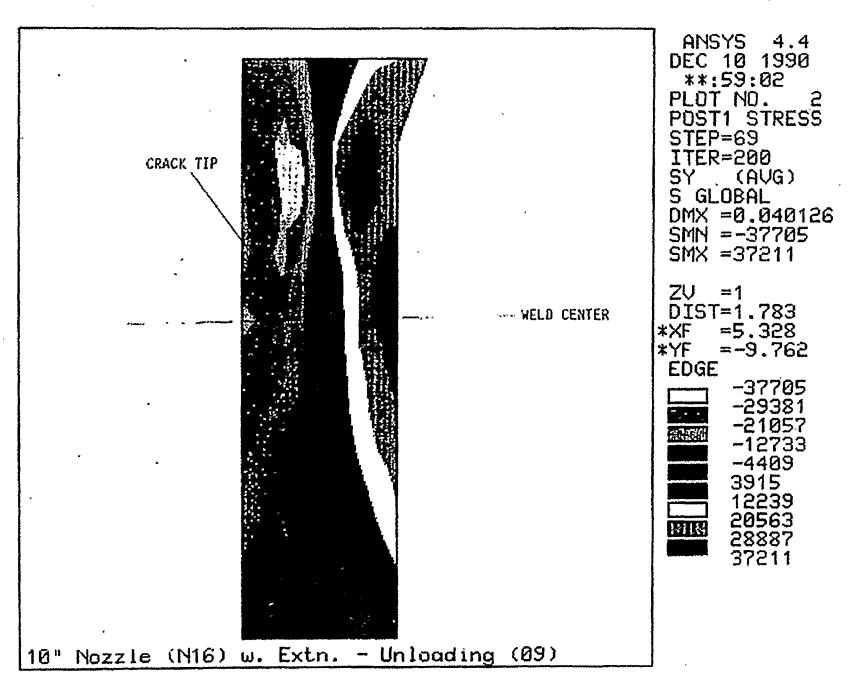
FIGURE 3.7 POST MSIP AXIAL STRESSES IN THE SAFE-END-TO-EXTENSION WELD (0.788% CONTRACTION)

- INELASTIC ANALYSIS BASED ON THE ACTUAL POST-MSIP DISTRIBUTION CORRESPONDING TO FIELD MEASURED PIPE CONTRACTION INDICATES THAT THE CRACK REMAINS IN THE COMPRESSIVE REGION. NO FURTHER FRACTURE MECHANICS EVALUATION NECESSARY
- UT INSPECTIONS CONFIRM THAT CRACK HAS BEEN ARRESTED
- ANALYSIS RESULTS RECONFIRM THAT SAFE OPERATION CAN BE CONTINUED
