SUBJECT: Special rept: on 930726, offgas recombiner trains A & B
 isolated on low flow shortly after valving in steam to SJAE
 B. Suspects isolation caused by passing slug of water from
 SJAE B train. Operating Procedure N2-OP-9 will be revised.

John H. Mueller
Plant Manager-Unit 2
Nuclear GenerationSeptember 1, 1993
NMP88389United States Nuclear Regulatory Commission
Attn: Document Control Desk
Washington, DC 20555RE: Nine Mile Point Unit 2
Docket No. 50-410
NPF-69**Subject: Special Report**

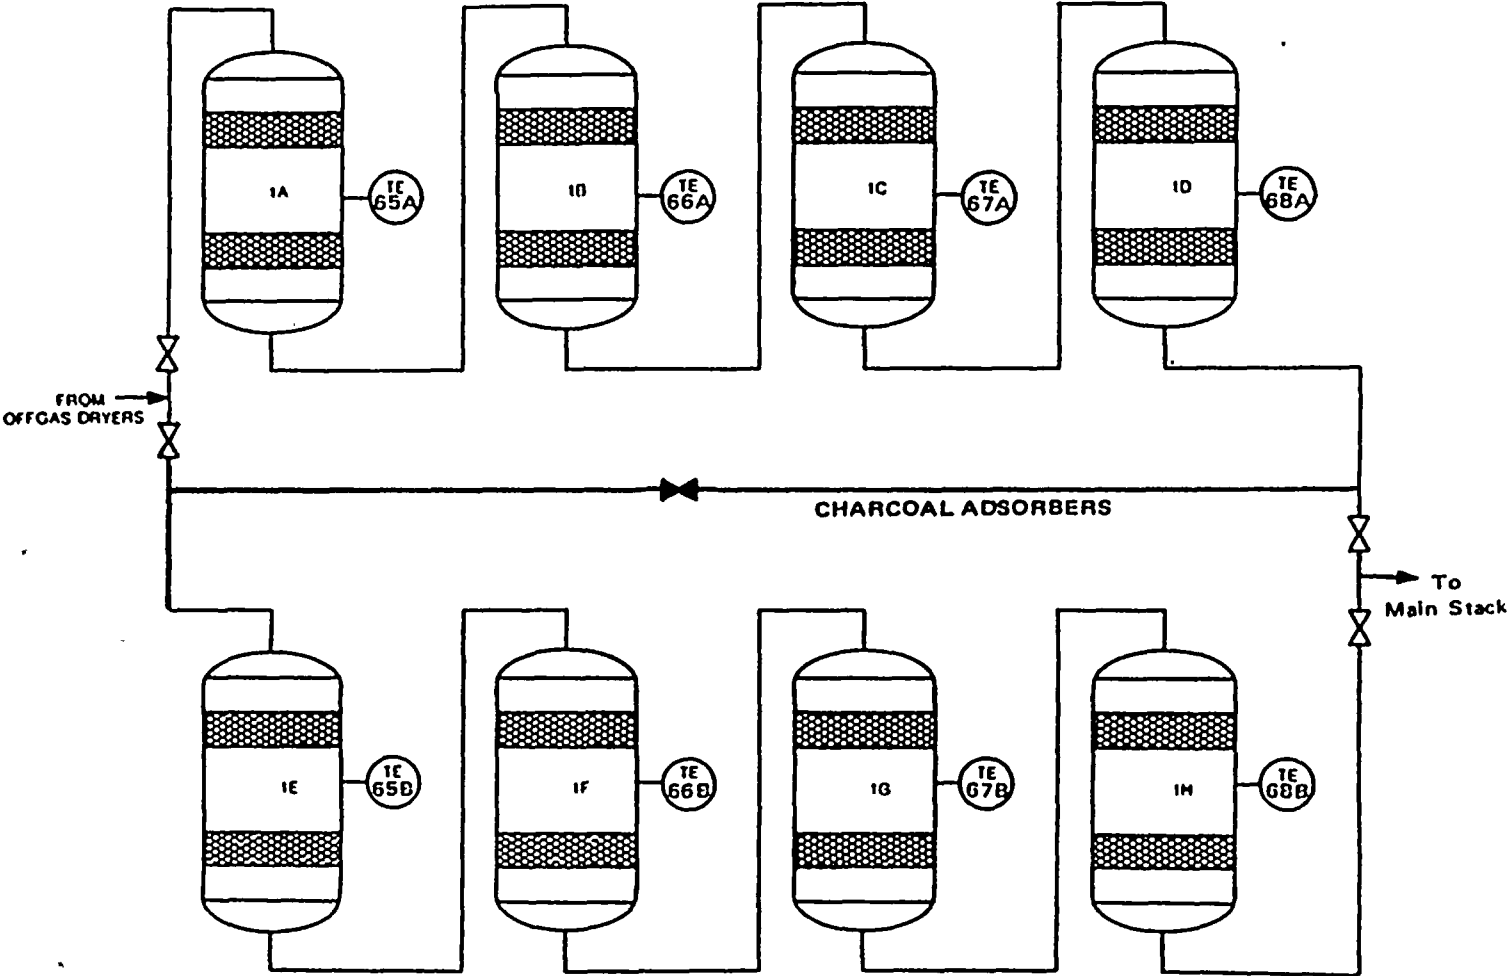
ATTACHMENT 1

Between 0800 and 2200 hours on July 26, 1993, the temperatures for the first two charcoal adsorber beds in each adsorber train (1A and 1E - see attached drawing) rose from a nominal 60 to 70 degrees Fahrenheit to 99 and 121 degrees Fahrenheit, respectively. At 2200 hours, operators investigating the temperature rise in the 1A and 1E charcoal beds found the vessel shell at the top of the 1A and 1E beds very warm to the touch. At 0200 hours on July 27, 1993, charcoal vessel top temperatures were measured at 250 degrees Fahrenheit for bed 1A and 286 degrees
