SUBJECT: LER 93-011-00:on 931119,reactor scram & ESF actuation  
 occurred.Caused by poor work organization & planning.  
 Work planning guide revised & procedure changes will be  
 evaluated.W/931220 ltr.

FACILITY NAME (1) <b>Nine Mile Point Unit 2</b>	DOCKET NUMBER (2) <b>0 5   0 0   0 4   1 0</b>	PAGE (3) <b>1 OF 017</b>
--	---	-----------------------------

TITLE (4)  
**Reactor Scram and ESF Actuation Caused by Poor Work Organization and Planning**

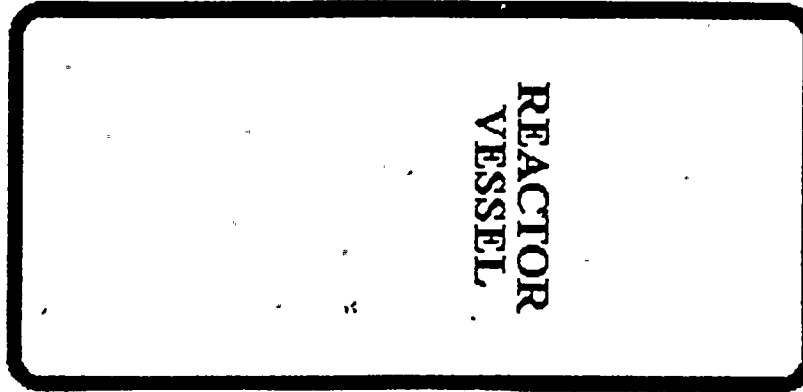
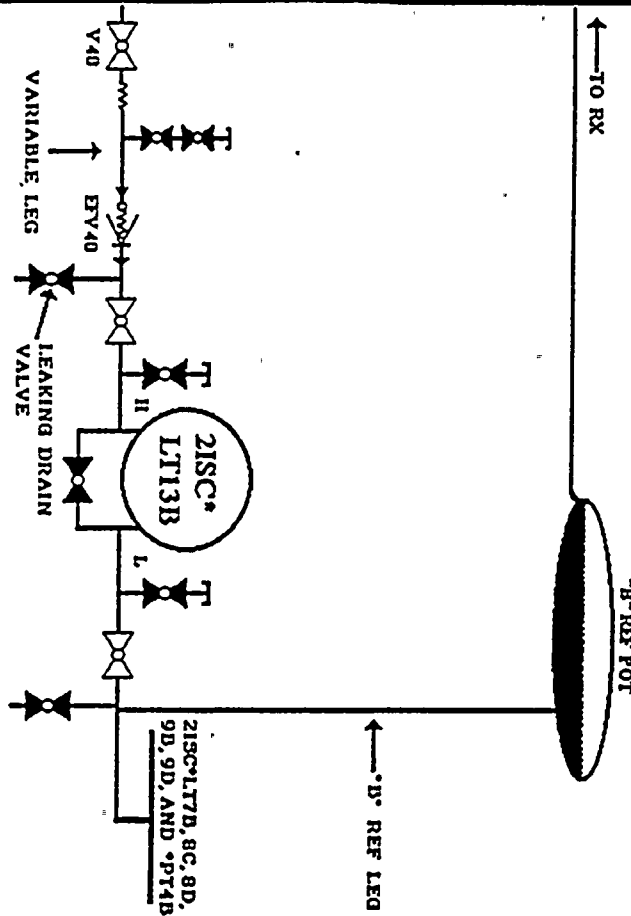
FIGURE 1

The root cause of this event was poor work organization and planning. The variable leg instrument root valve was closed prior to isolating instruments on the affected instrument line. The process of valving a level transmitter out of service then caused a hydraulic perturbation in the reference leg instrument line, initiating the Division II RRCS and ECCS signals.

During the performance of Instrument and Control Surveillance Procedure N2-ISP-ISC-R002, "Reactor Instrument Line Excess Flow Check Valve Operability Test with Process Fluid and Pressure," excess flow check valve 2ISC\*EFV40 failed to close properly (see Figure 1). This valve is located on the variable leg of the fuel zone level transmitter 2ISC\*LT13B. The reference leg for this level transmitter is the "B" instrument reference leg. A Work Order was initiated to replace the valve. At 0119 hours, a red markup (tagout) was placed on root valve 2ISC\*V40 (on the variable leg), isolating the excess flow check valve from the reactor vessel. At this time, the fuel zone level recorder indicated that the reactor vessel level went from offscale high to offscale low. However, other reactor vessel level indications remained offscale high due to the reactor being flooded up for the hydrostatic leak testing. The low level on the fuel zone recorder indicates a loss of pressure in the variable leg of the fuel zone level transmitter. At approximately 0337 hours, the fuel zone level transmitter 2ISC\*LT13B was being taken out of service to support excess flow check valve replacement. During this process of valving the fuel zone level transmitter out of service, a hydraulic perturbation was experienced on the "B" instrument reference leg. The perturbation caused a pressure spike on the "B" reference leg for reactor level transmitters 2ISC\*LT7B, 9B, 9D, 8C and 8D, and reactor high pressure transmitter 2ISC\*PT4B, initiating the event described in the above paragraph. There were no perturbations experienced on any of the other instrument reference legs.

of the level transmitter decreased, indicating a leakage path downstream of the root valve. Then, the process of valving the level transmitter out of service caused a hydraulic perturbation in the instrument reference leg. The possible causes for this hydraulic perturbation include:

1. not fully closing the transmitter's reference leg isolation valve,
2. dirt or debris on the valve seat of the transmitter's reference leg isolation valve,
3. a damaged seat or disc that allowed leakage past the transmitter's reference leg isolation valve seat, or
4. an improper valving sequence for isolating the level transmitter.

The exact cause of the perturbation is not known. It is postulated that the level transmitter's isolation valve on the reference leg leaked by, due to not being completely closed, because of inadequate torque or dirt/debris under the valve seat which was flushed clear prior to the testing on November 25, 1993. The reference leg momentarily depressurized when the level transmitter equalization valve was opened. This was caused by the high differential pressure that existed between the reference leg and variable leg of the level transmitter. This pressure difference initiated a surge in the reference leg which caused a pressure spike on the level and pressure transmitters associated with that reference leg.

6. Problem Identification (PID) #3723 was written to repair/replace the drain valve on the variable leg of level transmitter 2ISC\*LT13B. This work will be done during the fourth refueling outage, currently scheduled for Spring 1995.
