U.S. NUCLEAR REGULATORY COMMISSION  
REGION I

REPORT/DOCKET NO. 50-410/93-81  
LICENSE NO. NPF-69  
LICENSEE: Niagara Mohawk Power Corporation  
FACILITY NAME: Nine Mile Point Unit 2  
INSPECTION DATES: November 29, 1993 through December 17, 1993,  
and January 24-28, 1994

Areas Inspected: Announced team inspection by regional and contracted personnel to review the functionality of Nine Mile Point Unit 2 electrical distribution system.

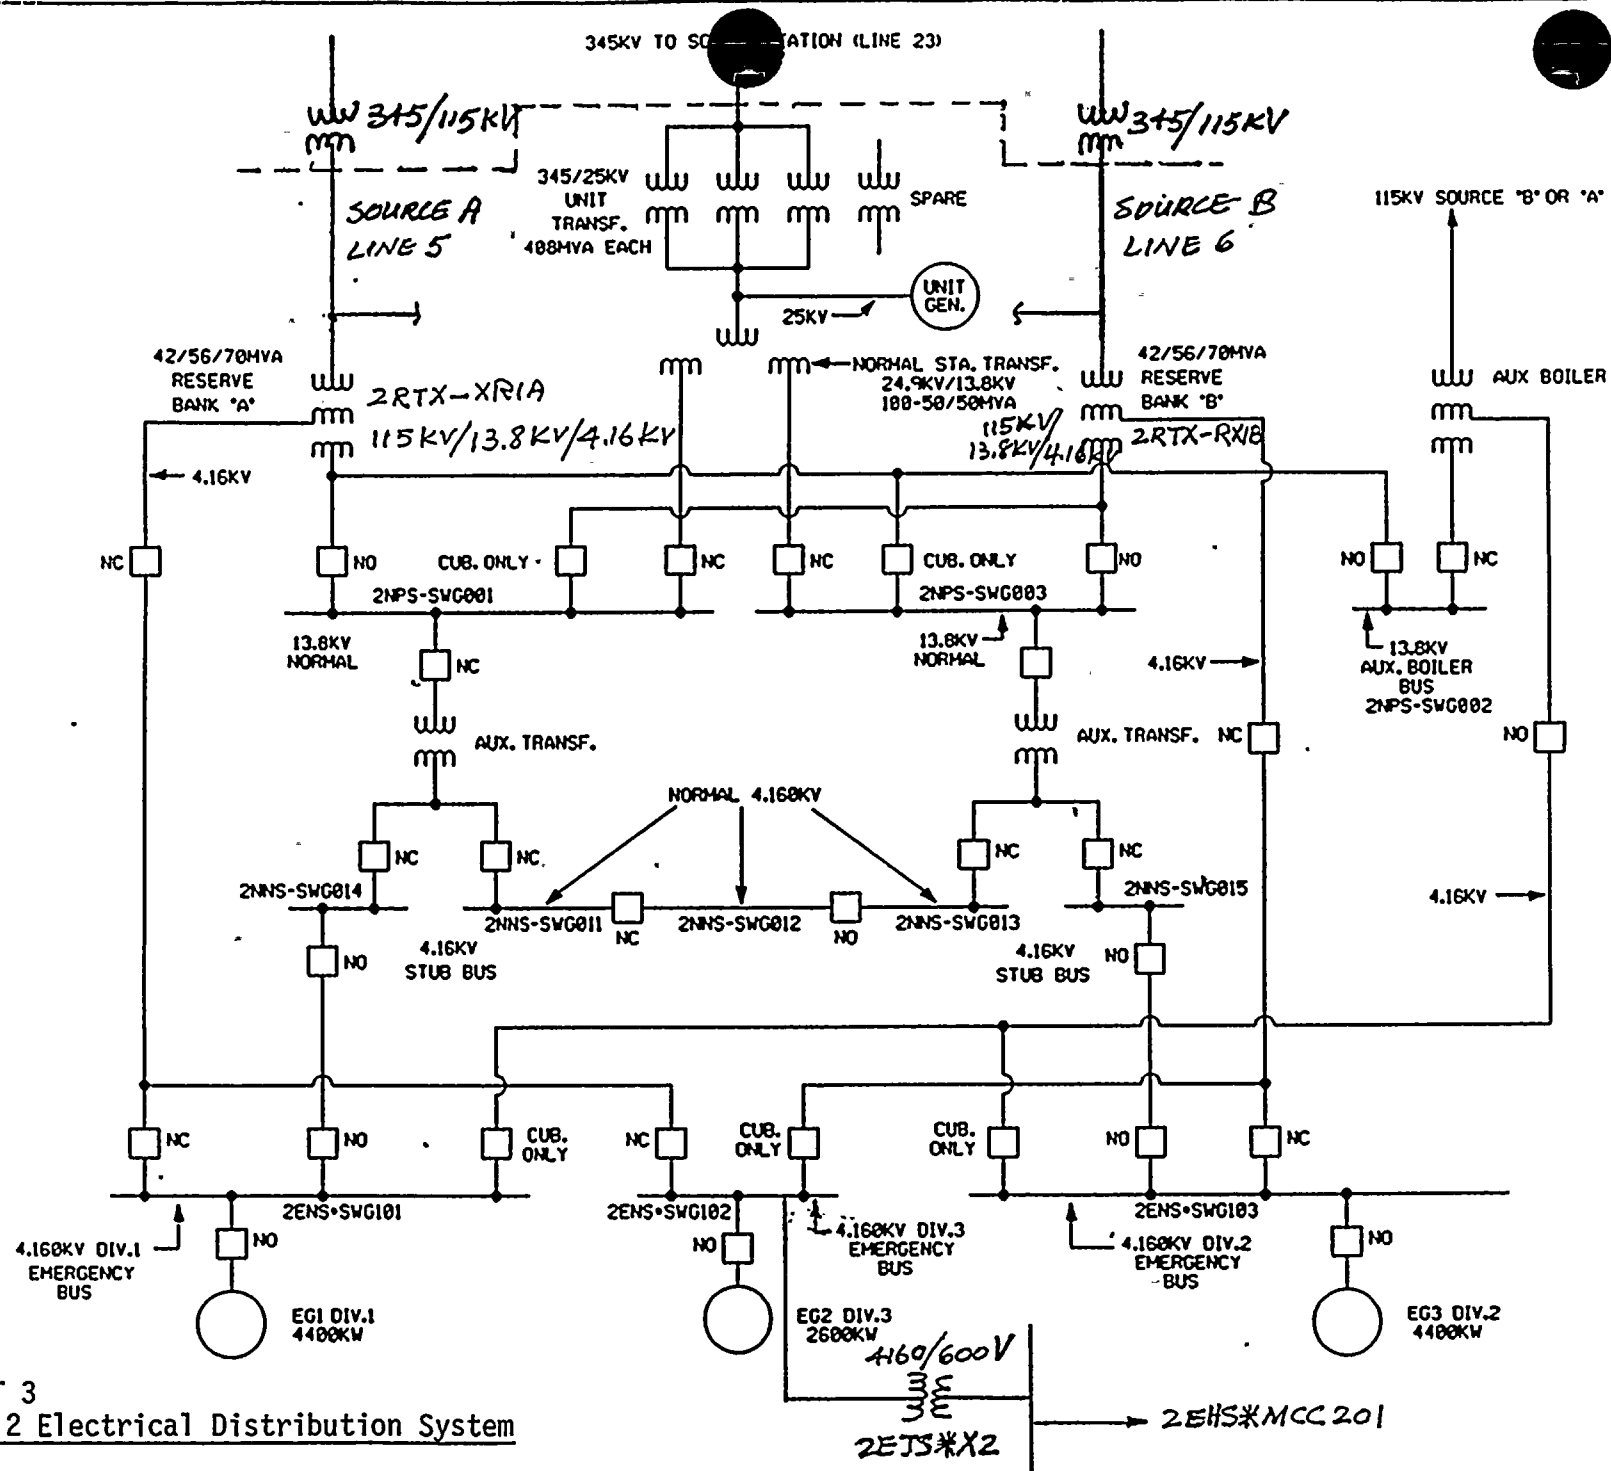
ATTACHMENT 3  
 Nine Mile 2 Electrical Distribution System

The electrical power output of the NMP2 main generator was rated 1348.4 MVA, 0.9 power factor at 25 kV. The generator output voltage was stepped up to 345 kV by a 408 MVA transformer bank located at the station. Connection of this transfer bank to the NMPC grid was made at the Scriba 345/115 kV switchyard which is located approximately 3000 feet from NMP2. In addition to this connection from NMP2, the 345 kV section of the Scriba switchyard also had connections to (a) the NMP1 output, (b) the Fitzpatrick nuclear station output, and (c) the NMPC network via two transmission lines. The 345 kV section of the Scriba switchyard utilized a breaker and a half scheme with two 345-115 kV autotransformers. These two autotransformers were equipped with automatic load tap changers (ALTC) and each served a separate bus in the 115 kV section. These ALTCs were in the auto-mode and the output voltage of each auto transformer was set at 118 kV. The NMP2 electrical distribution system is shown in Attachment 3.
