U.S. NUCLEAR REGULATORY COMMISSION

Report Nos.: 94-03
94-03

Facility: Nine Mile Point, Units 1 and 2

Dates: January 23 - March 5, 1994

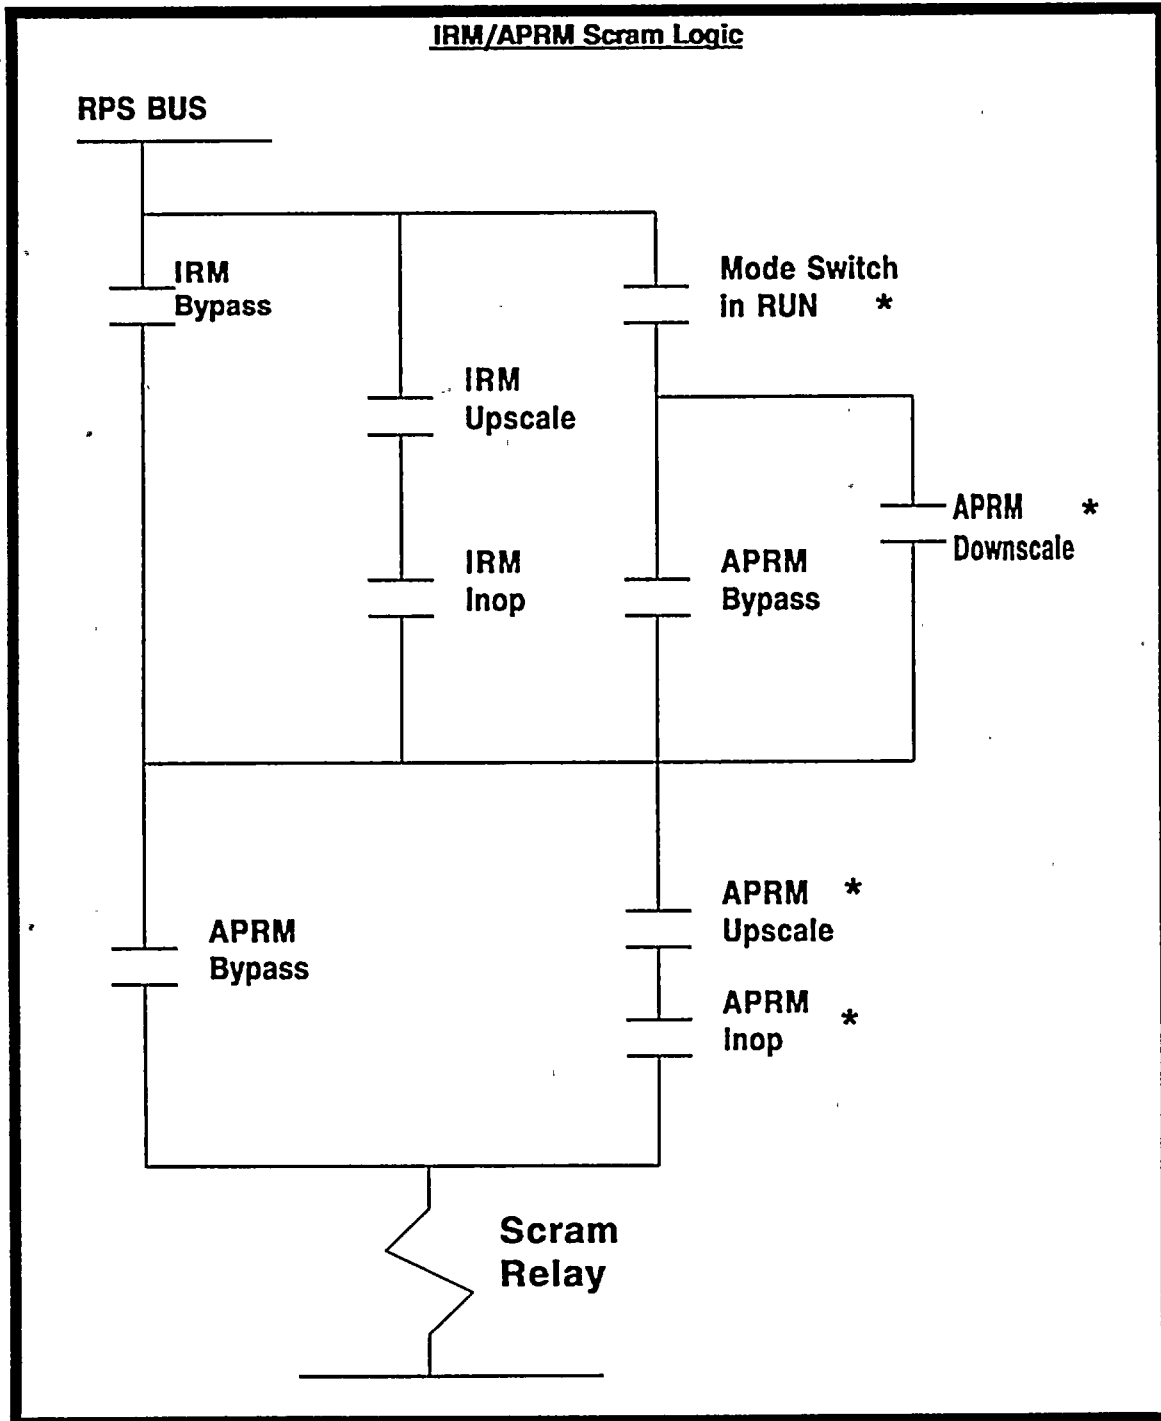
ATTACHMENT 1

Reference the attached drawing (typical of four channels per trip system).

- the four contacts marked with an asterisk are closed,
- the IRM Upscale and Inop are closed, and
- the IRM and APRM bypass contacts are open.

Thus, the associated scram relay is kept energized. Specifically, the IRM upscale scram function (greater than 95% of full scale) is in parallel with the APRM downscale scram function (less than 5% of full scale). An IRM that is in standby causes the IRM Inop contact to open, enabling the associated APRM to generate a half-scram signal if the indication falls below 5% of full scale; the four IRMs that are in operate basically bypassed that scram signal. The inspectors questioned the appropriateness of 4 of 8 of the APRM channels having one of the Technical Specification scram functions apparently bypassed during power operations while the other 4 channels have enabled the downscale scram function.

Unit 1 TSs require the IRM upscale and the APRM downscale trip functions to be operable when the reactor mode switch is in the RUN position. The initial purpose of this coincidence circuit was to ensure the operators maintained an indication of reactor power during startup. An associated note states that the IRMs are bypassed when the APRMs are onscale and the APRM downscale is bypassed when the IRMs are onscale. The note was confusing and allowed for different interpretations. The inspectors initially determined that the APRM downscale scram function should be enabled based on review of the TS bases, related deficiency/event reports (DERs) and safety evaluations, comparison to instrumentation of other plants of similar vintage, and discussions with NMPC engineering and operations personnel. In May 1992, NMPC initiated a DER due to the accelerated failure of IRM detectors; the IRM detectors were partially inserted into the reactor to ensure an upscale indication that would cause the IRM upscale contact to open, thereby enabling the APRM downscale scram function. The final disposition of the DER stated that the IRM should be fully withdrawn (as recommended by the vendor), this would cause the IRMs to indicate onscale. Thus the APRM downscale scram function would be bypassed. The safety evaluation did not provide an adequate justification for the change in operating philosophy.
