U.S. NUCLEAR REGULATORY COMMISSION

Docket/Report Nos.: 50-220/96-06
50-410/96-06

Facility: Nine Mile Point, Units 1 and 2

Dates: March 31 - June 1, 1996

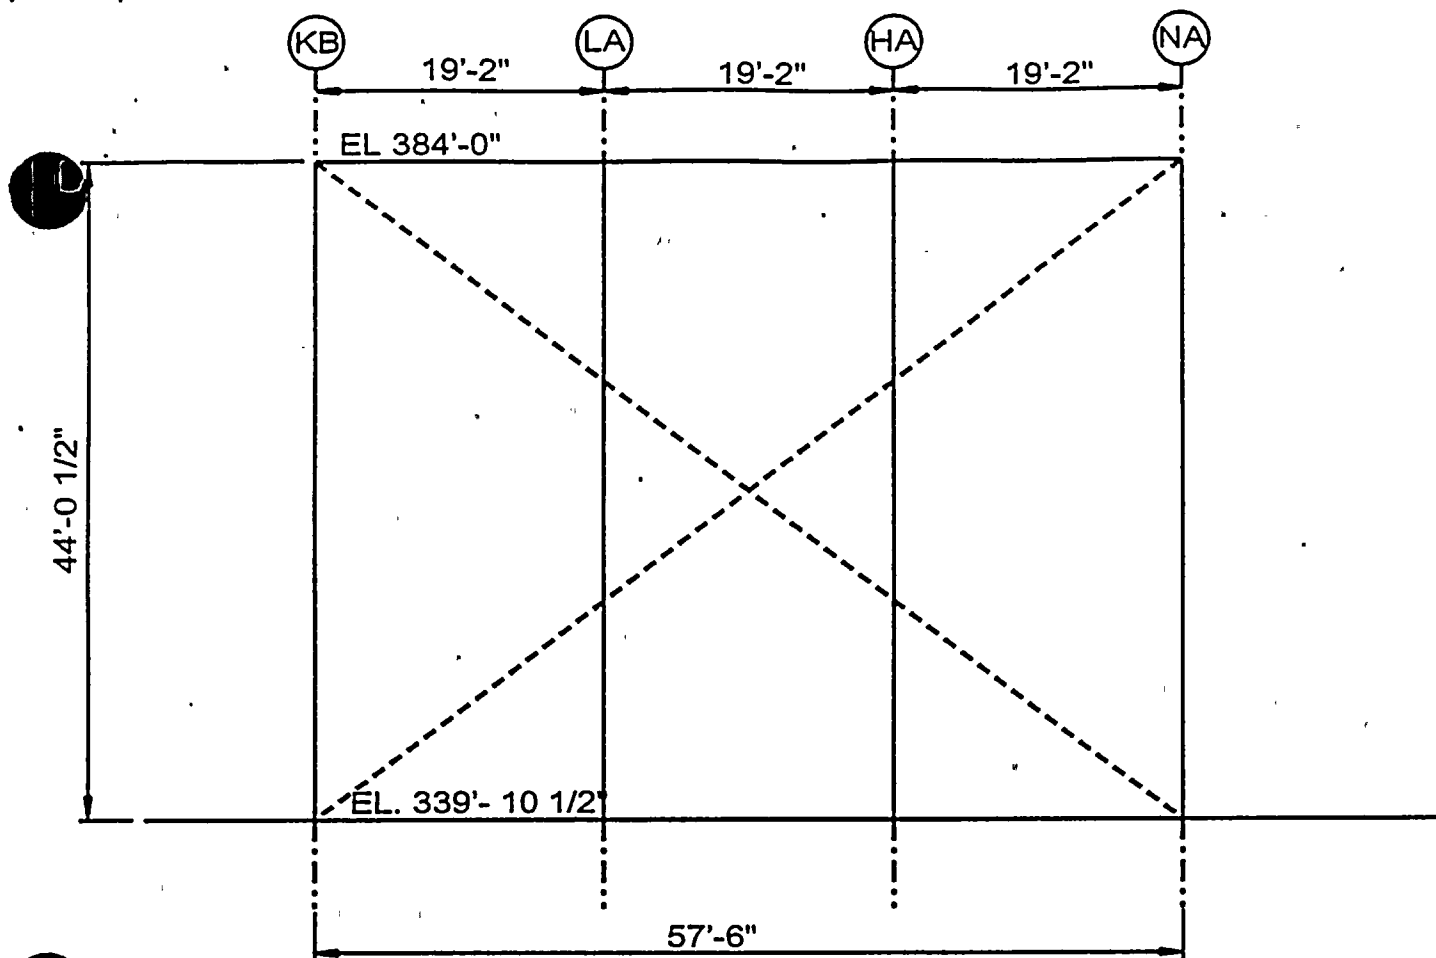
REACTOR BUILDING PRESSURE RELIEF WALL PANELS
(ELEVATION LOOKING EAST)

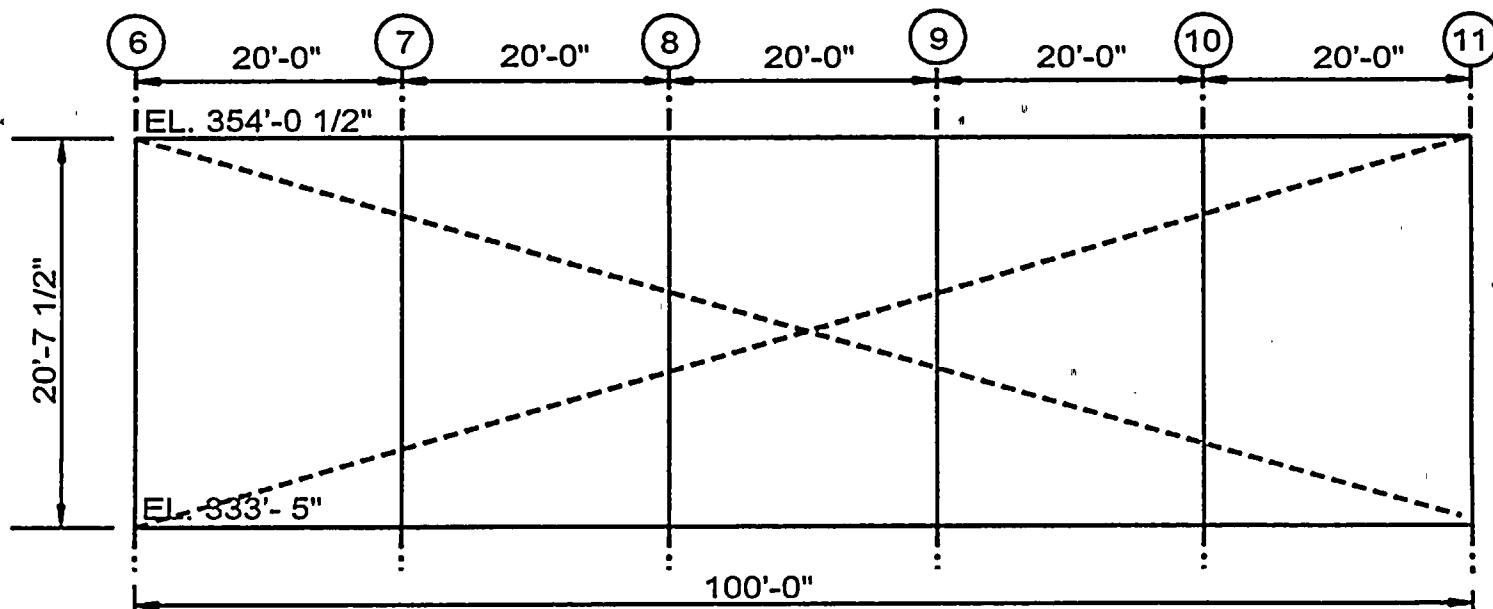
TURBINE BUILDING PRESSURE RELIEF WALL PANELS
(ELEVATION LOOKING NORTH)
